A large mid- Saxon timber structure in the intertidal zone  
Sea View, Mersea Island, Essex  
Coastal and Intertidal Zone Archaeological Network Report  
September 2022

A large mid- Saxon timber structure in the intertidal zone  
Sea View, Mersea Island, Essex, TM 02631 12256  
Coastal and Intertidal Zone Archaeological Network (CITiZAN) Report

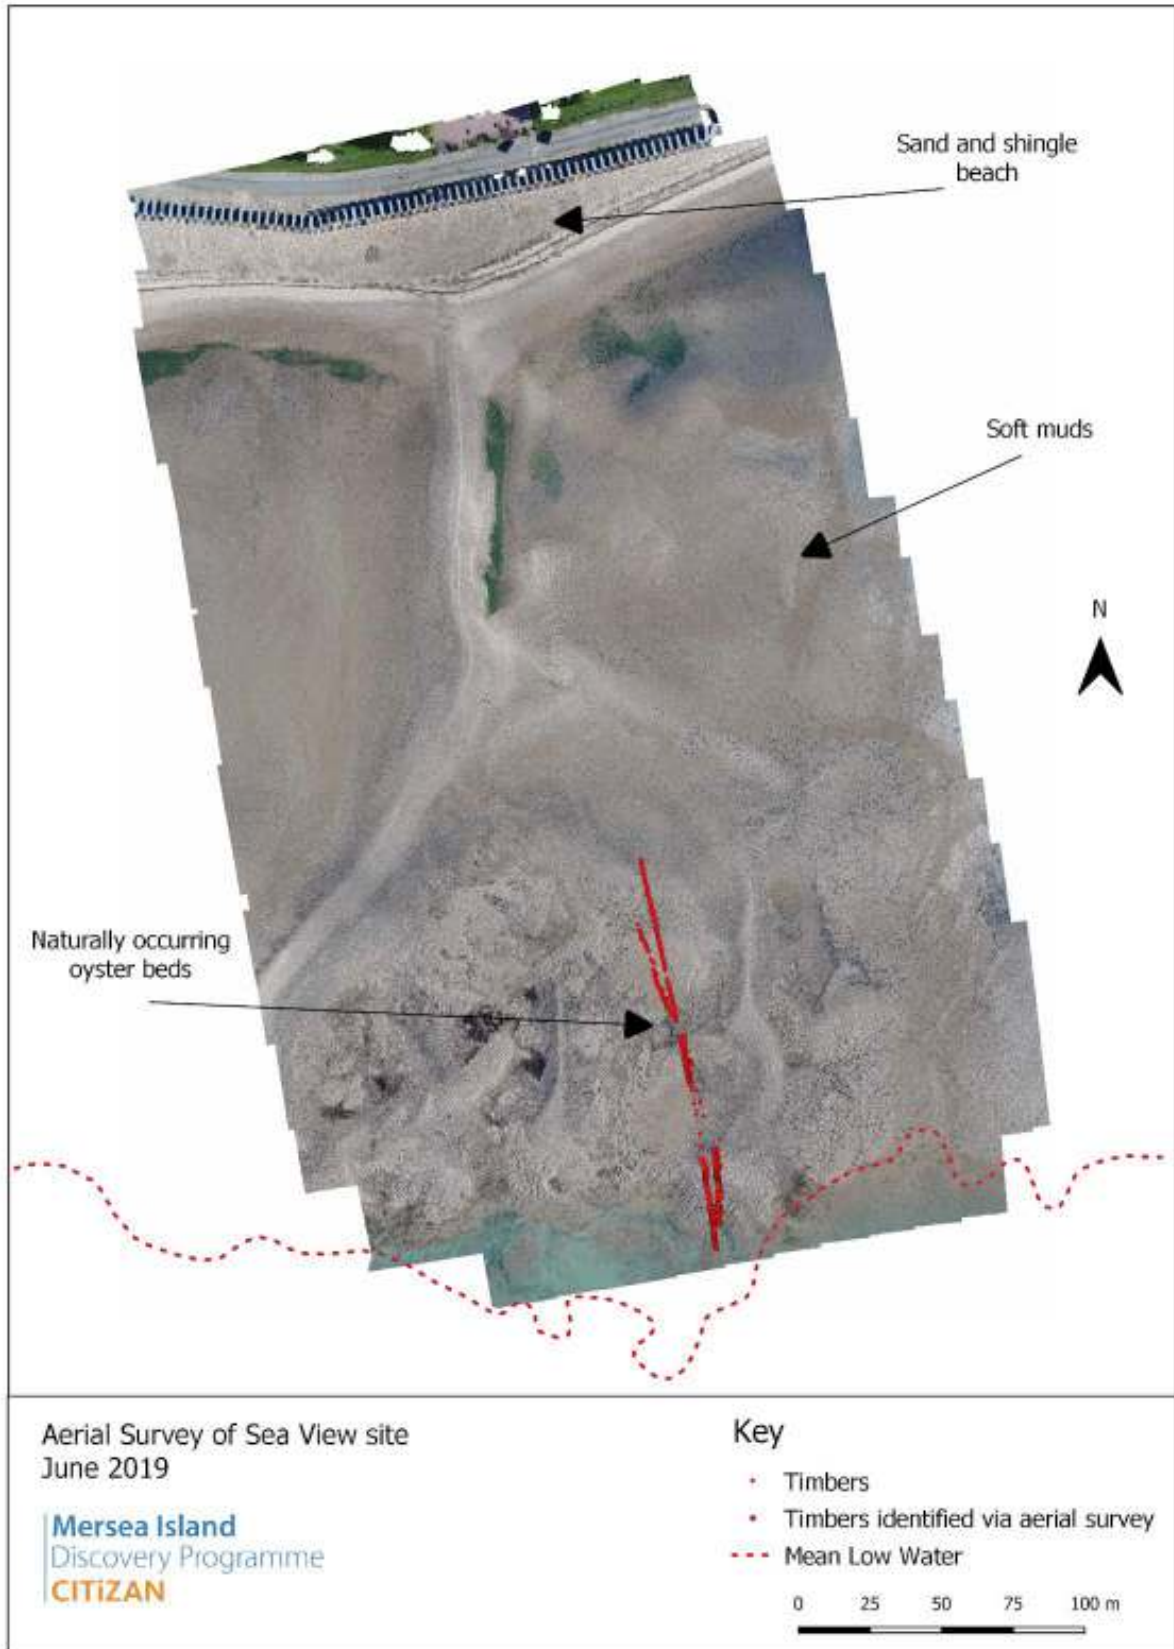
Figure 2: Aerial survey of Sea View Site, June 2019

CITiZAN were alerted to the Sea View site by volunteer James Pullen in the late summer of 2019. He described groups of linear timbers features perpendicular to the present shoreline with a complex arrangement of smaller stakes and uprights towards the low water line. He went on to produce an aerial survey (*fig.2*) of the area and proposed CITiZAN visit the site for an initial walkover survey to confirm that the site was not modern and of archaeological interest. This was undertaken by CITiZAN Archaeologist Oliver Hutchinson in October 2019 and a sample of uprights were surveyed to record presence/absence of bark, tool marks, dimensions etc. Non-invasive cleaning back of oyster shells and loose muds was conducted to examine the makeup of the foreshore. Samples of an exposed wattle panel or collapsed wattle fence were taken on the basis that the remains appeared fragile and at risk of imminent loss. The panel may provide a Relative Sea Level Indicator point when dated and if confirmed to be in situ.

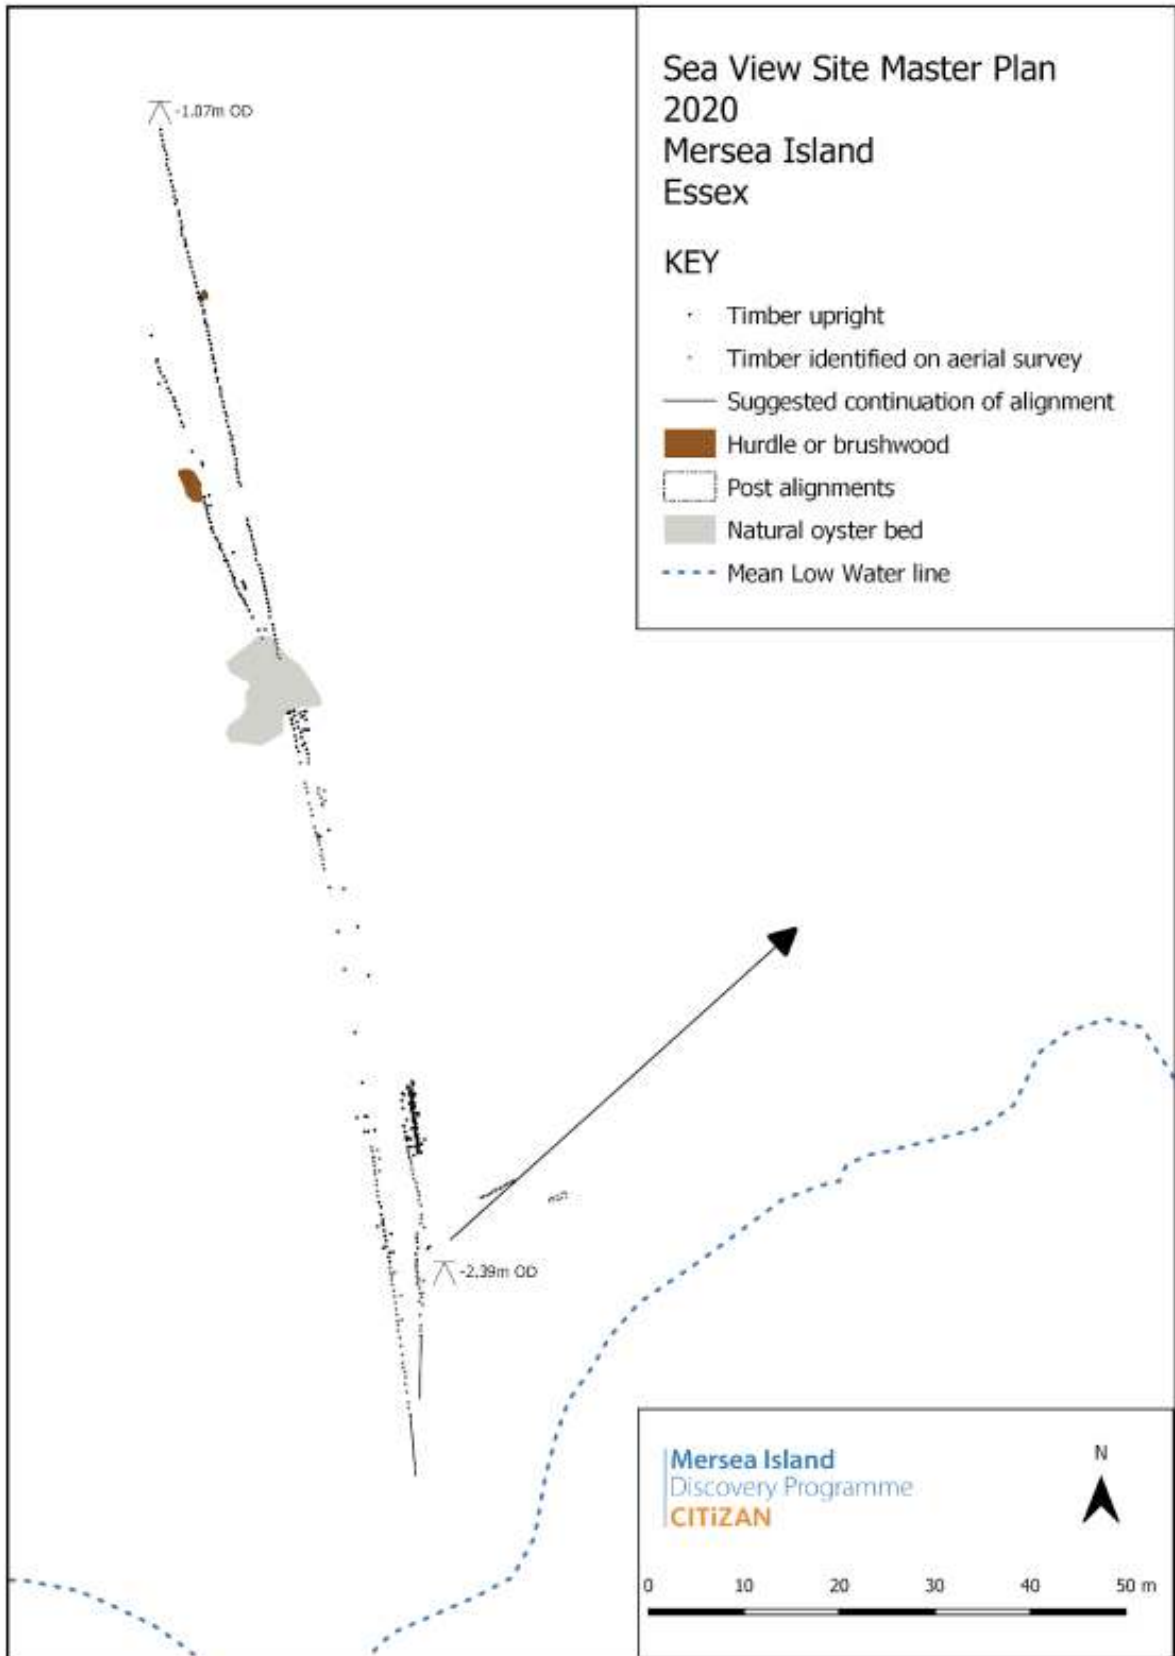
Figure 3: Plan of Sea View site 2020

The principle remains observed fall into three categories as identified on the site plan (*fig. 3*) and are grouped thus; 1) two linear timber features, 2) two sections of exposed wattle or brushwood 3) two short alignments of posts running perpendicular to groups 1 and 2.

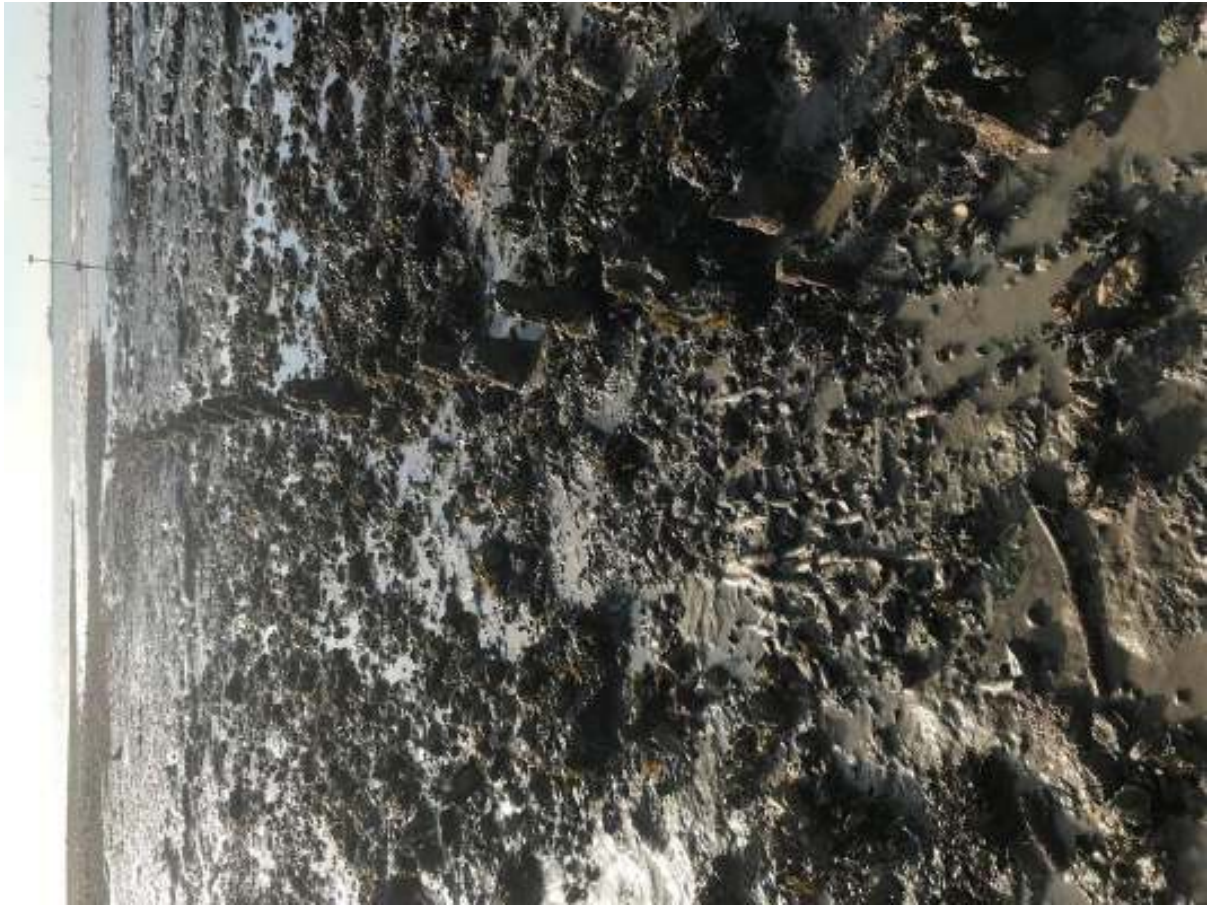
*Feature 1:* A row of timber piles (*fig. 4*) running 138m north-south, perpendicular to the present shoreline. The alignment tapers westwards at the southern end towards an adjacent alignment (Feature 2). A natural oyster bed obscures a 5m section roughly in the centre of the row, but it is assumed that Feature 1 is a continuous row given the similarity in timber, spacing and alignment both to the north and south of the oyster bed. A clear terminal was observed at the northern end of the feature, but the observable remains run into the sea to the south making the original extent impossible to identify with certainty. Aerial survey indicates that the row continues beneath the surface of the water for at least a further c.10m on a downward slope into the sea before becoming unobservable beneath the water.

*Feature 1* comprised 100 vertical upright timber piles in the round. The piles average 160mm in diameter when measured at the base where the presence of bark indicates their original size as trunks. Over half the timbers have bark present at the base which appears to be a function of recent erosion, and, based on the quality of preservation, indicates that the trunks are likely of birch (*Betula*). The average diameter suggests the feature is made up of the trunks of relatively young trees, c.20 years old. They stand between 20mm - 600mm proud of the foreshore with the more exposed (and therefore taller) piles found towards the northern section of the alignment. The above ground tips of the piles are heavily eroded, often to a point made up of just heartwood. Below the tip the wood is friable and honeycombed, a likely result of erosion. The piles are regularly spaced averaging 500mm apart and set vertically with a considerable degree of precision. The northernmost exposed pile is squared at the base, measures 100mm diameter across its rounded upper portion and displays extensive tool marks and facets suggesting a worked, pointed end below the surface. To the southern end of the alignment several slightly outlying piles were recorded, possible repairs or bracing elements. Two small archaeological interventions suggest that the piles were set in a trench *backfilled with soft, blue grey, sterile clay* although further intervention is required to confirm this proposal. Not all the timber piles in this feature were fully surveyed due to time constraints.

*Figure 4: Feature 1 looking south with Feature 3 (hurdle panel) in the foreground. The natural oyster bed that obscures the centre of the alignment can be seen towards the upper portion of the image.*

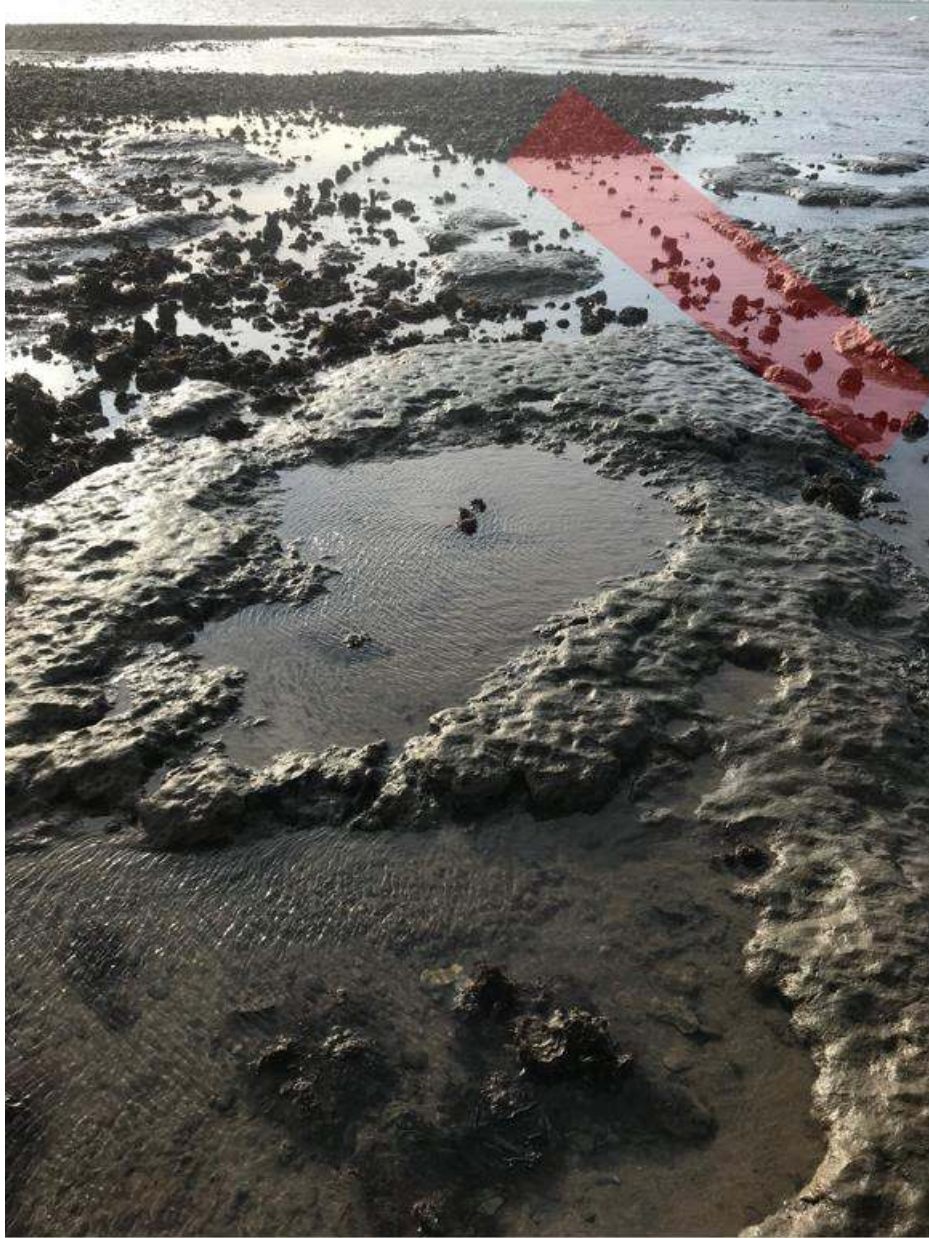
*Feature 2:* A second row of smaller piles (*fig 5.*) and stakes extending 124m nw-se. All but one are in the round and they average 100mm diameter. No bark was present on any timbers in this row. All appear to have been set vertically but with less precision than those in Feature 1. Several posts have adjacent smaller stakes (observed but not surveyed due to time constraints) driven in immediately adjacent, presumably wedges or repair work to provide stability. To the immediate south of the oyster bed in the middle of the feature a series of smaller adjacent rows of stakes and posts have been exposed to the east of the main alignment. These range in diameter from 100 – 50mm and are set with their upper tips leaning away (eastwards) from the vertical piles. This form is also evident at the southern end where three further parallel rows of over 40 posts and stakes of various sizes are exposed running for 7m along the eastern (outer) side of the alignment (Fig. X). Set at a variety of

angles with upper tips pointing away from the main alignment they appear to form a bracing element to the feature. The exposed remains were not fully surveyed due to time constraints.

*Figure 5: Feature 2 highlighted in red. Image looking south*

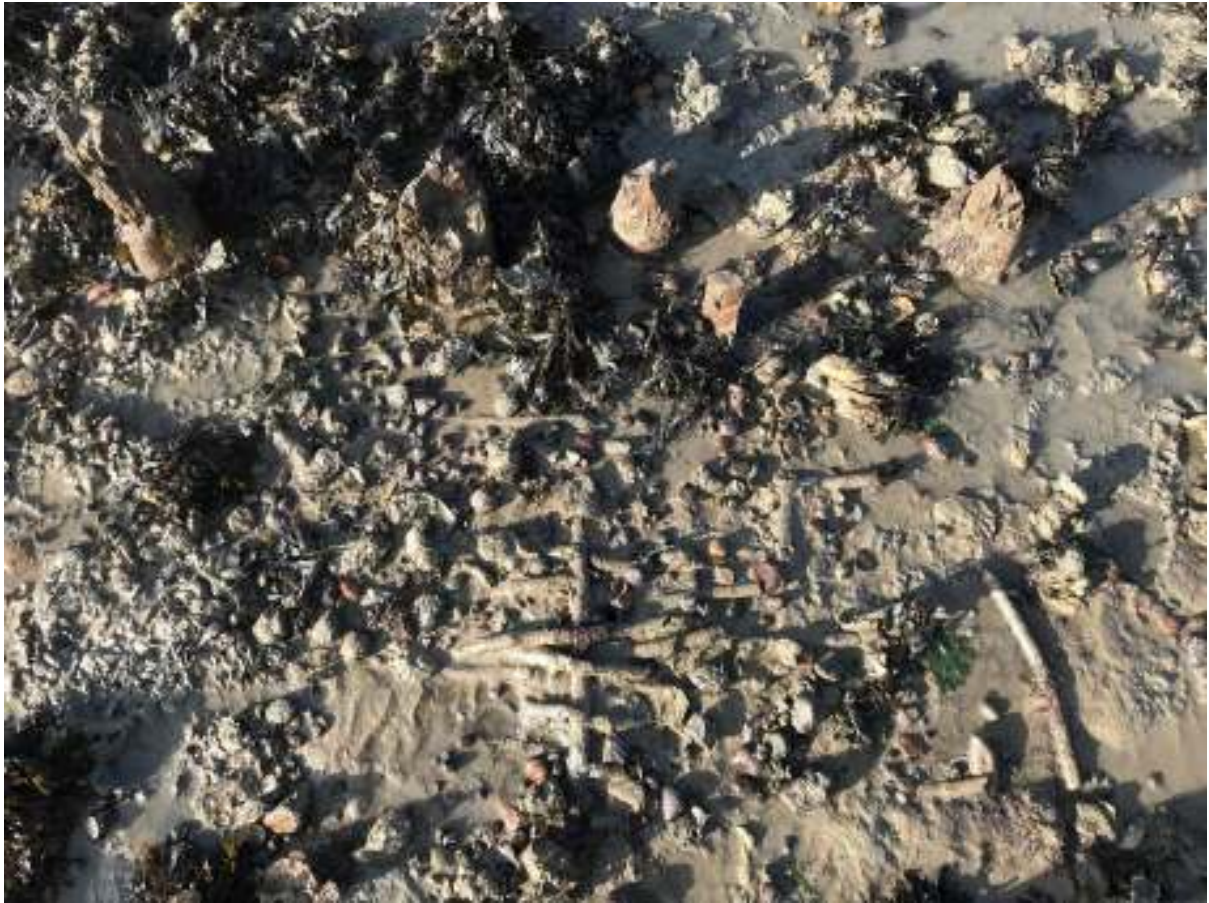
*Feature 3:* An exposed section of wattle panel (*fig 6.*) abutting the outer (eastern) face of Feature 1 was identified, cleaned and photographed. It is of rod and sail construction and measures 600 x 700mm. The presumably hazel wattles are firmly embedded in the exposed surface which lies at - 1.45m OD. The ends of two wattles show evidence of tool marks. It was not possible to ascertain with certainty if the panel was intentionally laid directly on to the surface beneath or if it came to rest as a result of collapsing from a position affixed to Feature 1. Further monitoring of the feature may provide evidence to establish an answer. Given the risk of loss to erosion this feature was sampled for species ID and C14 dating including two samples on which tool marks are present.

*Figure 6: Feature 3 - a section of wattle hurdle work*
