Survey of intertidal remains adjacent to  
scheduled ancient monument 1013832  
Tudor Blockhouse  
East Mersea, Essex

September 2022

## A CITIZAN survey intertidal remains adjacent to scheduled monument 1013082 -Tudor Blockhouse at Cudmore Grove, Mersea Island, Essex

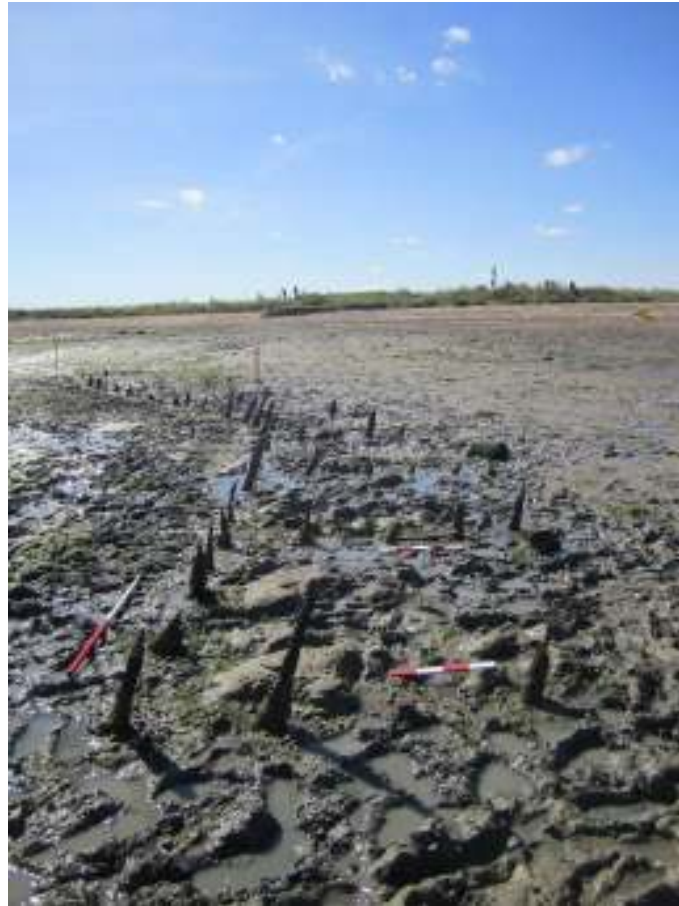
*Feature 101:* A 20m long alignment of roundwood uprights average *c. 150mm* in diameter all set at a raking angle *c.110* degrees to the north towards feature 102. Species unclear and not yet sampled for identification. Presumably Hazel wattle work is evident around 90% of the feature and continues to a depth of at least 150mm (evidenced by a small archaeological intervention). The arrangement creates a shallow V shape and consists of two seaward faces abutted by a series of uniformly set perpendicular rows of posts creating pens or braces reinforcing the seaward faces. The uprights vary in height measuring between *c.60mm* on the upper limit of the foreshore and up to 1m in height at the southernmost extent. The exposed wattle is well preserved, varies in diameter between 30 – 60mm with many cut ends bearing tool marks. It is however fragile and susceptible to erosion. The remains of a basket were observed within the superstructure (fig 4). A single radiocarbon date from a wattle sample returned a date of *c.1540AD* and was obtained in 2018 as part of a story for the Britain at Low Tide television programme.

*Figure 1. Feature 101 facing towards the beach. Note two 'faces' to the alignment on the left of the image*

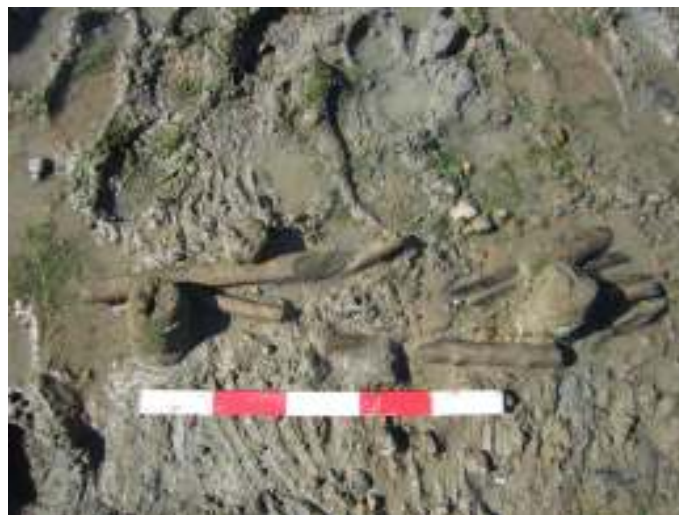
*Figure 2. Feature 101 wattles clearly woven into the superstructure with toolmarks visible*

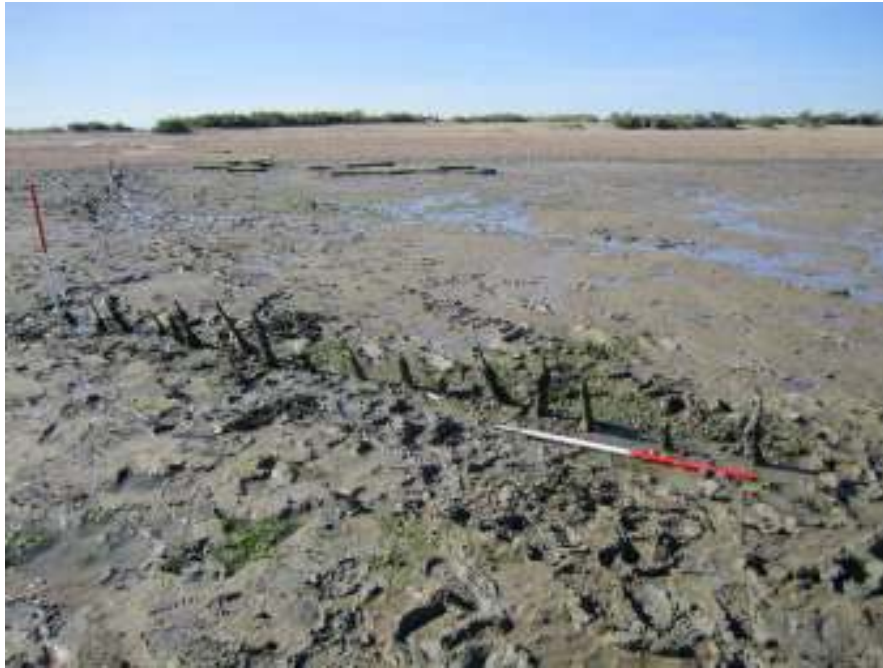
Feature 102: Similar in form to 101, but an altogether more sparsely arranged construction. 38m long arrangement of uprights, smaller in diameter and more widely spaced with less precision than feature 101. There is very limited evidence of wattles woven into the structure, although more could survive belowground. Uprights are set at raking angles pointing southwards towards feature 101. The feature appears to continue north-westwards below the modern shingle beach.

*Figure 3. Feature 102 looking eastwards towards the beach showing second face in upper left of image*

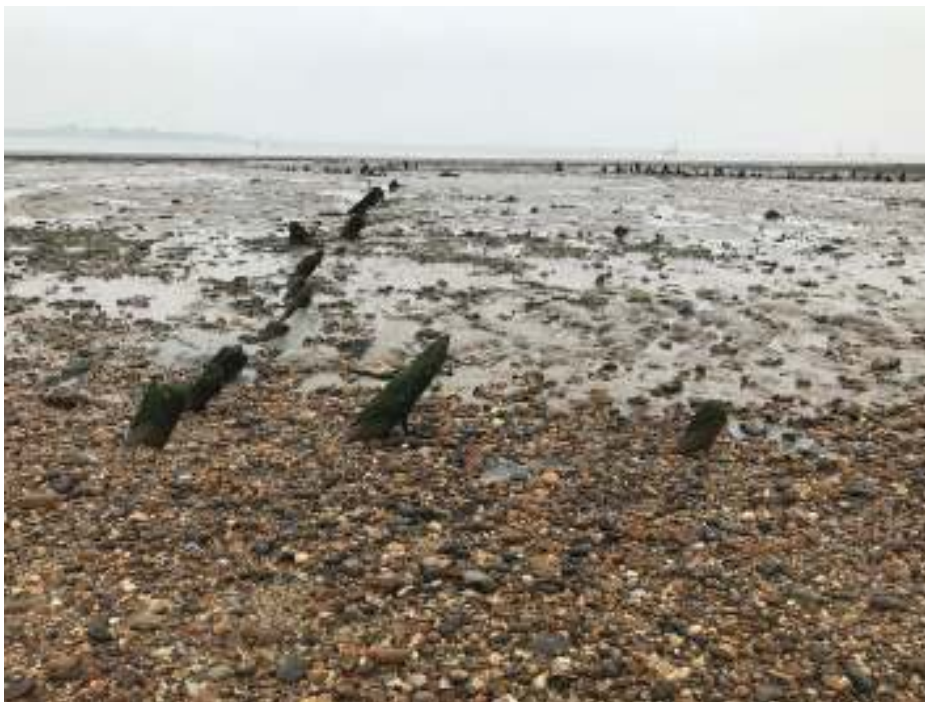
*Figure 4. Feature 102 looking seaward from freshly exposed uprights on beach. Note feature 101 to upper right of image*

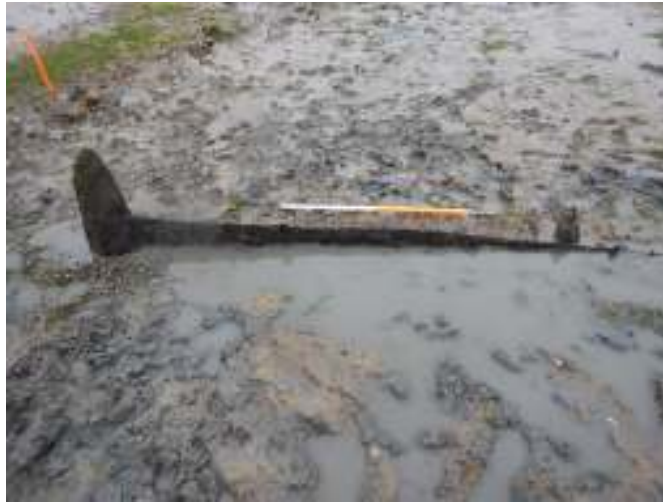
*Feature 103:* Remains of a likely fence structure comprising a large, square section oak upright with mortice hole into which a roughly worked crossbeam sits. Thin planks (staves?) are pegged overlapping into the crossbeam and continue below the surface, presumably creating a solid timber fence. The eroded remains of a second large upright are visible and extend the alignment to the NE, but no evidence of crossbeam was found. An alignment of roundwood posts c.60mm diameter was

*Figure 5. Feature 103 timber fence. Note overlapping staves pegged to crossbeam*

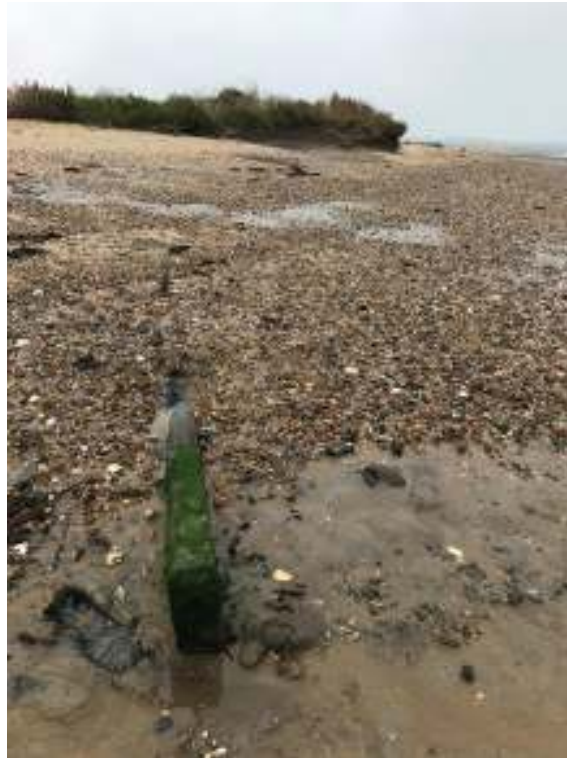
*Feature 104:* A large timber beam set horizontally on the foreshore measuring 2.4 x 0.3 x 0.15m, possibly oak or elm, and likely in situ. It extends due south from the apex of the fort ramparts. Small roundwood uprights are evidence set against both faces of the beam. Large elm beams were recorded during the 2003 survey due east of the ramparts (now gone) and were of similar form (Damian Goodburn pers comm). The feature extends below the modern shingle beach towards the fort where there is possibly a high level of preservation of structural remains.

*Figure 6. Feature 105 facing due north - a large timber beam in situ with the blockhouse ramparts behind*

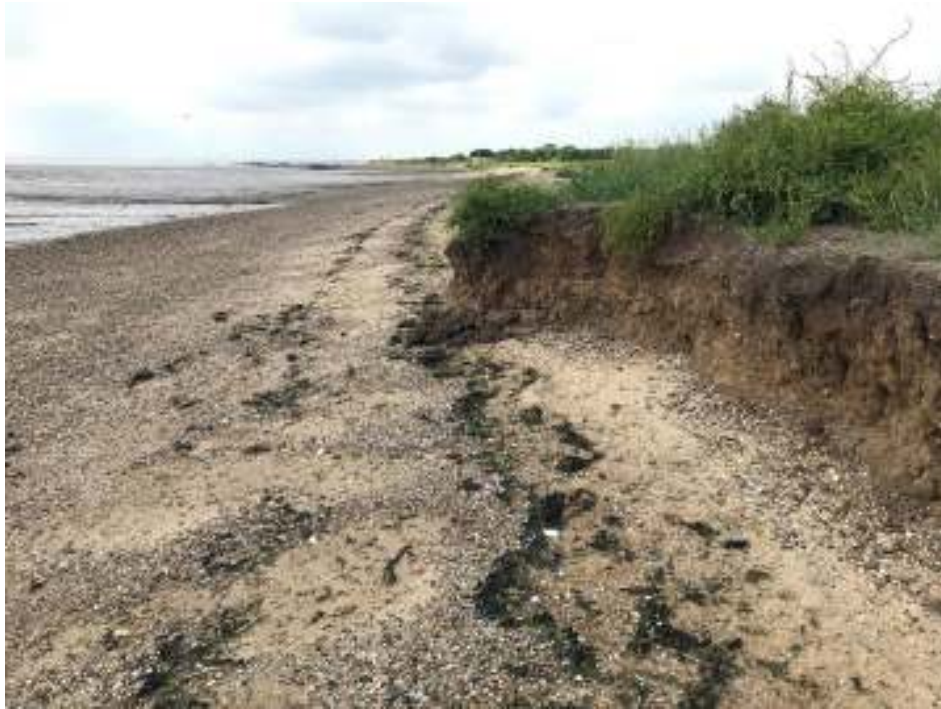
Since CITIZAN's initial visit in 2016 the easternmost extent of the ramparts has become completely exposed to the high tides, with waves now regularly washing against the earthworks. Their composition is clearly visible in section although no evidence of the proposed gabions within them has been observed by CITIZAN volunteers. On extremely high tides seawater crests over the grassy topside of the eastern apex, totally submerging the exposed face. The short to medium term outlook for this section of the site is not good, with the exposed inner fill of the ramparts susceptible to wave action. Collapse of the seaward facing exposure has already begun and further loss is assured and likely imminent. Figure 10 illustrates the changing shape of the structure as observed in aerial photography from 1955 and 2021. The 1955 image shows the site well protected by established saltmarsh and a creek system, with the high-water line well to the east. Since then, over 50m of coastline has eroded away in the vicinity of the site. The shape of the remains has been altered significantly by the loss of saltmarsh and exposure to the elements.

*Figure 7. Eastern extent of ramparts looking south. Note the strandline marked by seaweed now cuts through the structure*

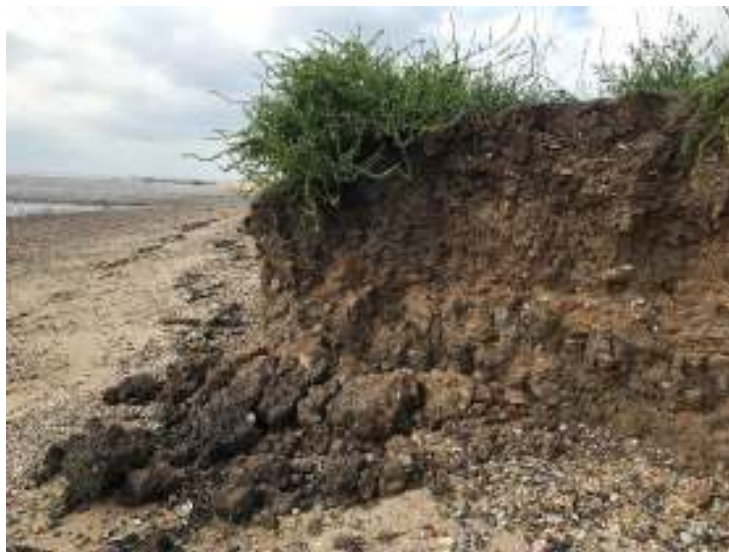
*Figure 8. Detail of collapse of eastern tip of the fort ramparts. Image facing south*
