SURVEY OF WORLD WAR TWO DEFENCES IN THE BOROUGH OF COLCHESTER

PROJECT REPORT: NOVEMBER 2007

Fred Nash
for
Colchester Archaeological Group
and
Essex County Council

Section A: SMR 8913 – 10961

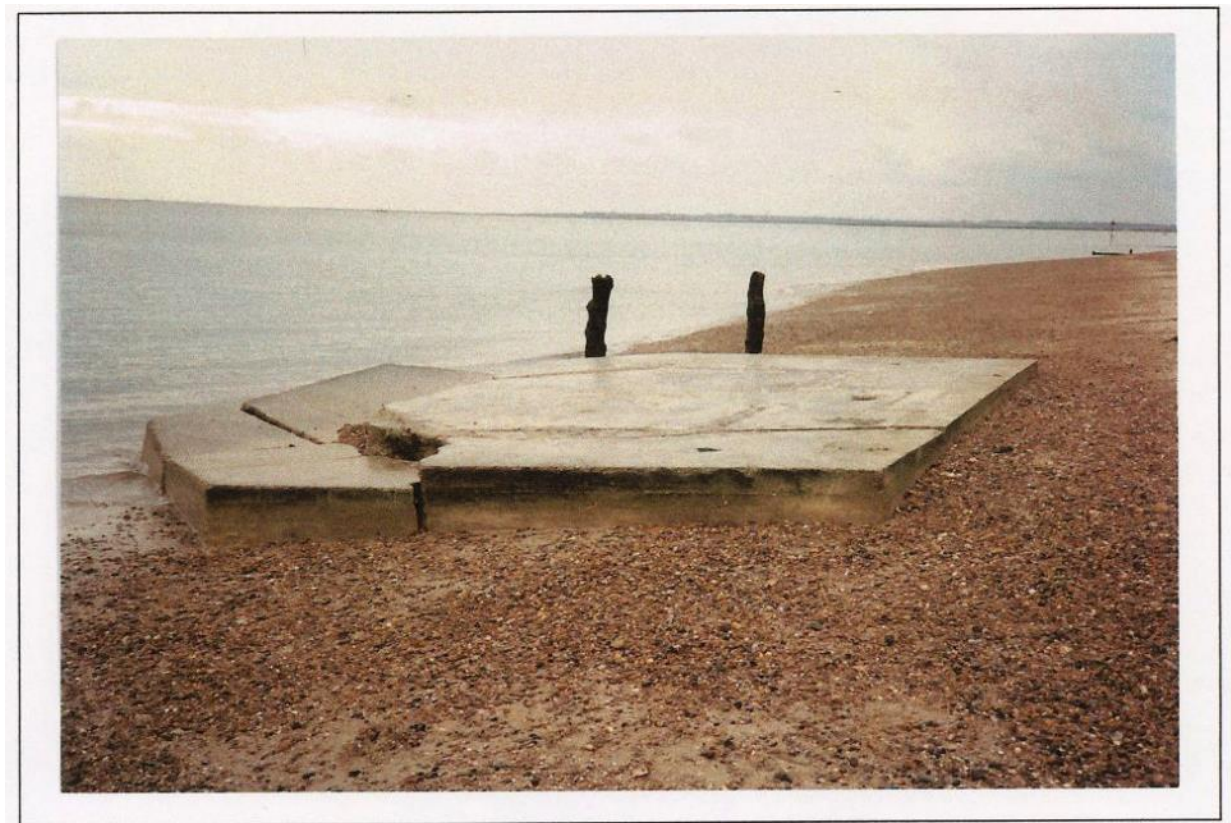
The concrete base of a pillbox stands on the beach 30 yards to the S of the garden wall of Shears Court. It is hexagonal, 22' x 23', with one longer side facing the beach. The original pillbox probably stood in the centre of this base as there are clear hexagonal wall markings, 11' x 13', with the entrance on the landward face. The undermining action of the sea, which reaches the base at high tide, has badly cracked the concrete.<1 > One photo of site.<2>

SITE ASSESSMENT: The base is being broken up by the action of the sea.

SMR 10019: In the construction of pillboxes, the concrete base was laid first and the main structure built on top. At West Mersea, although the base is now breaking up, the marks of the pillbox which stood on it can still be clearly seen.

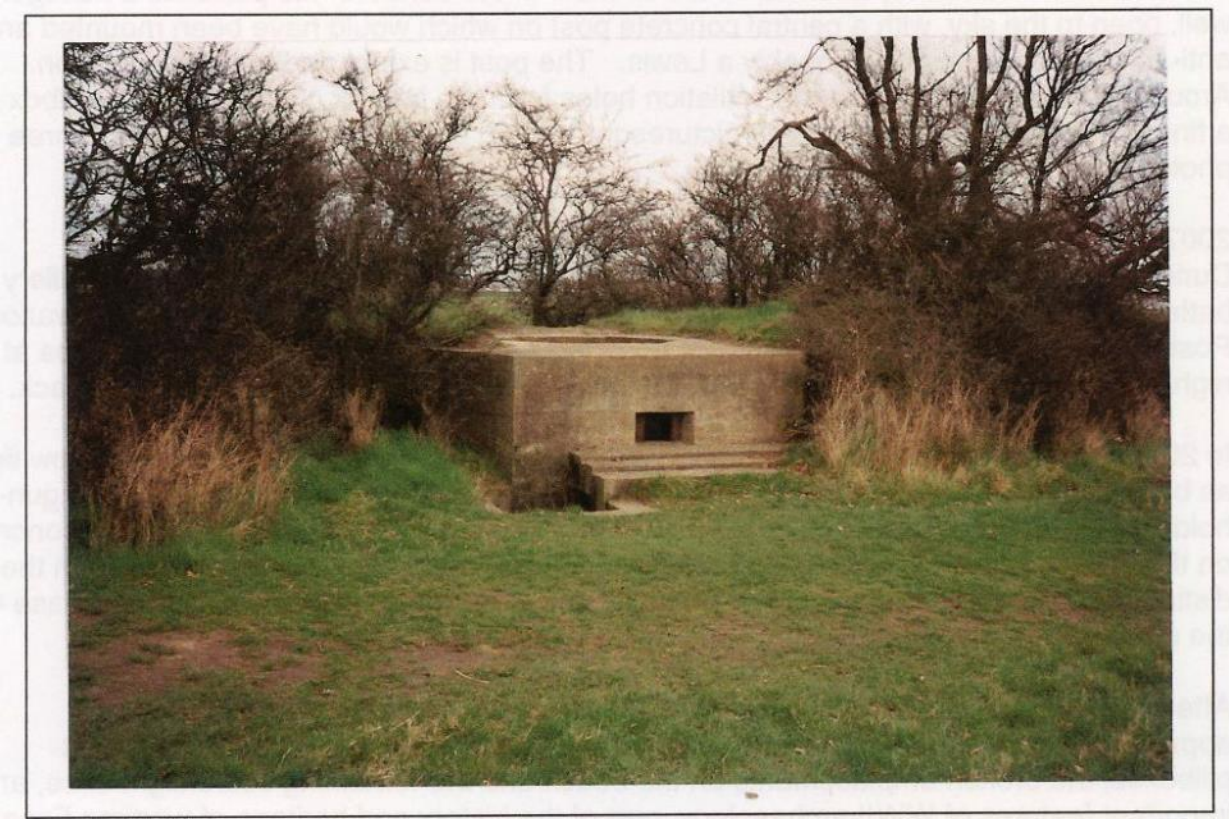
SMR 10027: Like its partner (SMR 10026), this anti-aircraft pillbox survives well at Cudmore Grove Country Park.

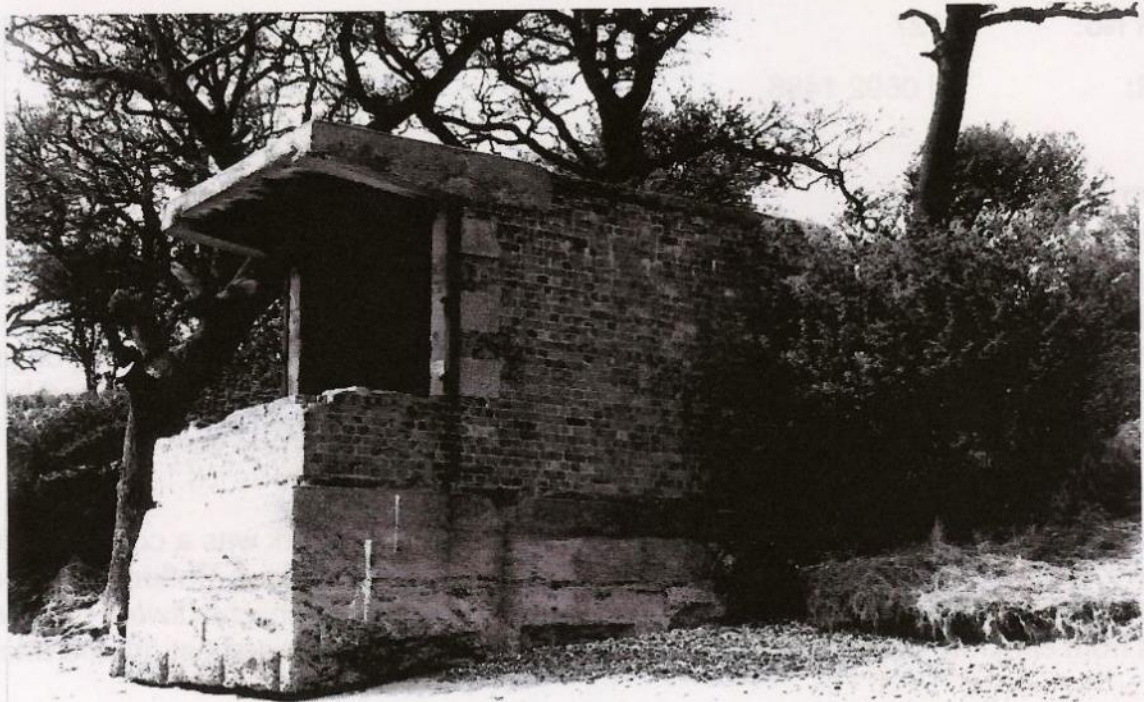
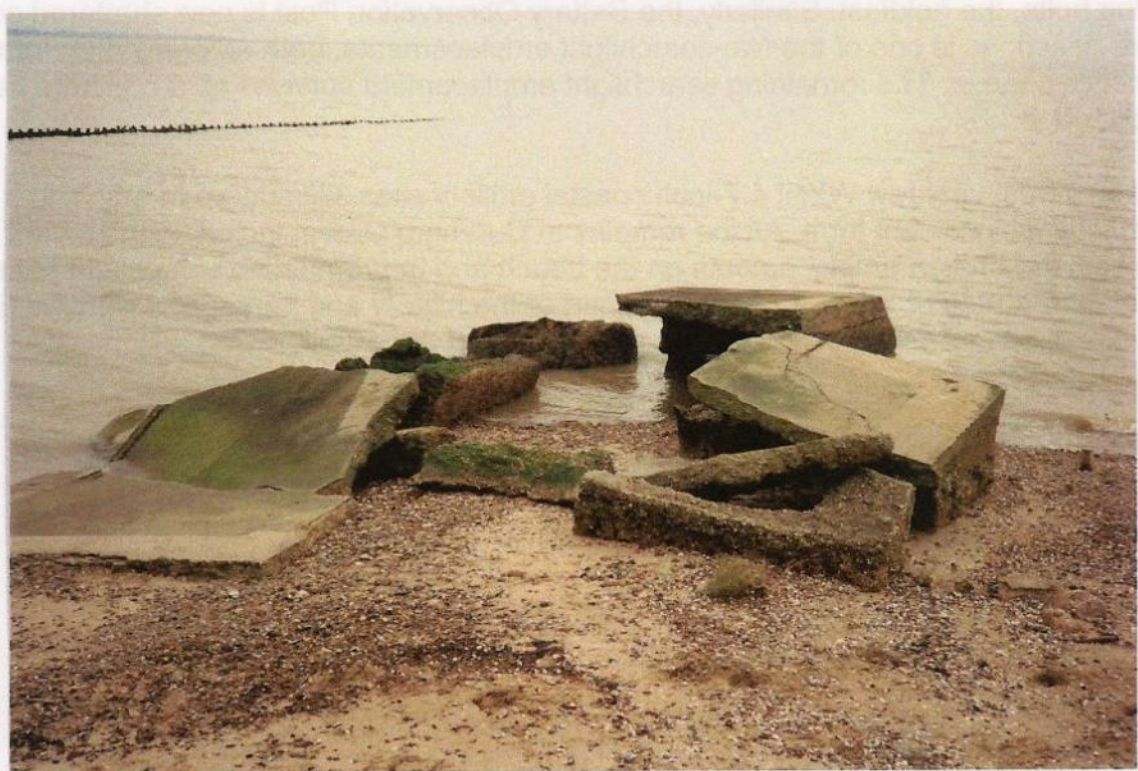
1993: This searchlight emplacement was part of the East Mersea coastal artillery battery. It is shown on maps dated 1960 and photos taken in 1974. <1> <2> Now the remains lie as broken concrete on the beach after extensive damage by coastal erosion. One photo of site. <3>

SMR 10028: One of the two coastal artillery searchlight emplacements which stood at the 4.7-inch gun battery at East Mersea. In 1974 it stood at the back of the beach. In 1993 it lies as broken, but still recognisable, concrete on the sands.

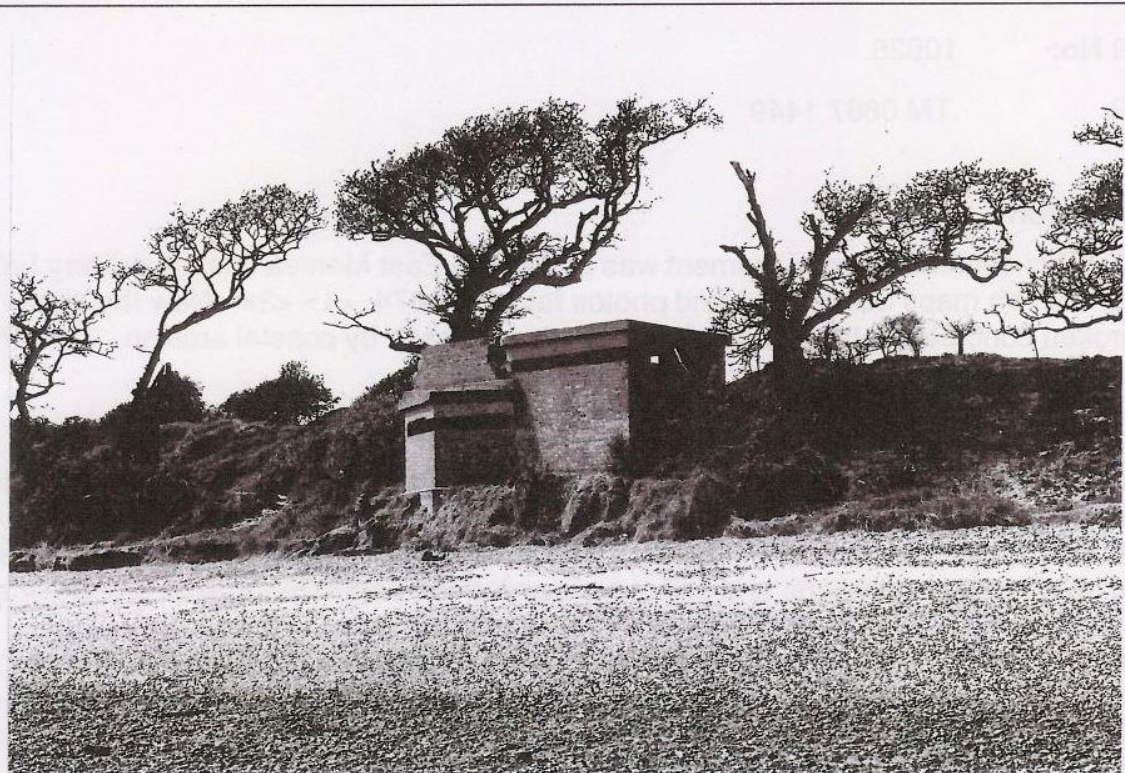
SMR 10029: The Battery Observation Post at Cudmore Grove Country Park. As it looked in 1974, and nineteen years later in 1993.

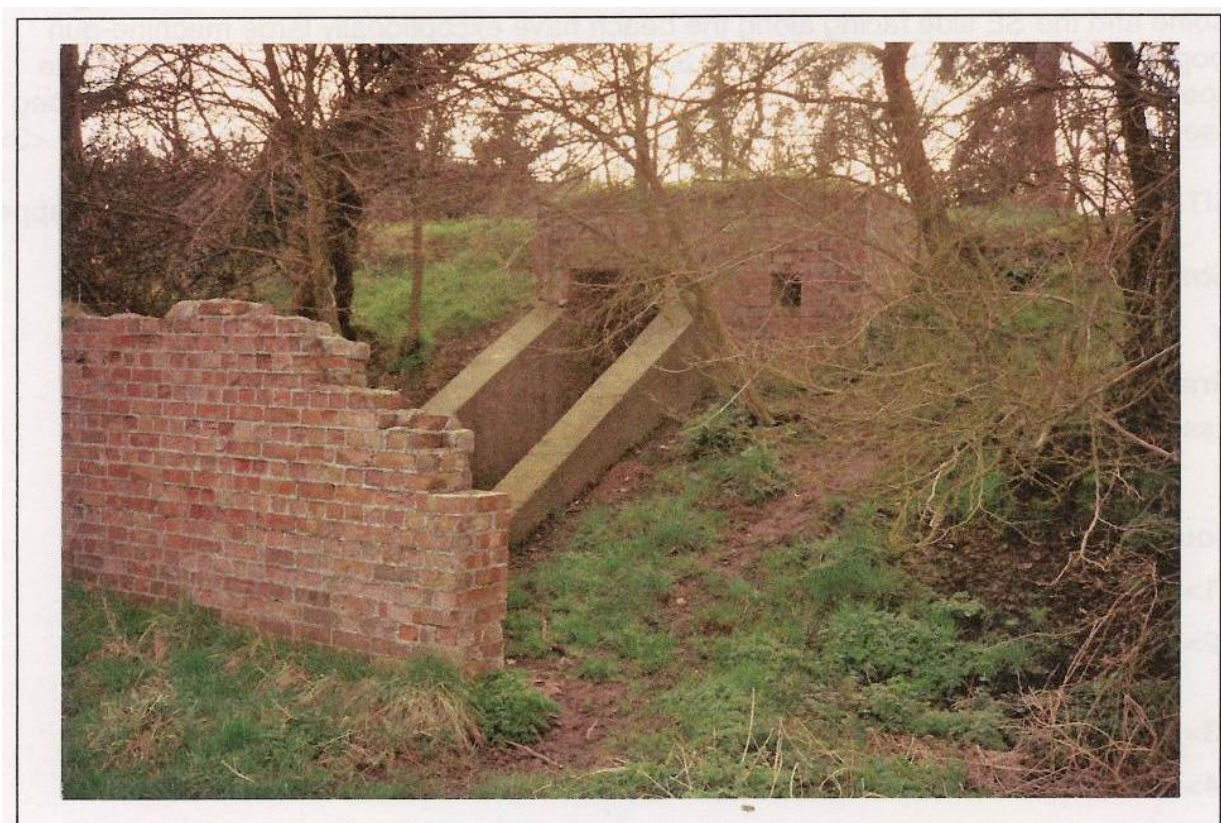
SMR 10036: Pictured in 1993, the decoy bombing bunker at East Mersea has now lost its blast wall.

SITE ASSESSMENT: The pattern of the bunker is probably the same, or very similar to, those extant at "WRI Spinnels Farm" (SMR 20309) and "HA2 Kirby le Soken" (SMR 20310). All three were N Series (Naval) decoys controlled from Harwich. Subject to an internal inspection to assess the condition of the structure, every effort should be made to ensure the continued survival of this shelter. <5>

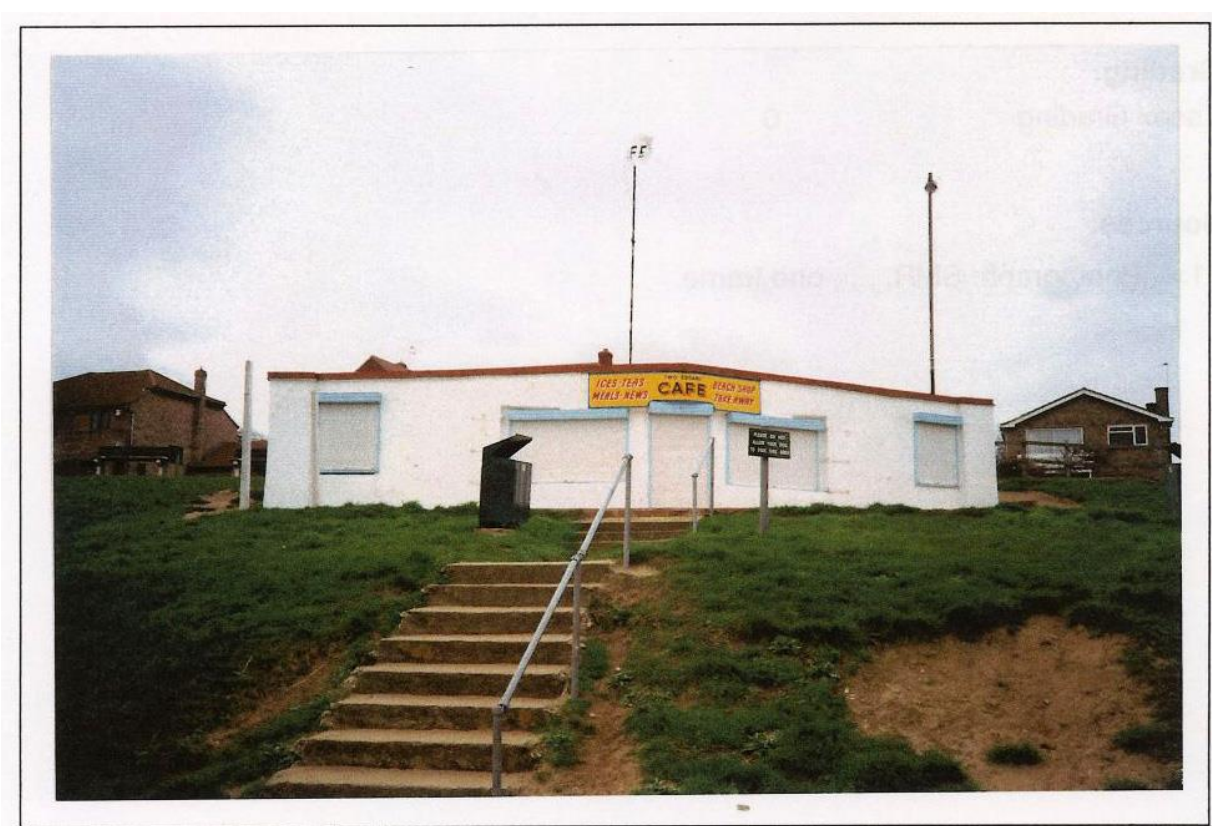
SMR 10039: The only surviving 4.7-inch gun casemate in Essex, the 'Two Sugars' beach cafe at West Mersea.

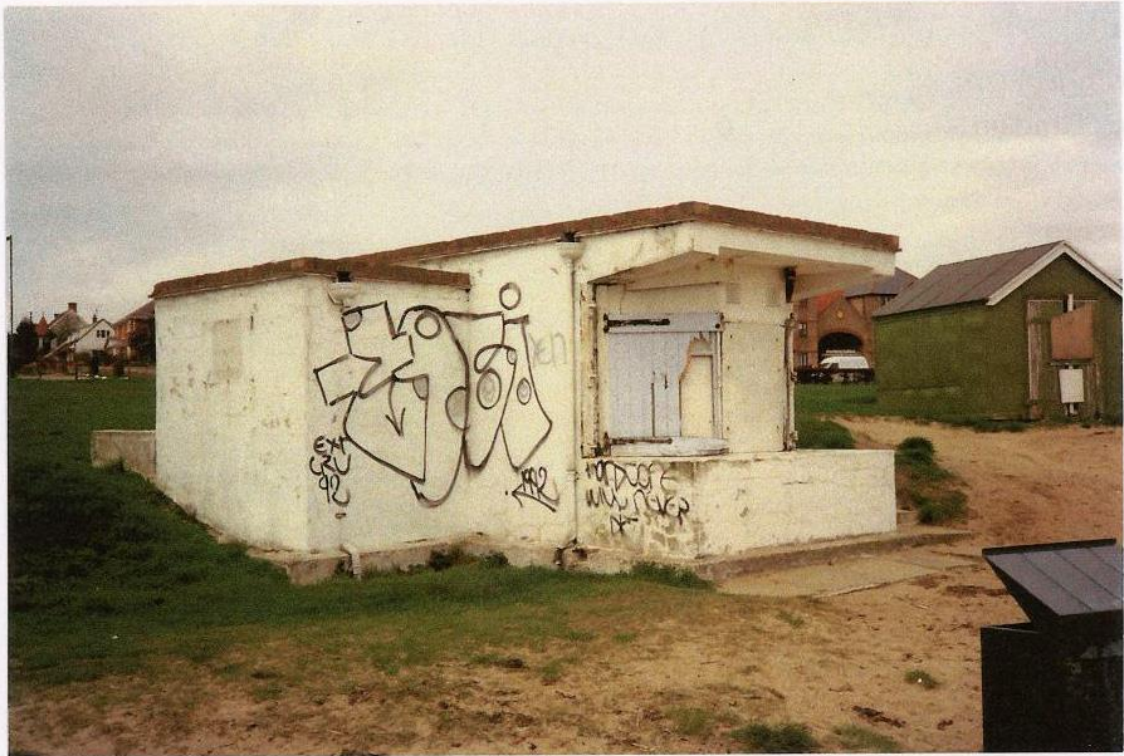
SMR 10041: Only a handful of Coastal Artillery Searchlight Emplacements survive in Essex. This one, at West Mersea, provided the night-time illumination for the 4.7-inch guns (SMRs 10038 & 10039) nearby.

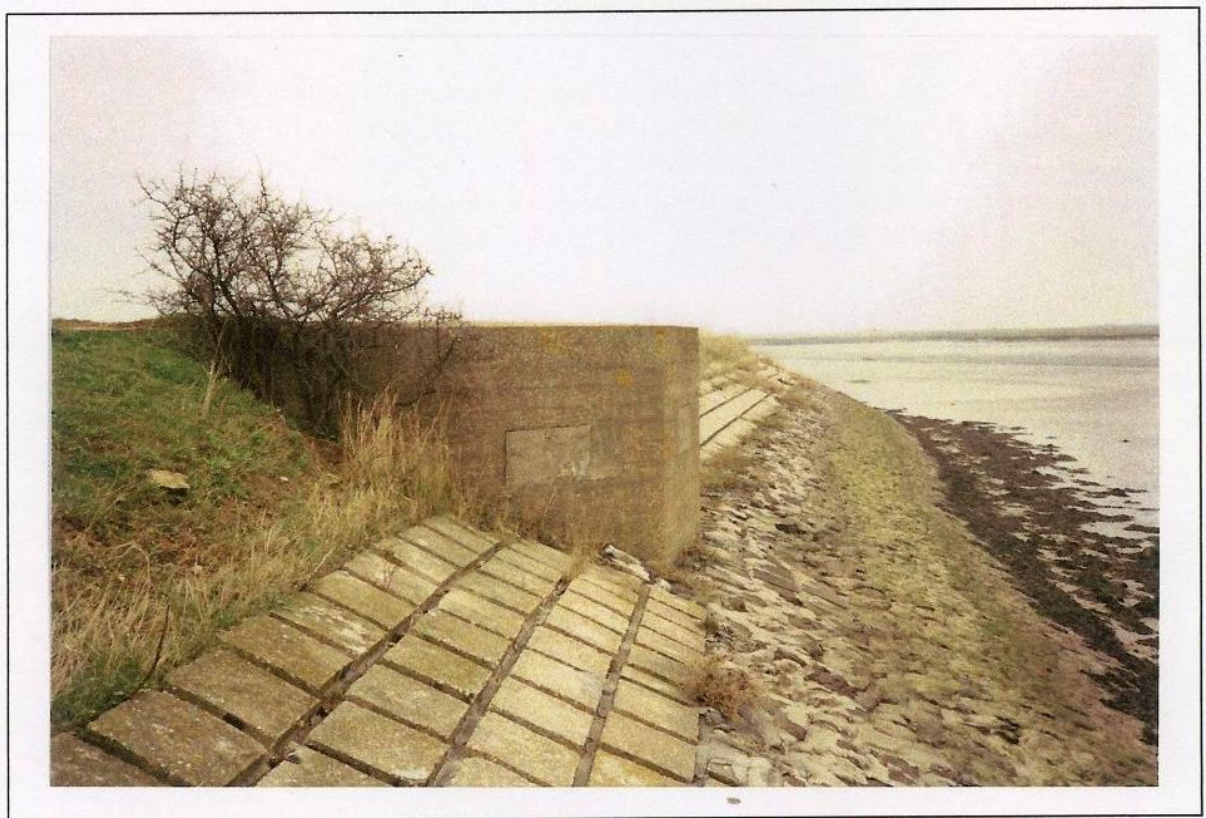
A 26' x 15' double-ended pillbox on the N bank of the Pyefleet Channel. It is octagonal with two long sides bisecting the sea wall, made of concrete and is sited 80 yards from the Strood causeway. Machine-gun fire from the pillbox would have effectively swept the causeway denying it to an attacker. The original sea wall has been widened considerably as a result of tipping and thus only the roof of the N end of the pillbox can be seen, at ground level. The few exposed loopholes to the S are all blocked up.. Two photos of site. <1>

SMR 10042: The through-the-seawall pattern of pillbox enabled the defenders to fire from loopholes at each end. Here, the landward side has been built up, covering the vertical face.

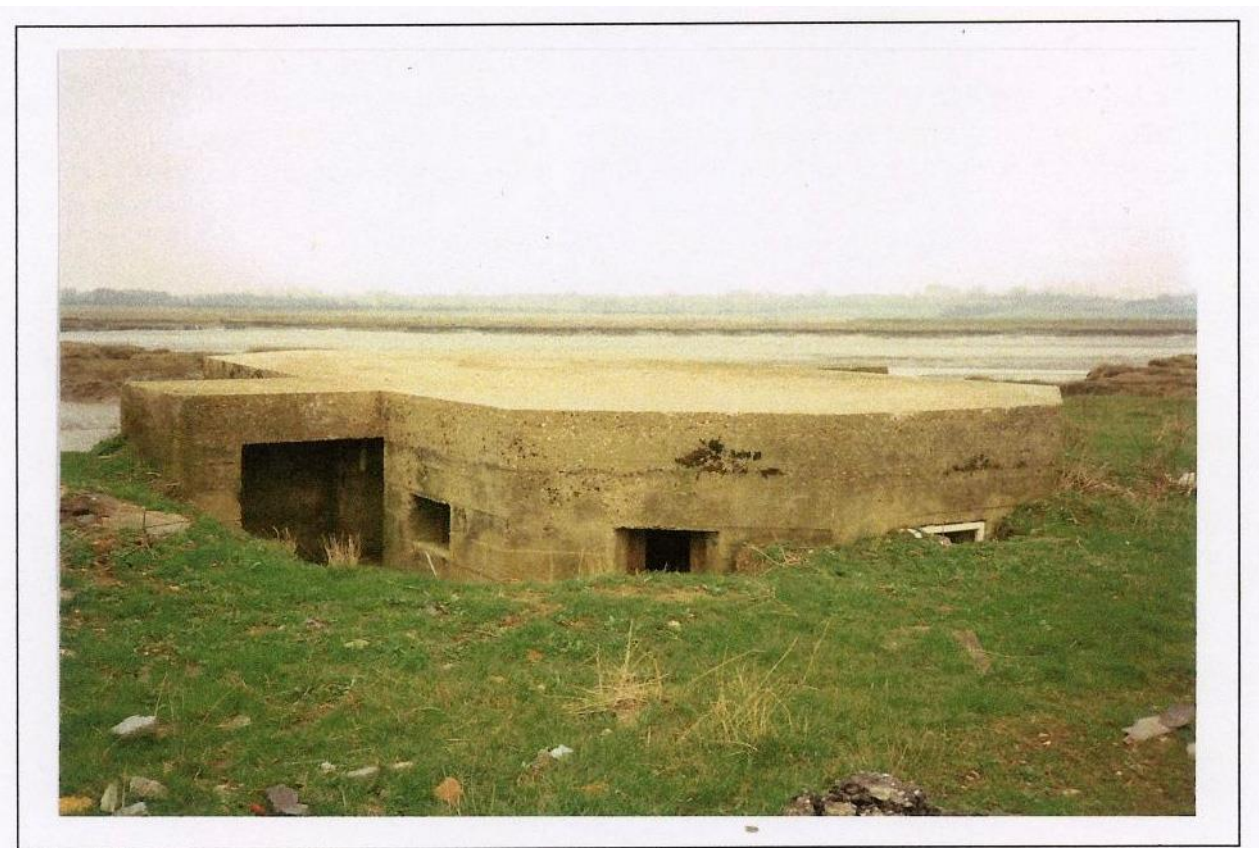
A 25' x 15' double-ended concrete pillbox bisecting the sea wall N of the Pyefleet Channel. It is octagonal with ten gun ports, five of which are open. Owing to a bend in the sea wall the pillbox generally faces E and W. It is possible to enter through the opening which is on the long N side. The far end of the Strood causeway can be seen through one of the loopholes and beneath this is what appears to be the remains of a concrete "pedestal" with a V-shaped channel, possibly for holding a machine-gun mounting.. One photo of site. <1>

SMR 10043: Although the seawall has been built up, the entrance and loopholes are still clear on this double-ended pillbox.

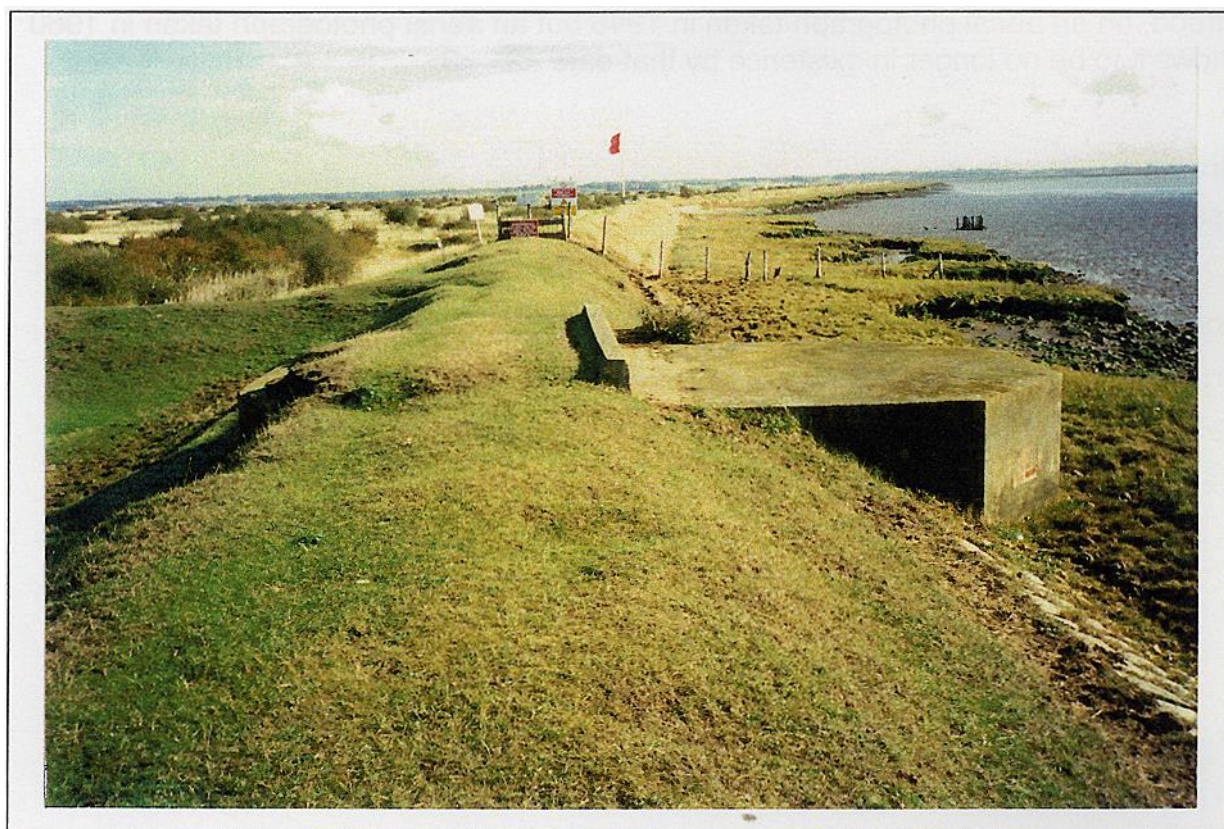
SMR 10732: One of a number of double-ended pillboxes built across the seawall at Langenhoe

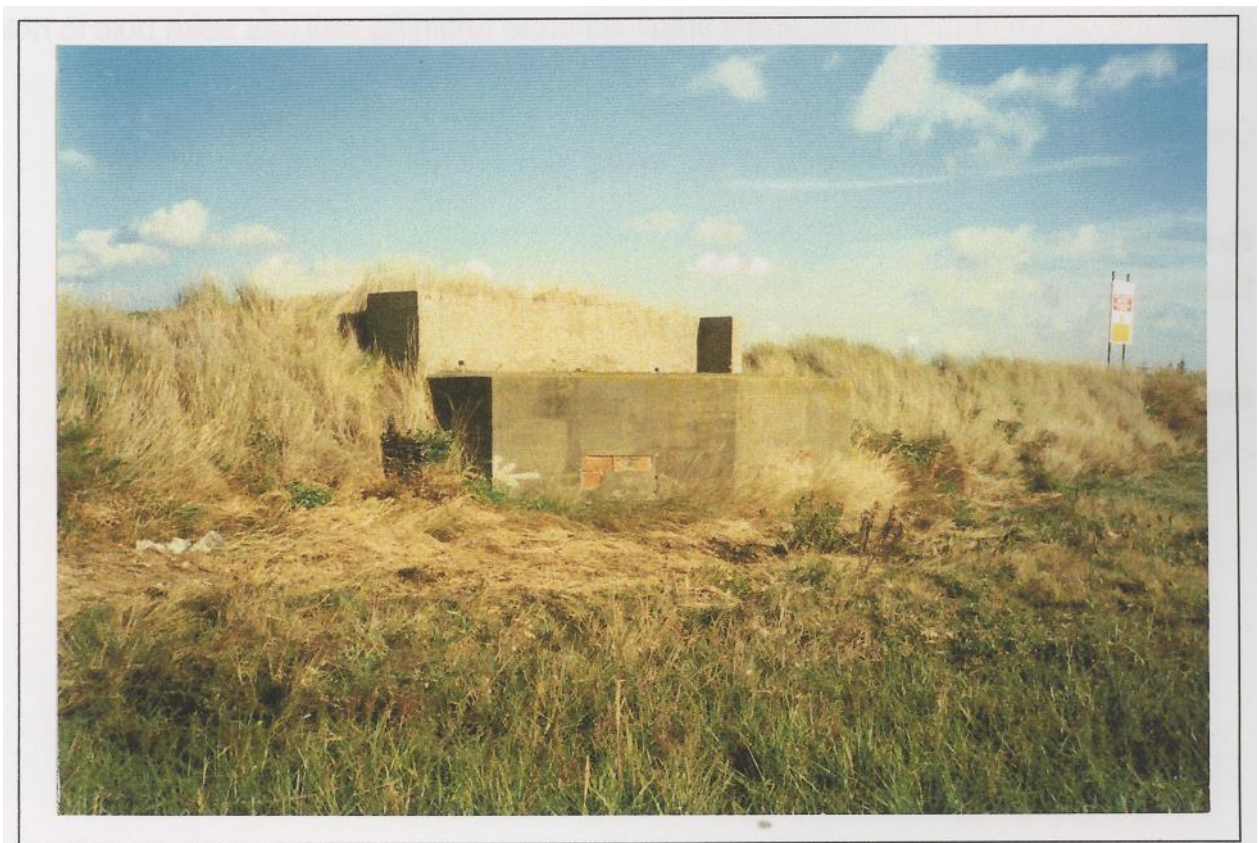
SMR 10733: The loopholes have been sealed since the end of the war to prevent flooding by the sea.

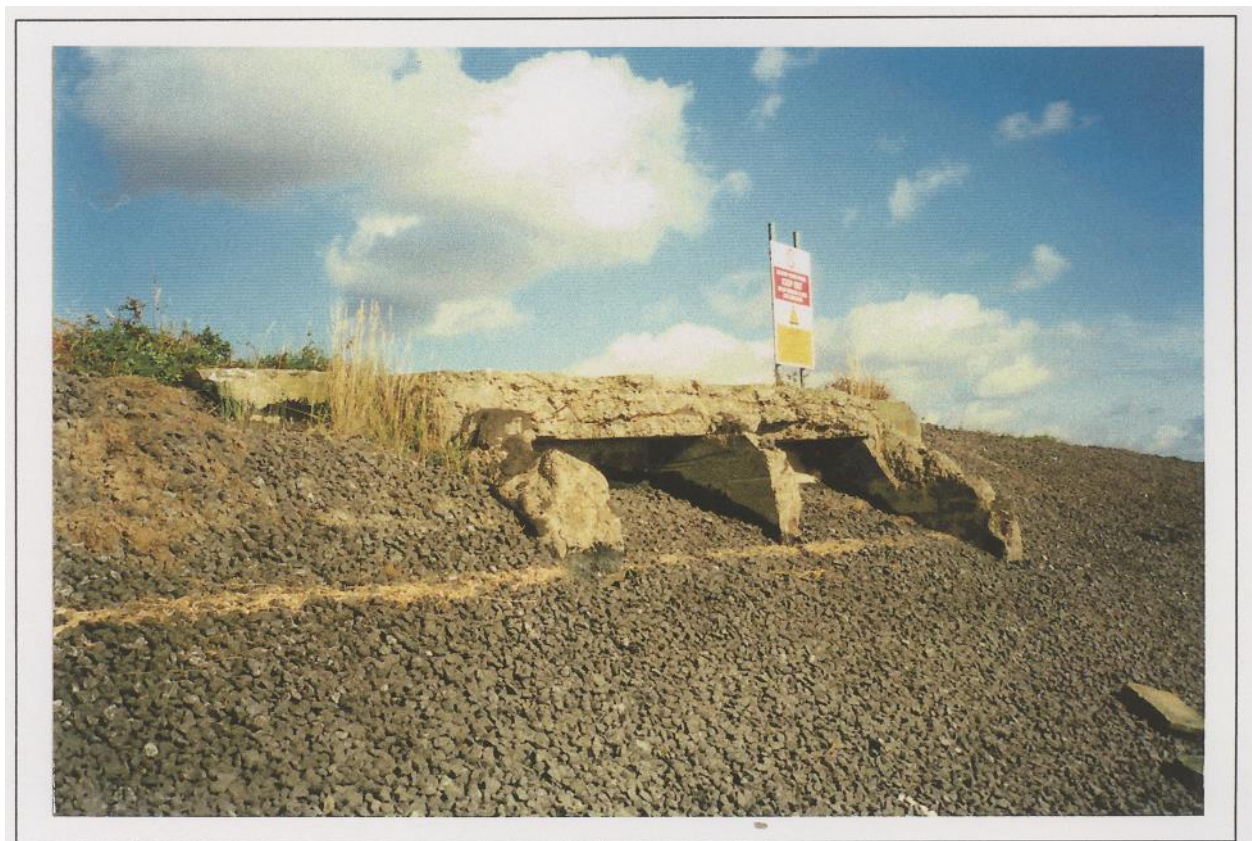
SMR 10734: This half-demolished double-ended pillbox provides an opportunity to see some of the inside construction

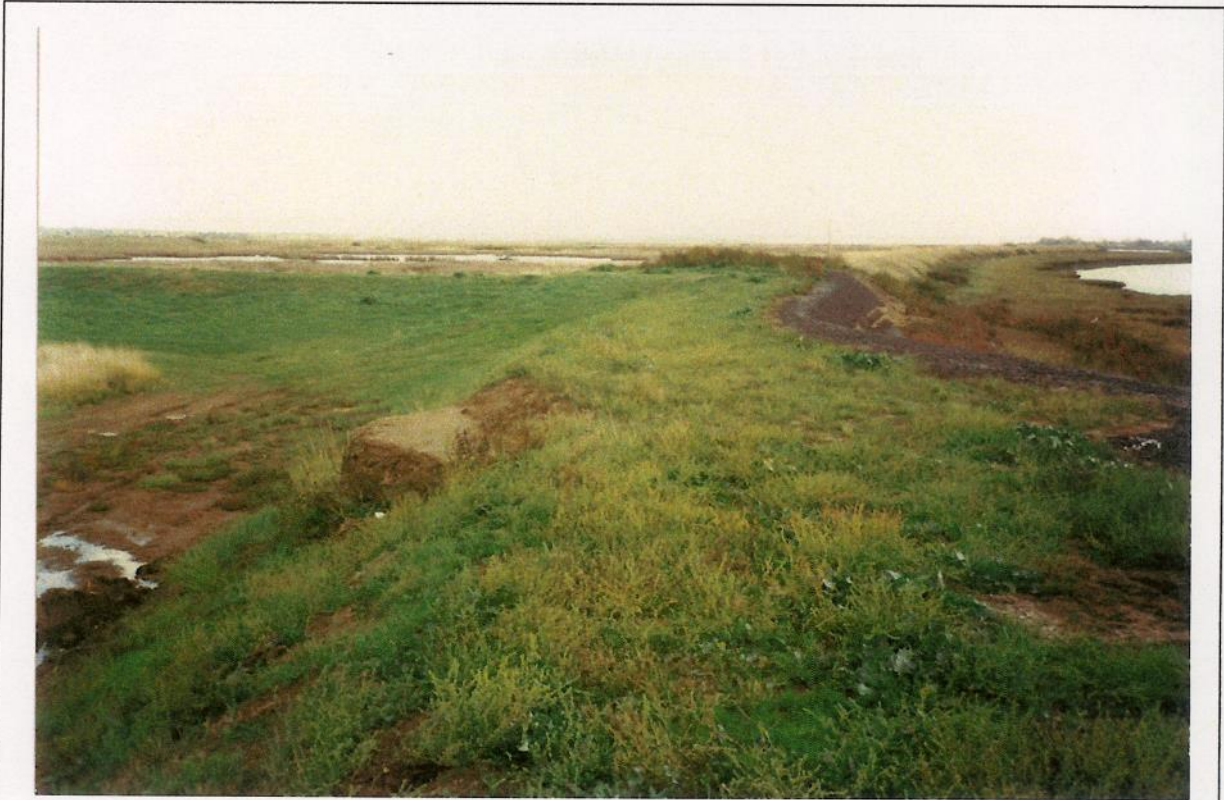
SMR 10735: As the seawall gets built-up more so the pillbox slowly disappears beneath it.

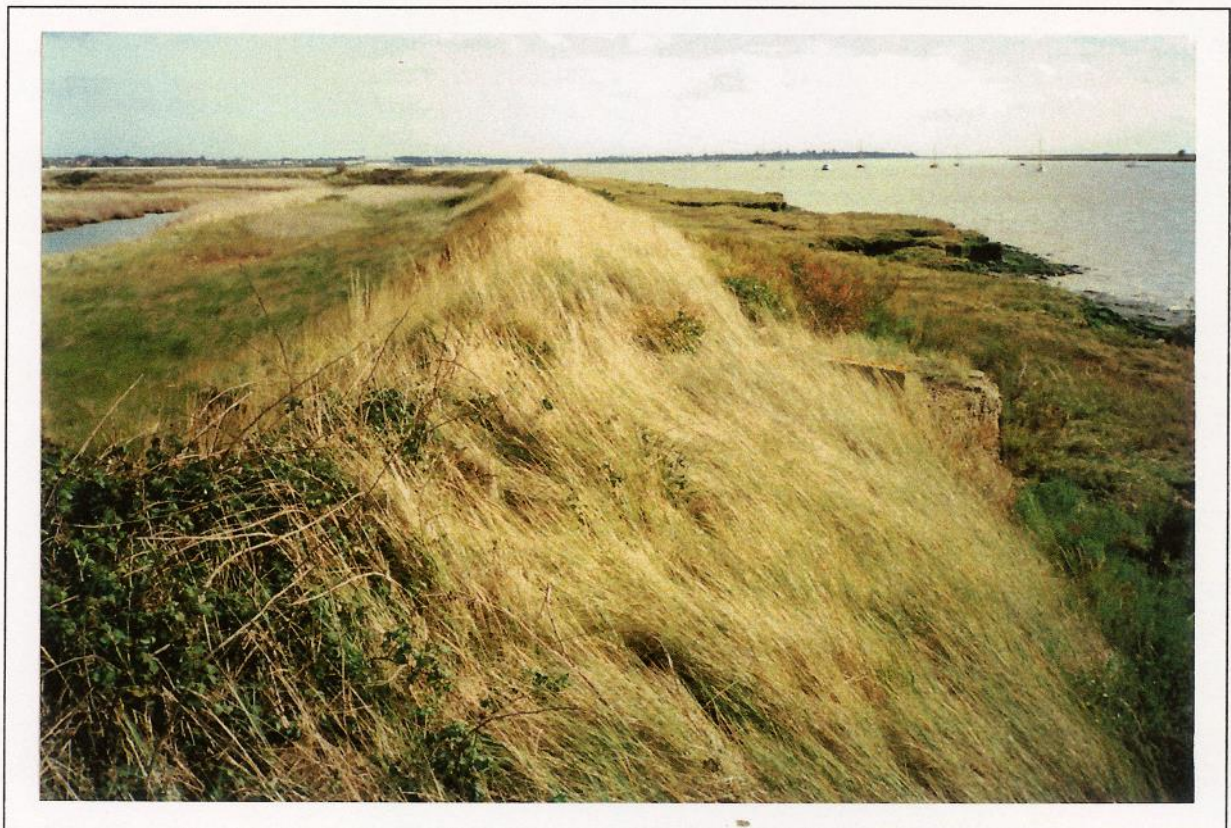
SMR 10736: Before the seawall was built up to its present level, it would have been possible to walk along the roof of this pillbox from one end to the other. Now, just a small part of each end can be seen

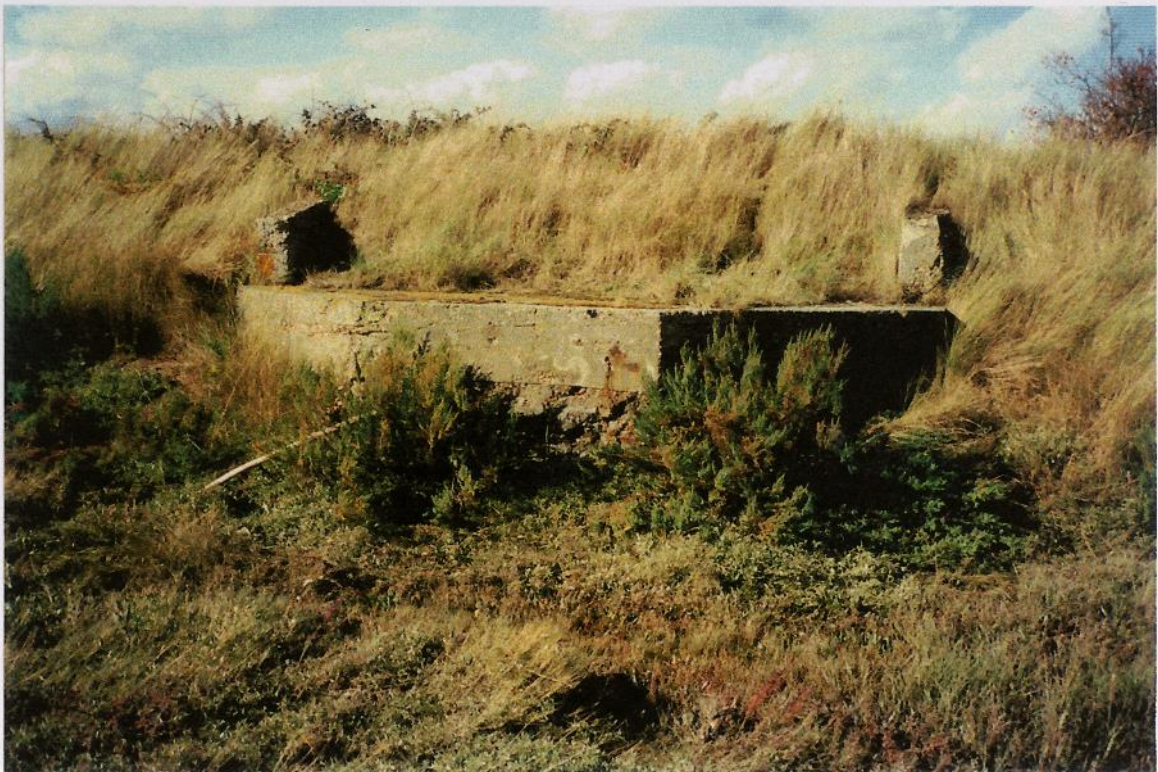
SMR 10737: These double-ended pillboxes were entered from a side access halfway along. At Langenhoe these have long been covered

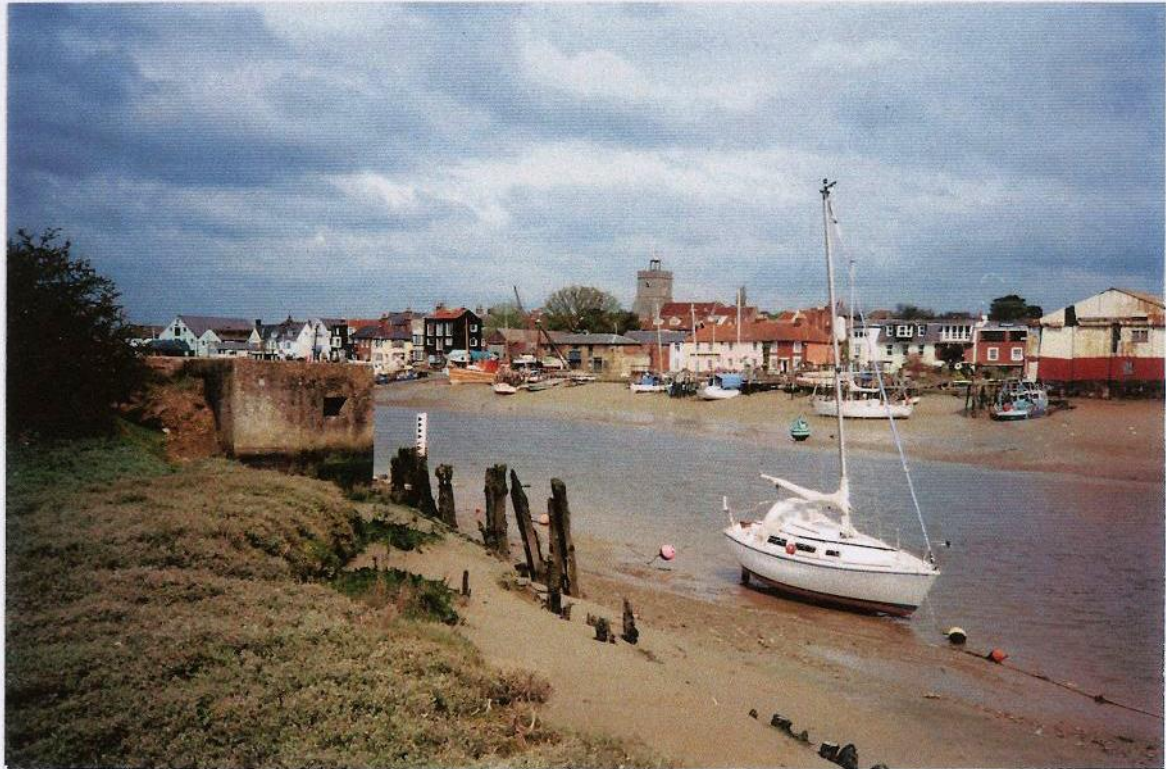
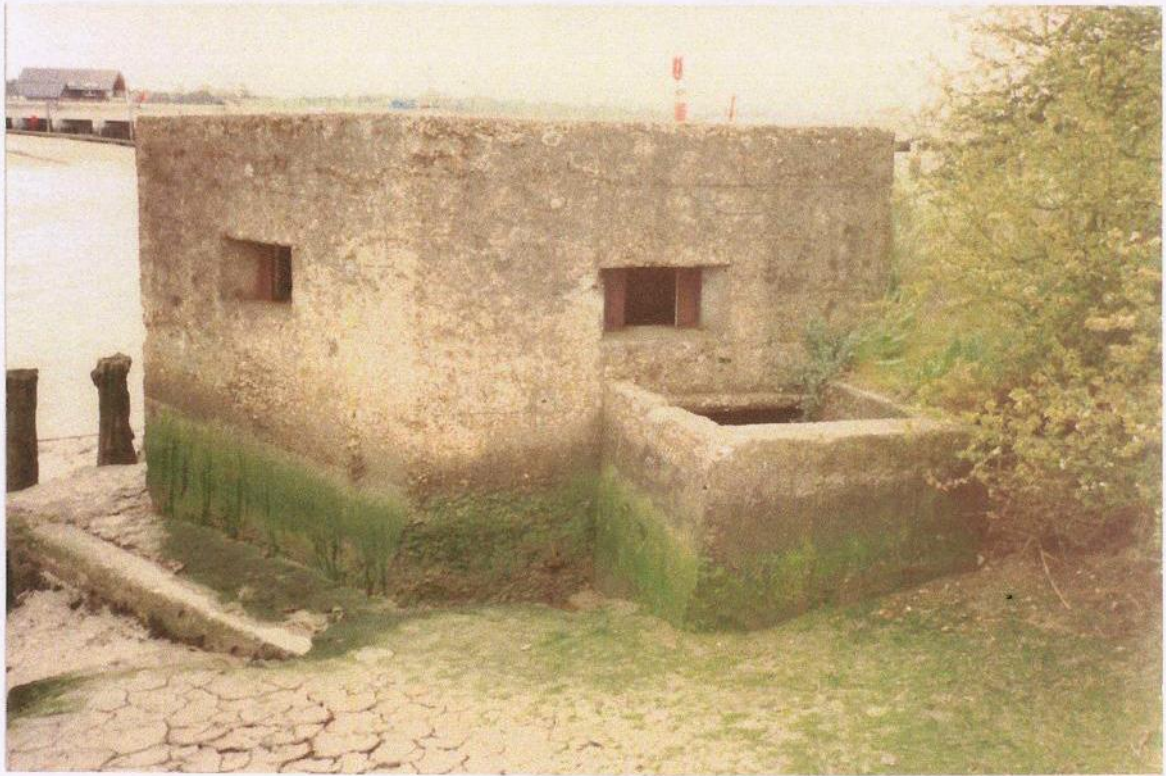
SMR 10877: The picturesque setting of this pillbox somewhat belies its more serious purpose. The drop-in entrance is very unusual; clearly designed to protect against flooding.

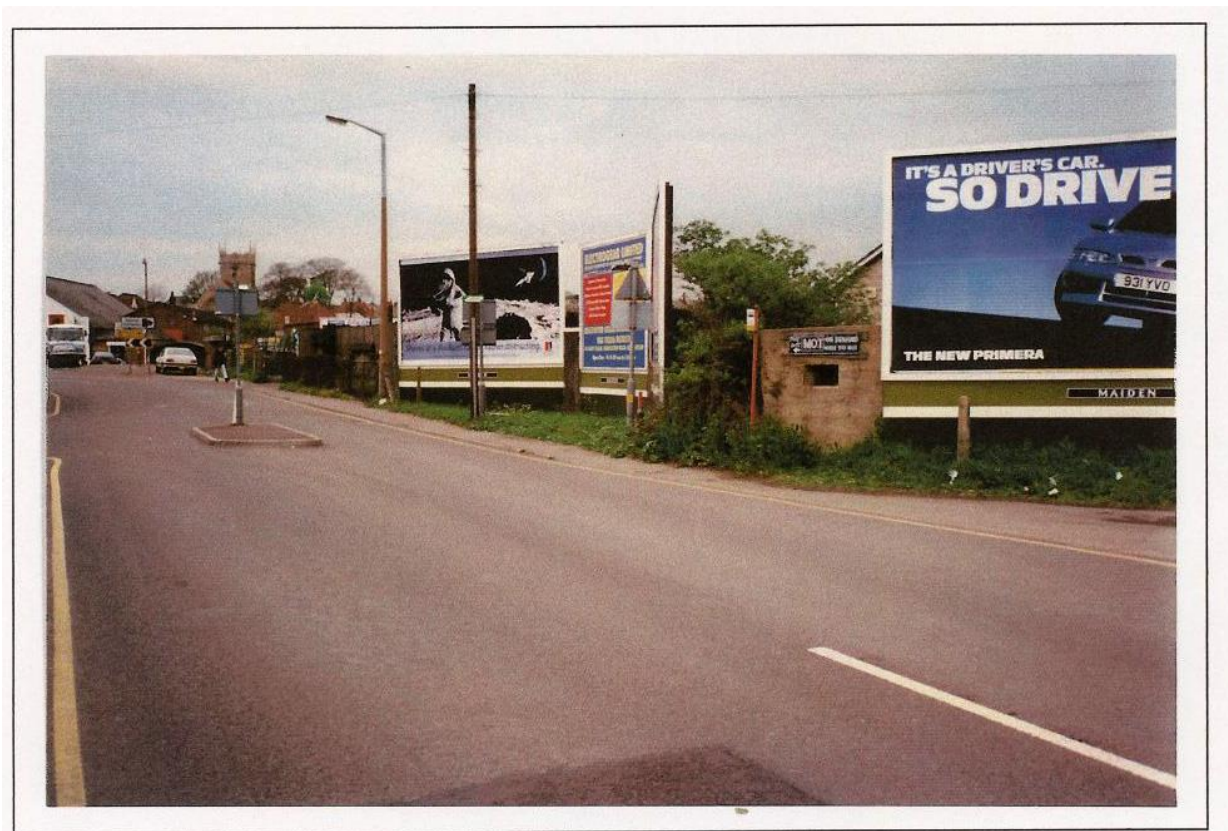
SMR 10888: During World War Two, Colchester was designated an 'anti-tank island' protected by a vast circle of pillboxes every 200/300 yards. This is one of the few surviving

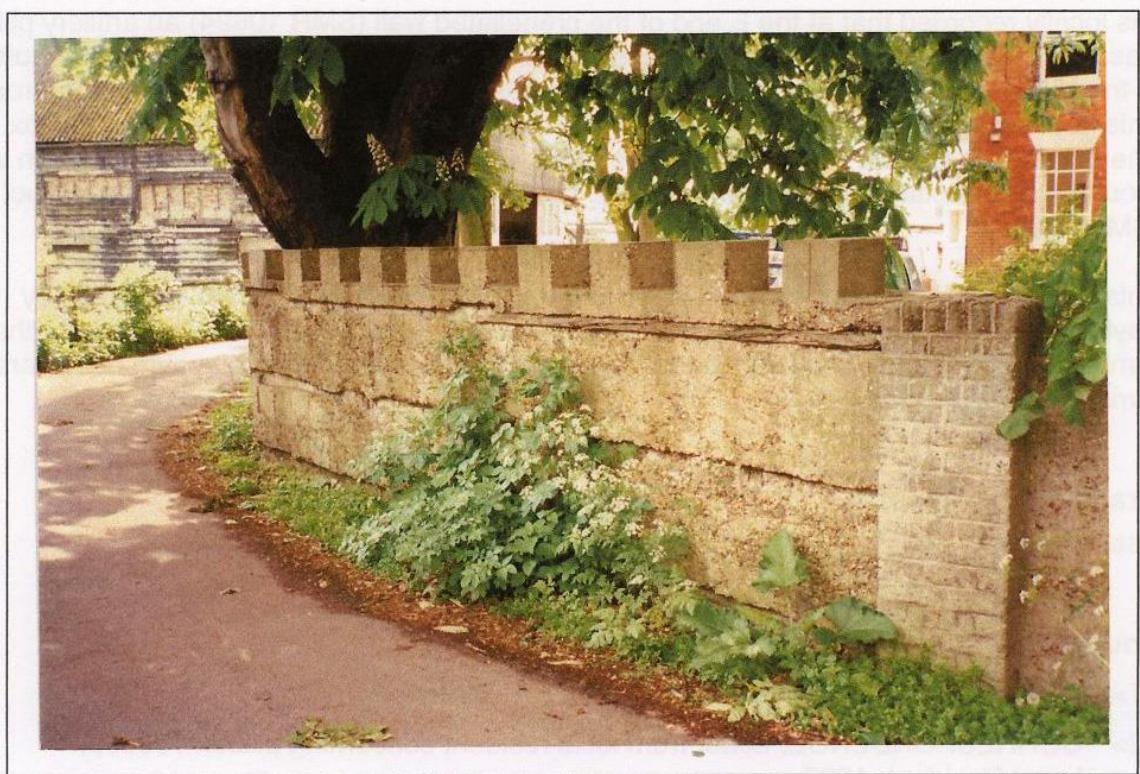
It is probable that at that time a fence bordered the garden — now a wall each side of the crenellated wall — and that 33' of it was taken down, replaced by the firing position and the fencing re-secured to the outside using the battens to nail it on to. This would have effectively disguised the position.

SMR 10894: At the time of compiling this report, over 2,000 WWII sites have been recorded in Essex. This is the sole example of a surviving crenellated firing post

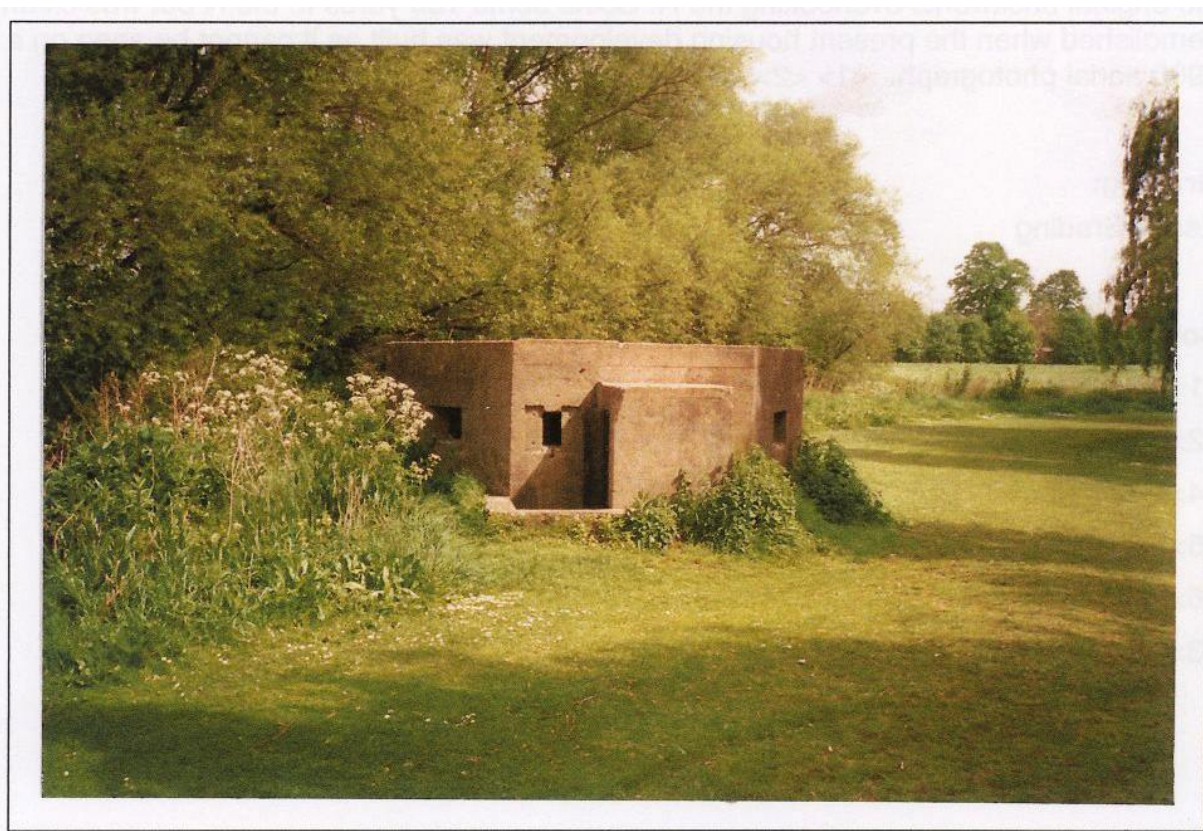
On the south bank of the river Colne is a concrete, Type FW3/22 pillbox facing northwards across the river. Its walls are 15in thick, it has an entrance on the south side and there are six loopholes. The entrance is via a low, steel door. This is a recent addition, but may well have replaced an earlier one. The loopholes are generally 10in wide x 12in high, but there is one 'slit-type', 7in wide x 12in high, beside the entrance. The pillbox measures 12ft 6in across. <1>

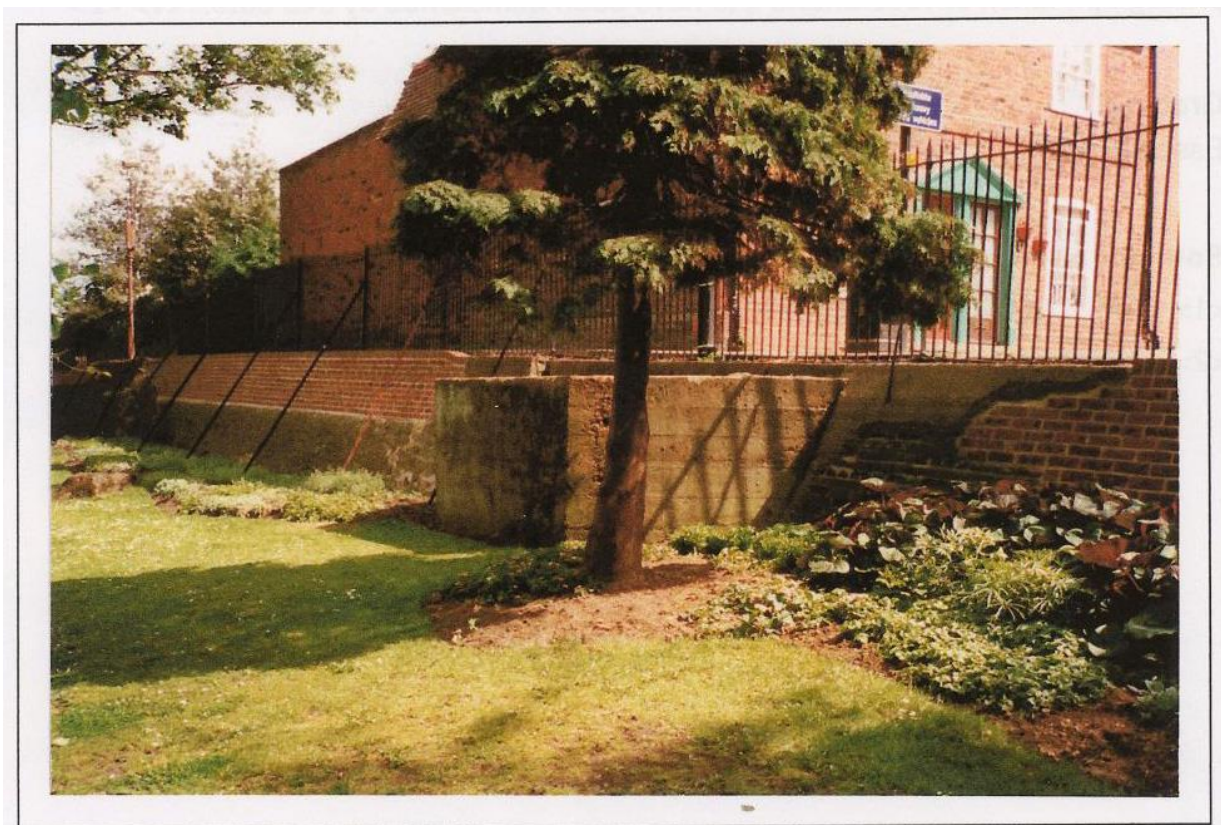
SMR 10911: Documented in wartime records, it is not immediately obvious that this is a base on which a WWII pillbox stood. On closer inspection, the marks in the surface, the reinforcement rods and distinctive shape all give it away.
