SURVEY OF WORLD WAR TWO DEFENCES IN THE BOROUGH OF COLCHESTER

PROJECT REPORT: NOVEMBER 2007

Fred Nash
for
Colchester Archaeological Group
and
Essex County Council

Section A: SMR 8913 – 10961

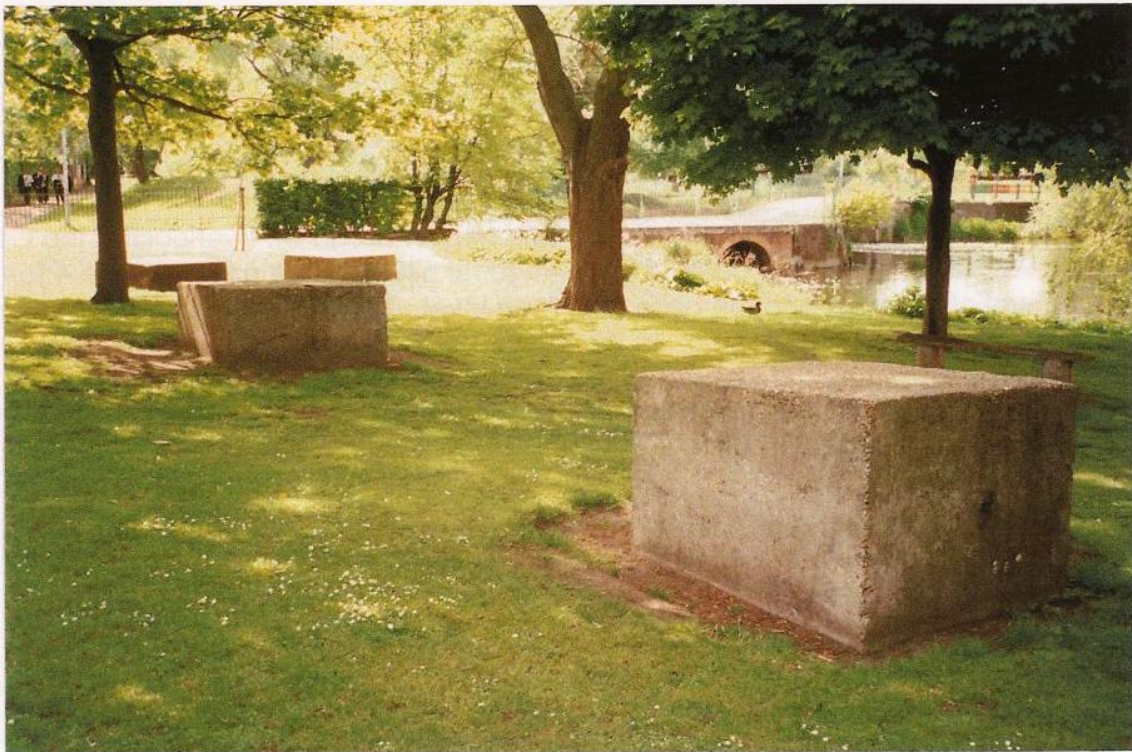
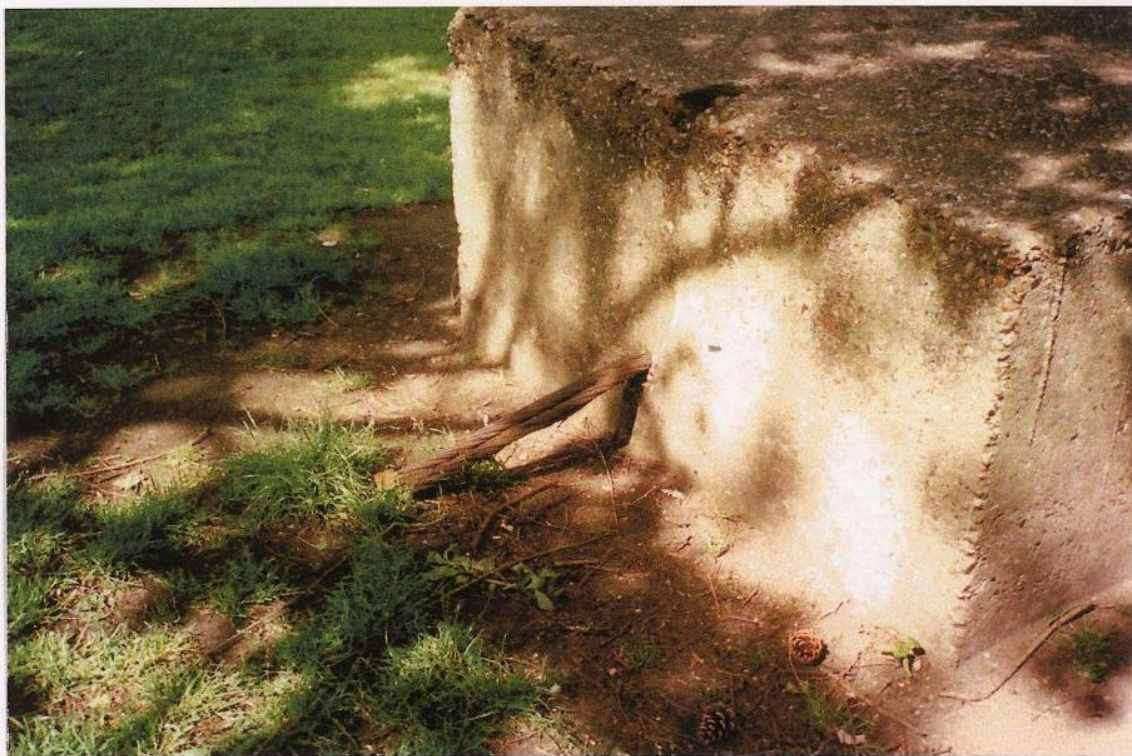
SMR 10912: Sitting like pieces of modern sculpture in Colchester Castle Park, for the casual observer it would be by no means easy to interpret the origin of these anti-tank blocks.

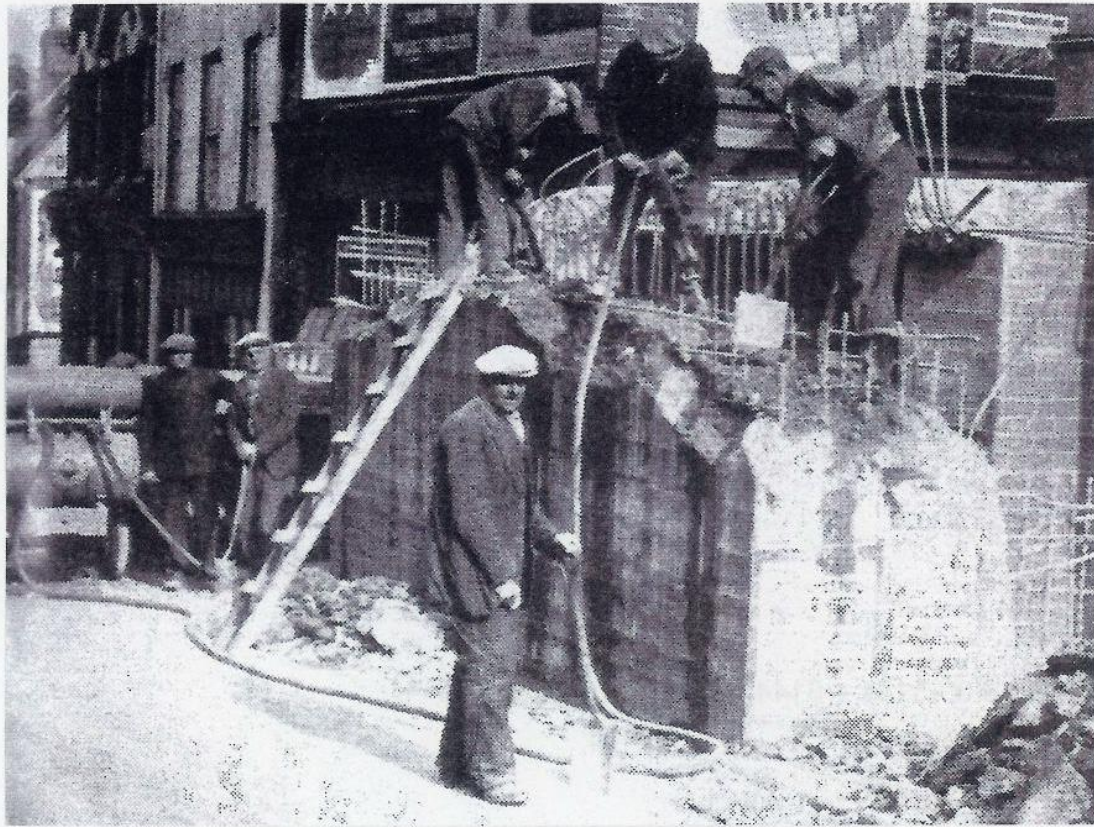
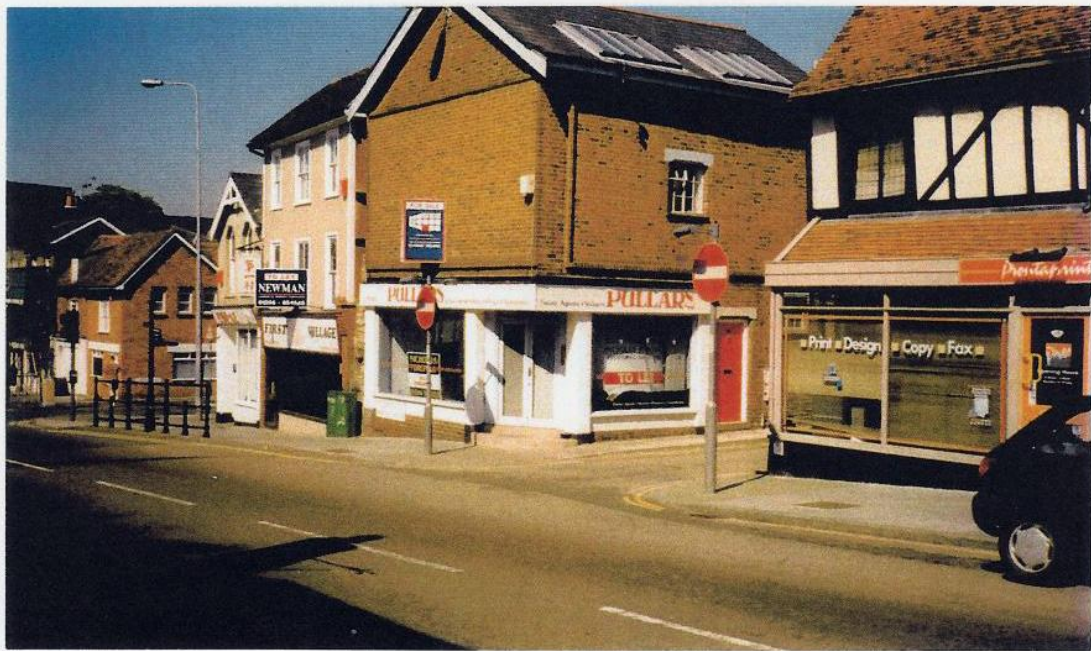
SMR 10915: Some pillboxes, particularly in the towns, were demolished long before the end of the war. The scene on North Hill in October 1944 is difficult to reconcile with that in 1997.

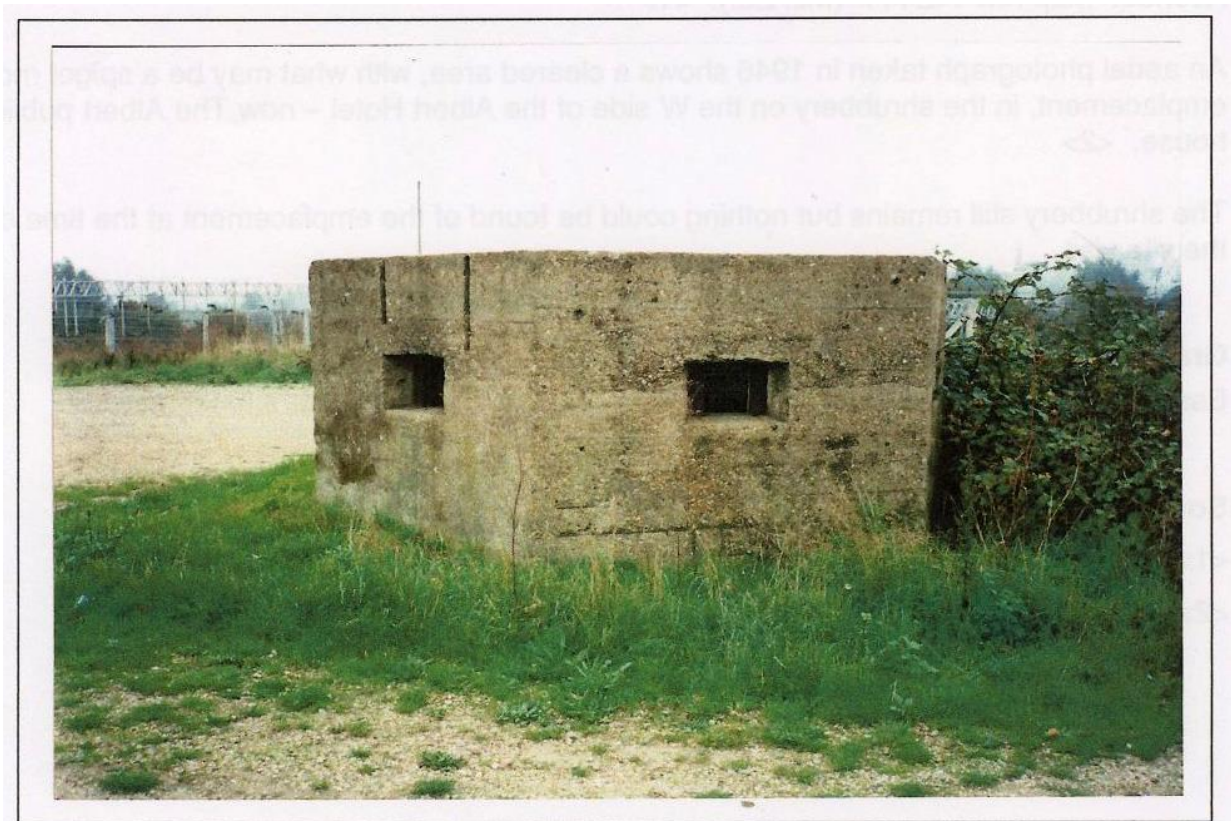
SMR 10919: The pillbox at North Station car park, before its demolition in 1995.

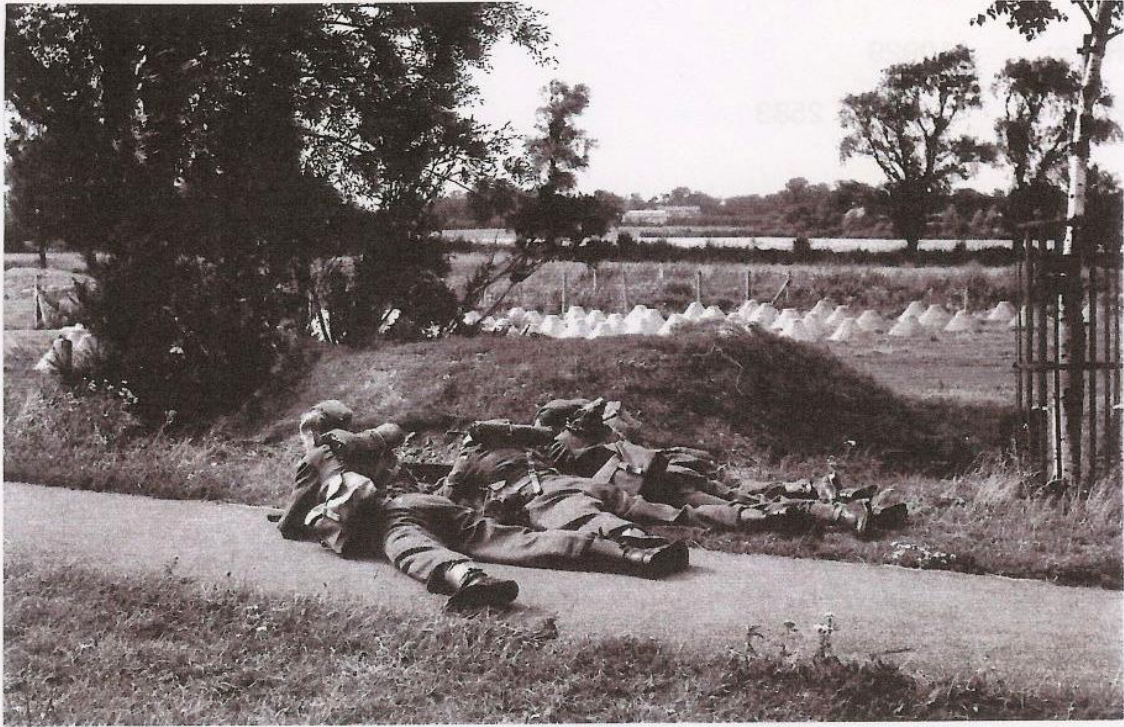
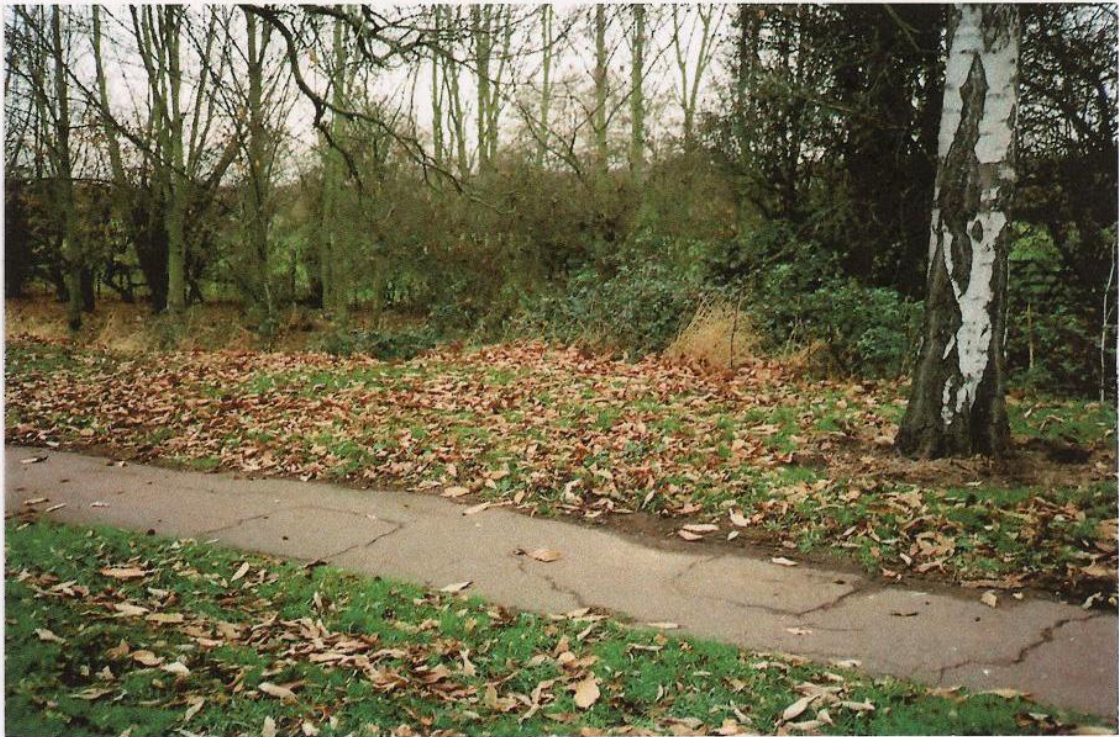
This very band of anti-tank pimples can be seen clearly in the background of a wartime photograph of the Colchester Home Guard on exercises. It was taken in August 1942, on exercise 'Crack'. <3>

SMR 10930: (Top) It is rarely possible to identify a particular defence site from a wartime photograph. This was one of a series taken by military photographers, captioned with the town and dated. 1940's aerial photographs, the countryside in the background and the path alongside Cymbeline Way did the rest. (Bottom) The spot today, the young trees hiding the view behind. (1942 photograph courtesy of the Imperial War Museum, London. H22528)

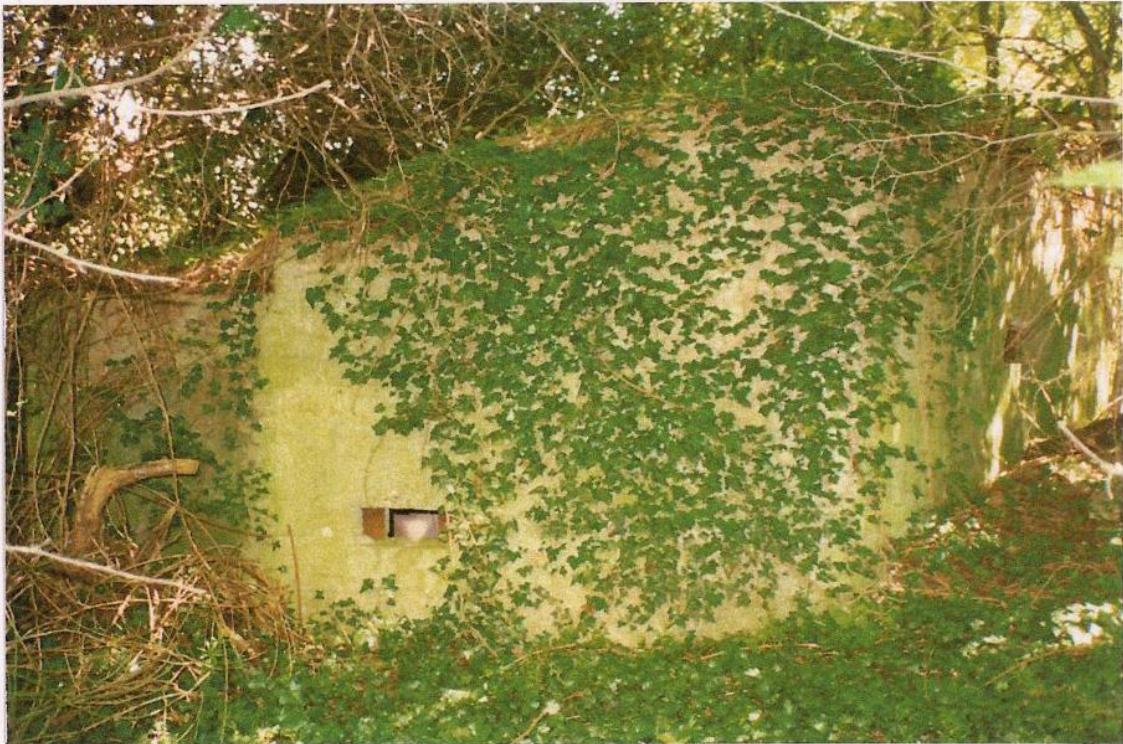
SMR 10937: Difficult to see on the ground, this pillbox appears to have been built on a number of levels to accommodate the steep slope on which it stands.

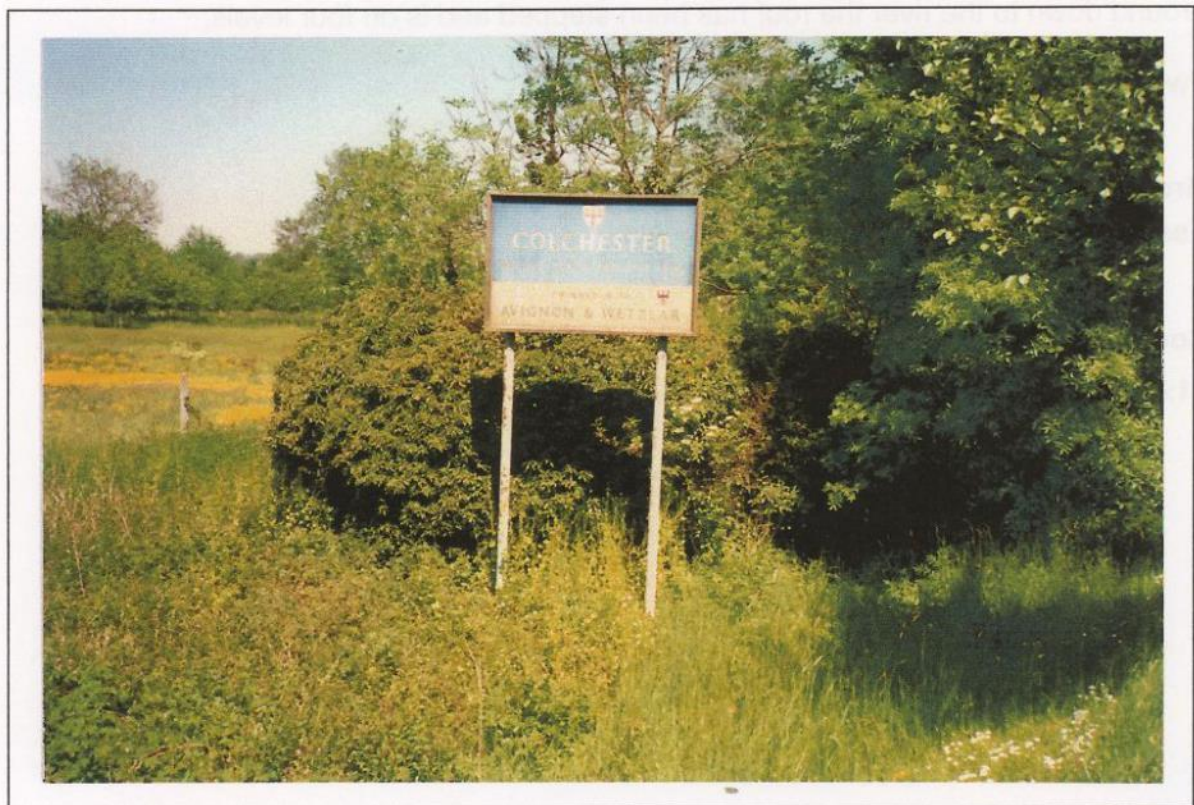
SMR 10938: Over the years, this pillbox has become so covered in thicket that it cannot be seen from only a few feet away.

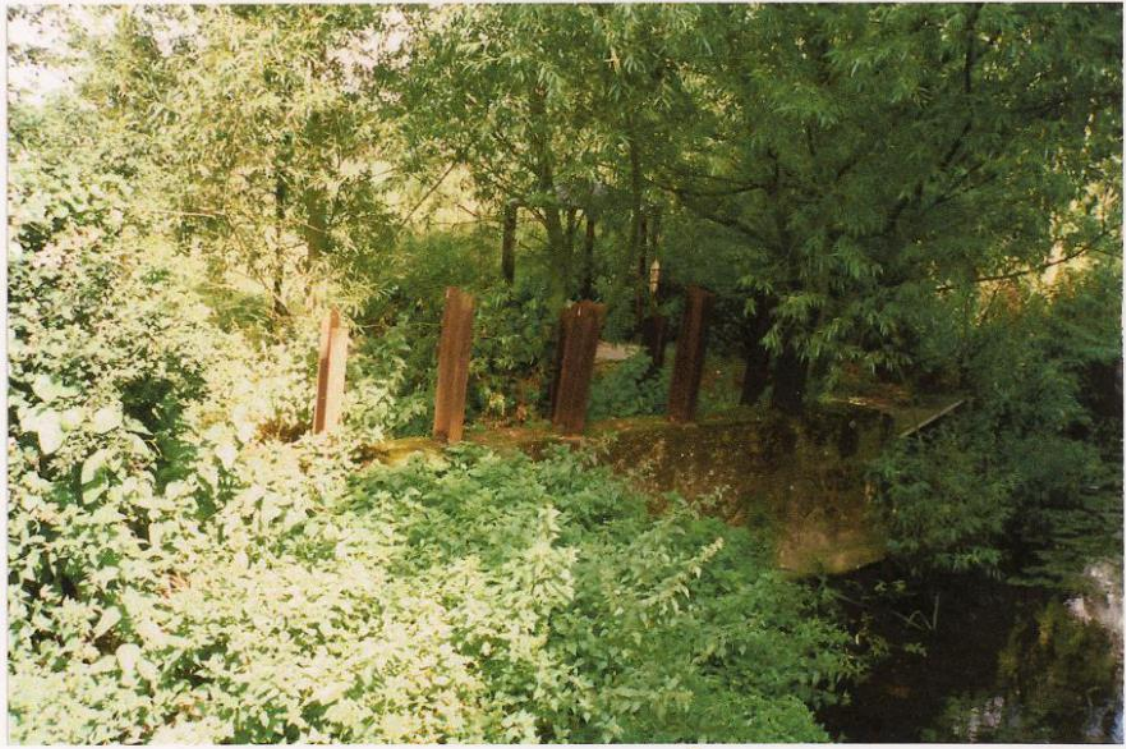
SMR 10939: During World War Two, hundreds of anti-tank rails were concreted into the banks of the River Colne in places where it was thought that armour might be able to cross. All, except these, have fallen beneath the oxy-acetylene cutter.

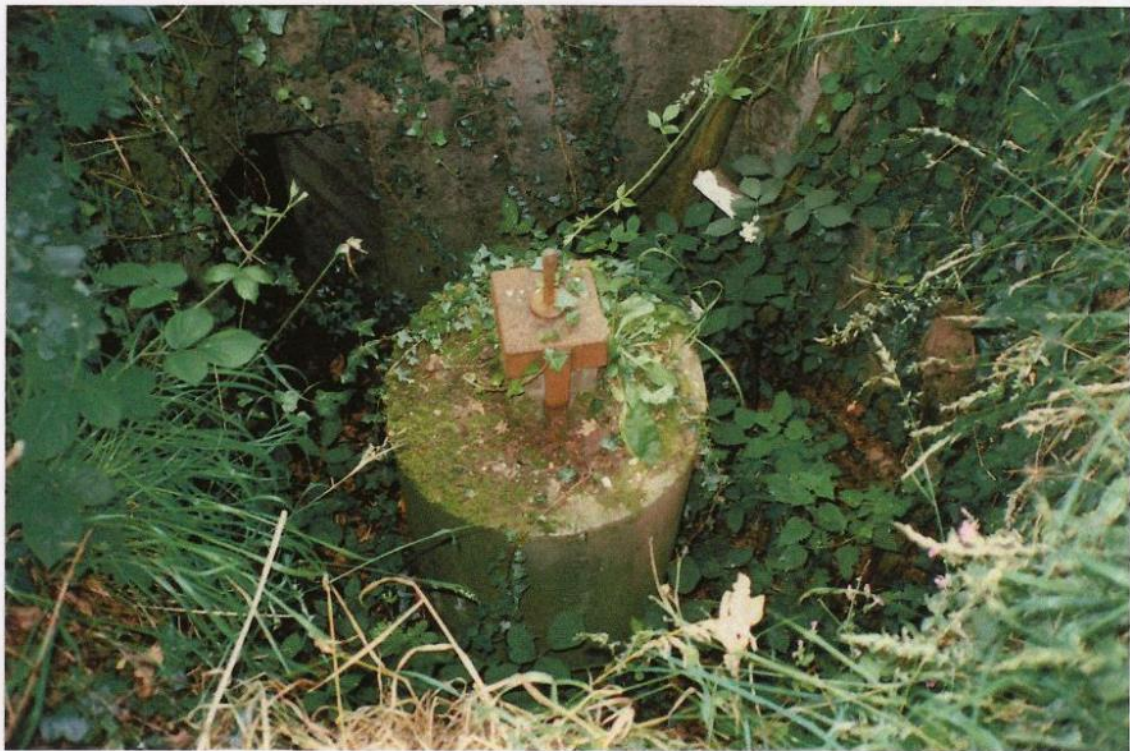
SMR 10945: The central well of the pillbox at Seven Arches Farm. The pedestal, with its steel mounting rod, would probably have held a Lewis gun from the First World War.

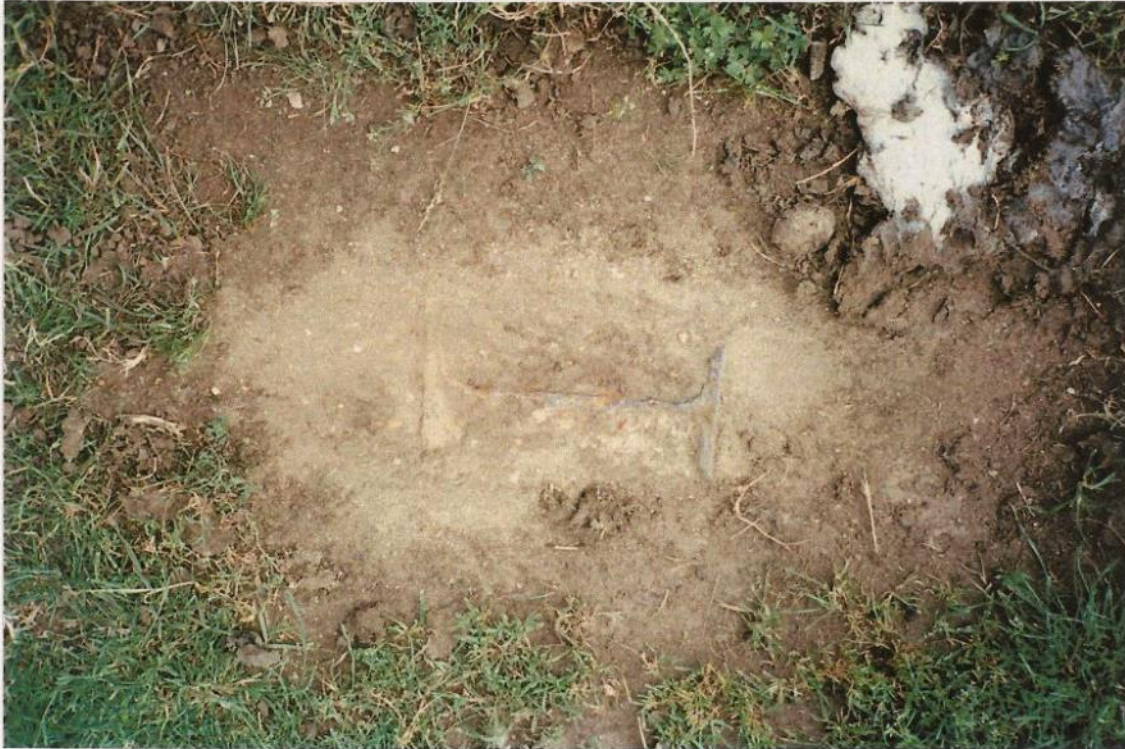
SMR 10946: The cut-off remains of around 100 anti-tank rails can be counted in the concrete, and in the grass embankment, at Seven Arches Farm

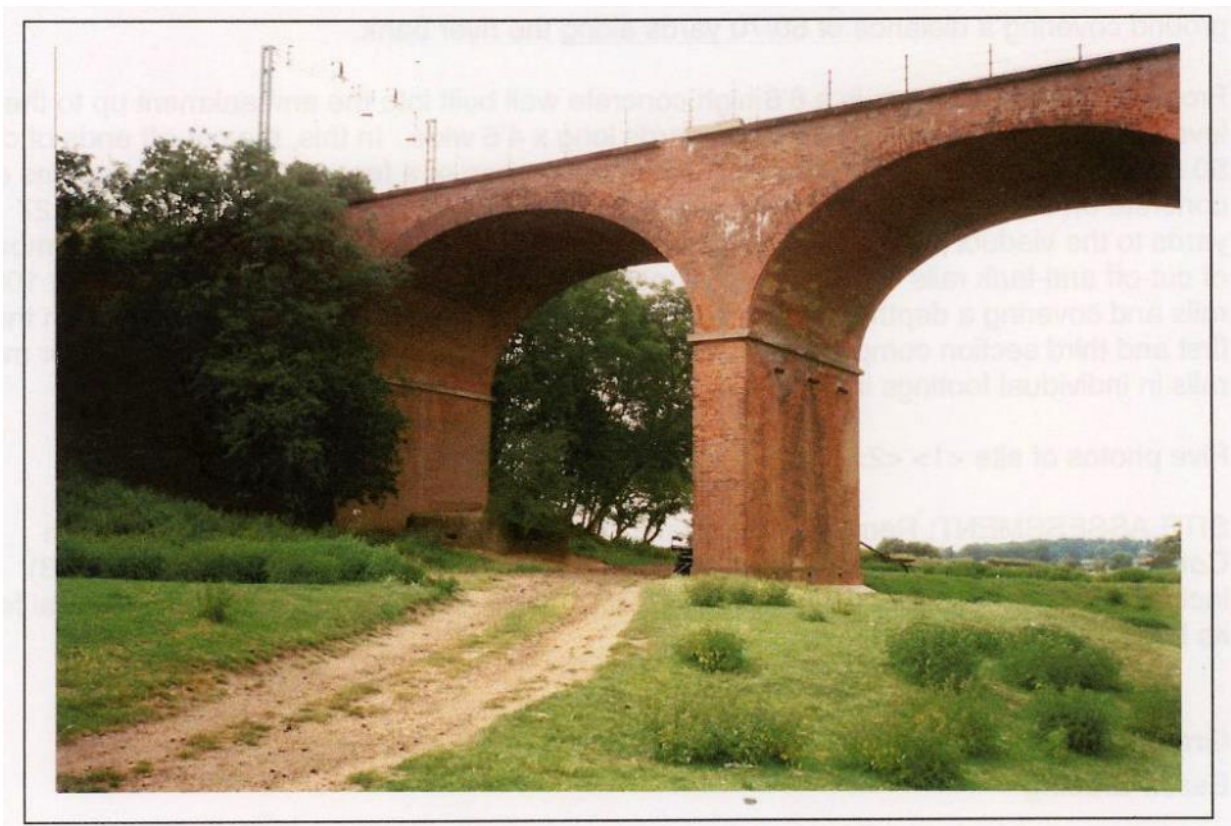
SMR 10947: Protected from air attack, this pillbox was particularly well-sited.

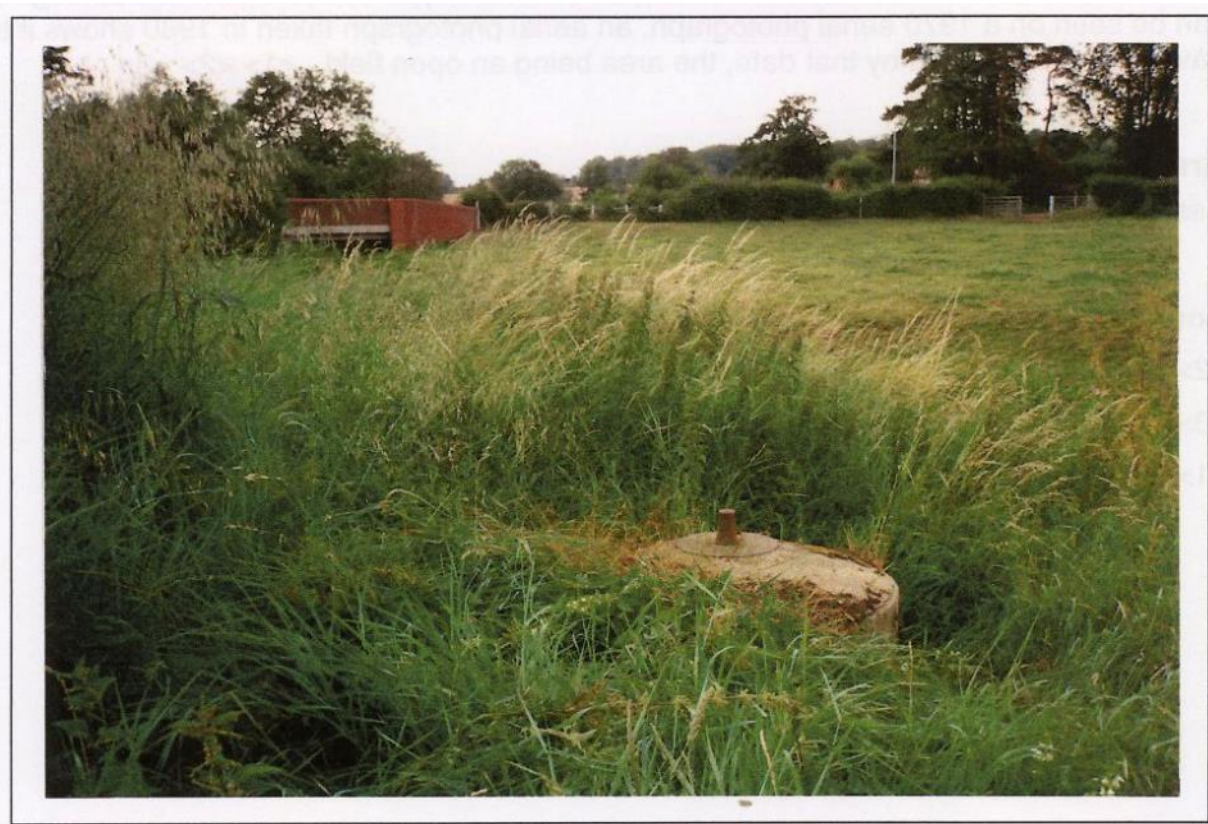
On the S bank of the R. Colne, about 70 yards E of New Bridge, is a spigot mortar pedestal. It is partly built into the bank which almost covers its rear. It is 3'6" in diameter and, unusually, has a steel pintle which is now rusty. Normally, pintles were made of high-grade stainless steel which remain, to this day, in pristine condition.

SMR 10950: With less than 50 extant spigot mortar emplacements recorded in the county so far, it is probable that many more lie hidden in the fields and hedgerows, unrecognised for what they are.

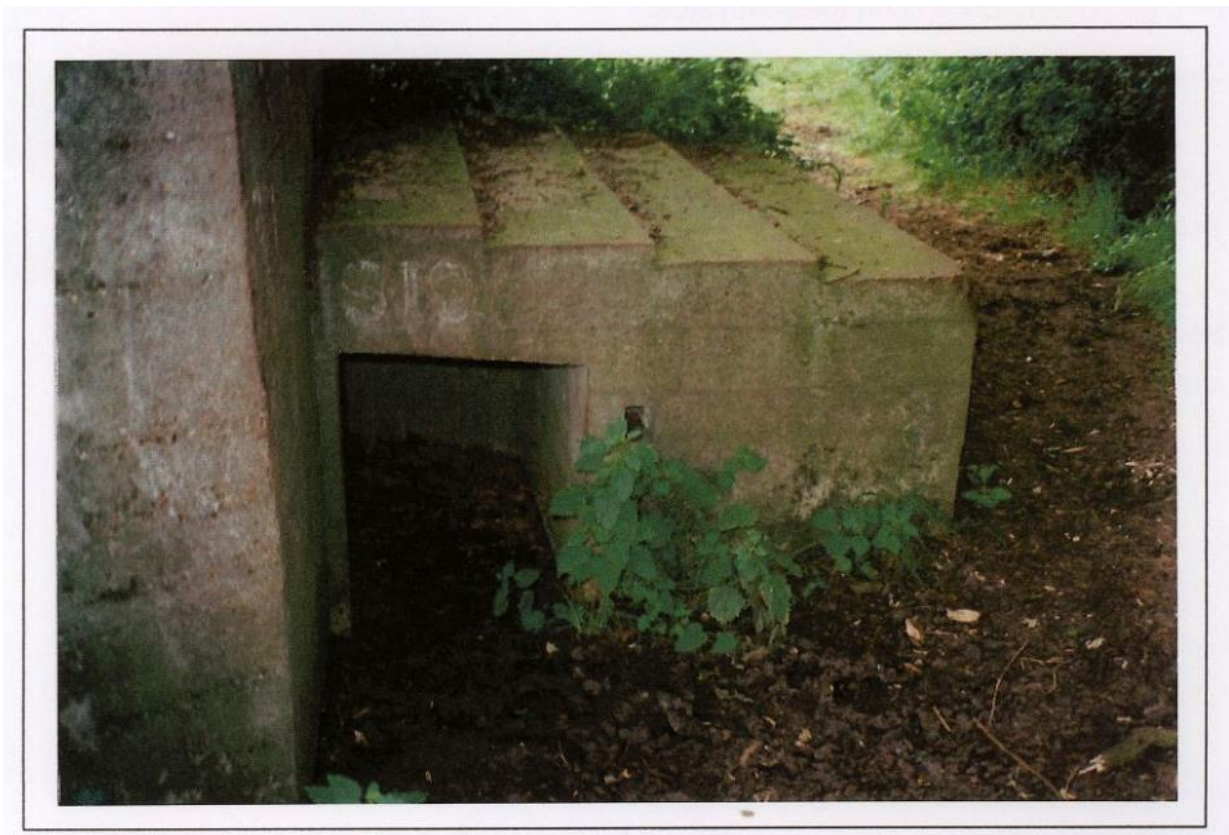
SMR 10956: During the war, pillboxes were individually identified with a number, often painted on the wall. Rarely, after 60-odd years, can this still be seen.

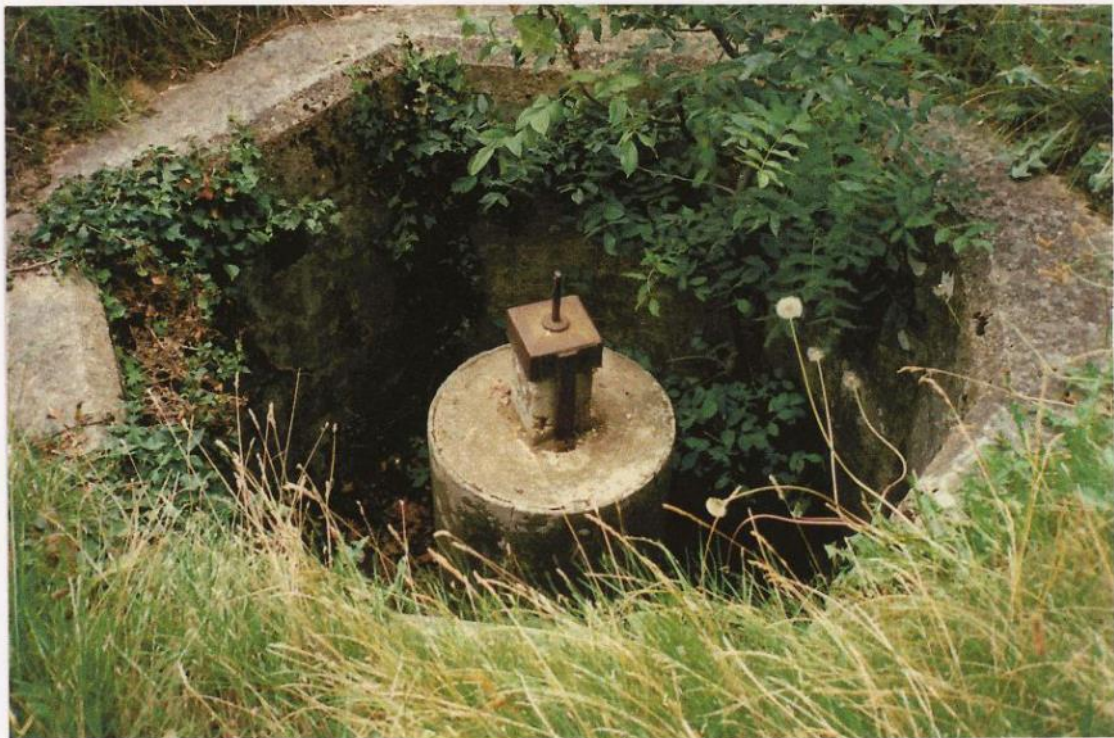
SMR 10957. The anti-aircraft machine-gun well of the Argents Lane pillbox. The pin on the top of the mounting would have held a World War One Lewis gun.

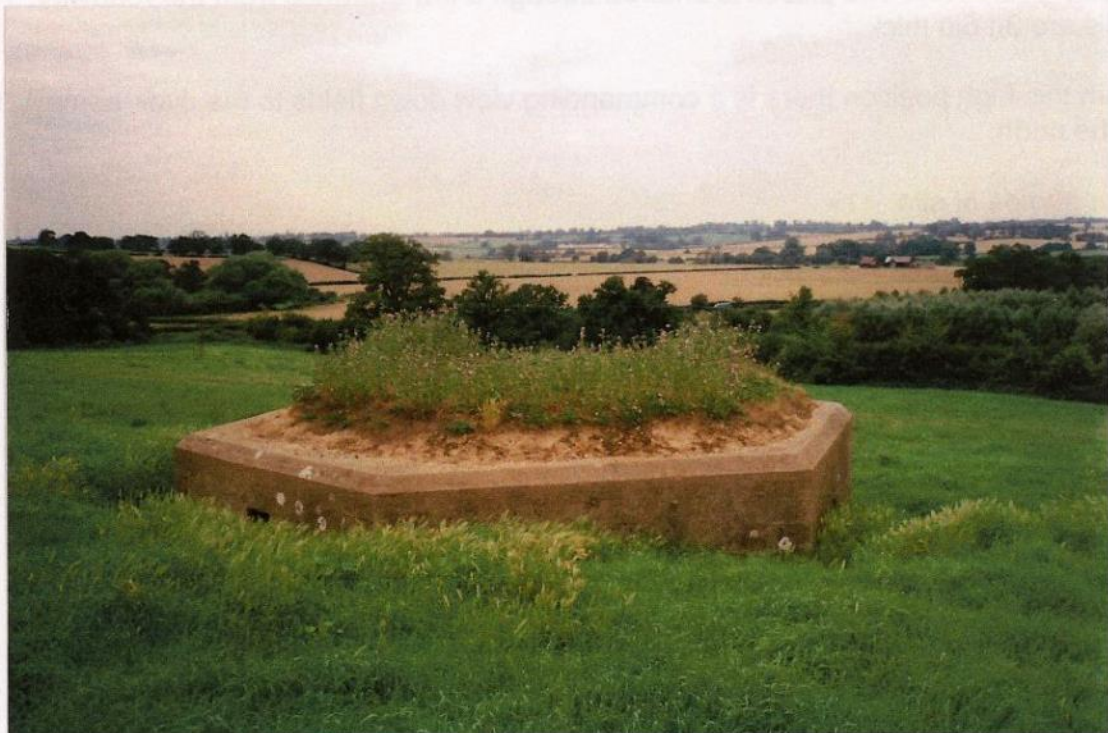
SMR 10958: Earth and grass on top of a pillbox is not a natural result of wind and weather but was a deliberate attempt, at the time of construction, to camouflage it against air attack.

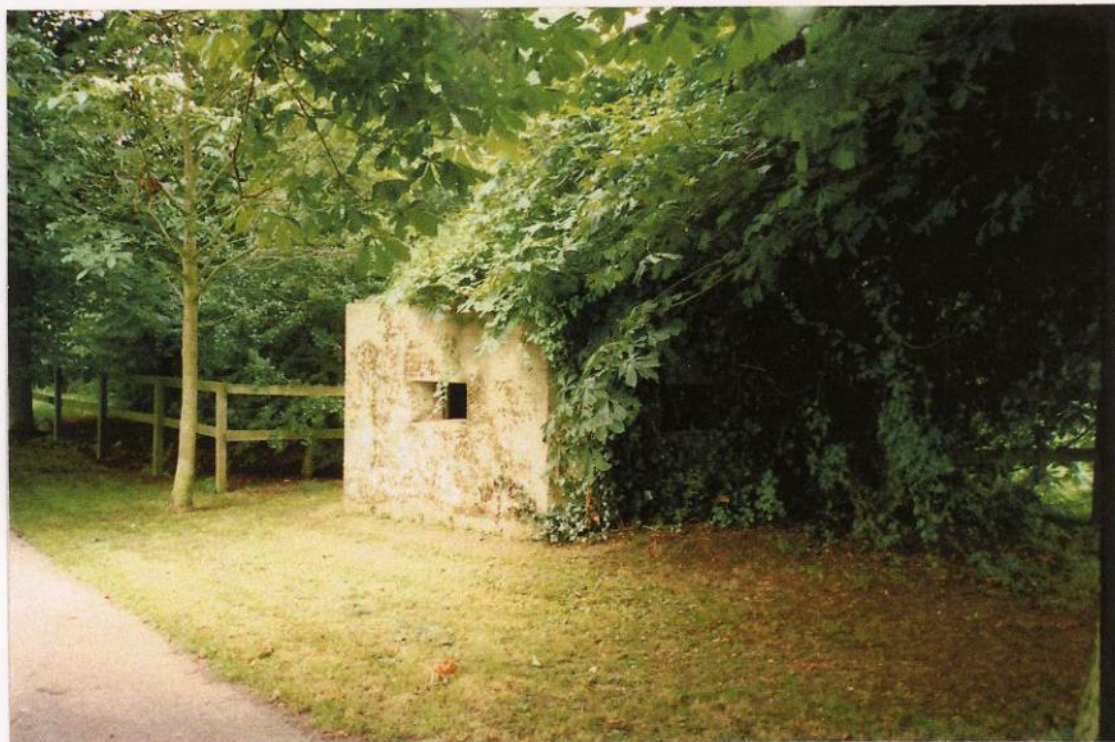
SMR 10960: The FW3/22 was one of the smallest of the pillbox designs during World War Two. Its 15-inch walls were intended to be bullet-proof rather than shell-proof.

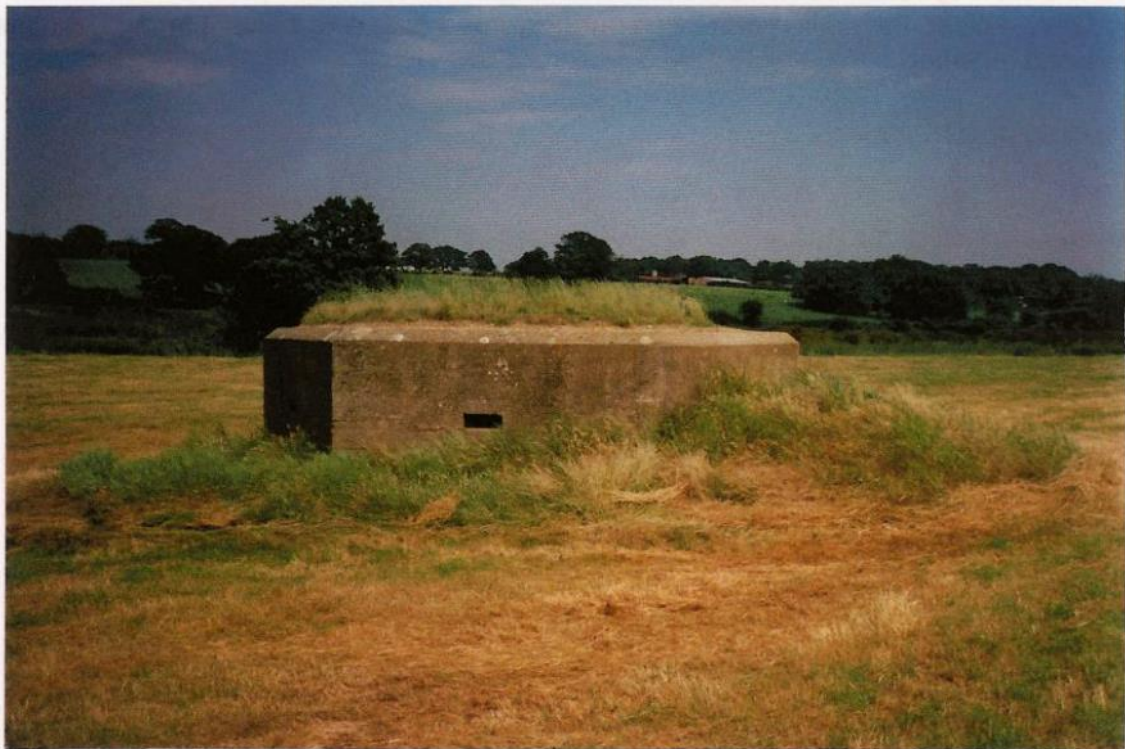
SMR 10961: The pillboxes of Great Porters Farm are a rare example of 100% survival, all in good condition. This is the 19' 6" infantry type.

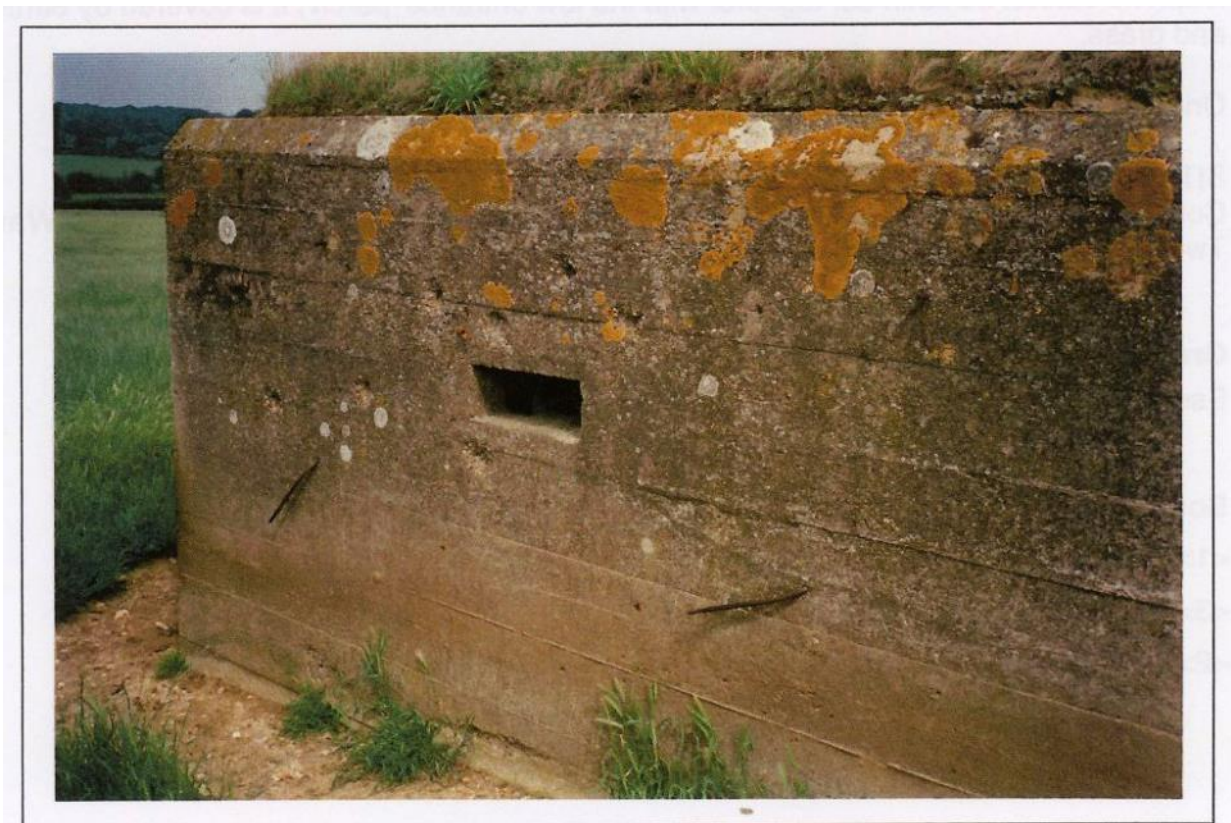
SMR 10962: The hooks, more usually found around the top of a pillbox, were probably to hang camouflage netting
