# **SURVEY OF WORLD WAR TWO DEFENCES IN THE BOROUGH OF COLCHESTER**

**PROJECT REPORT: NOVEMBER 2007**

### **Section C: SMR 20494 -- 21159**

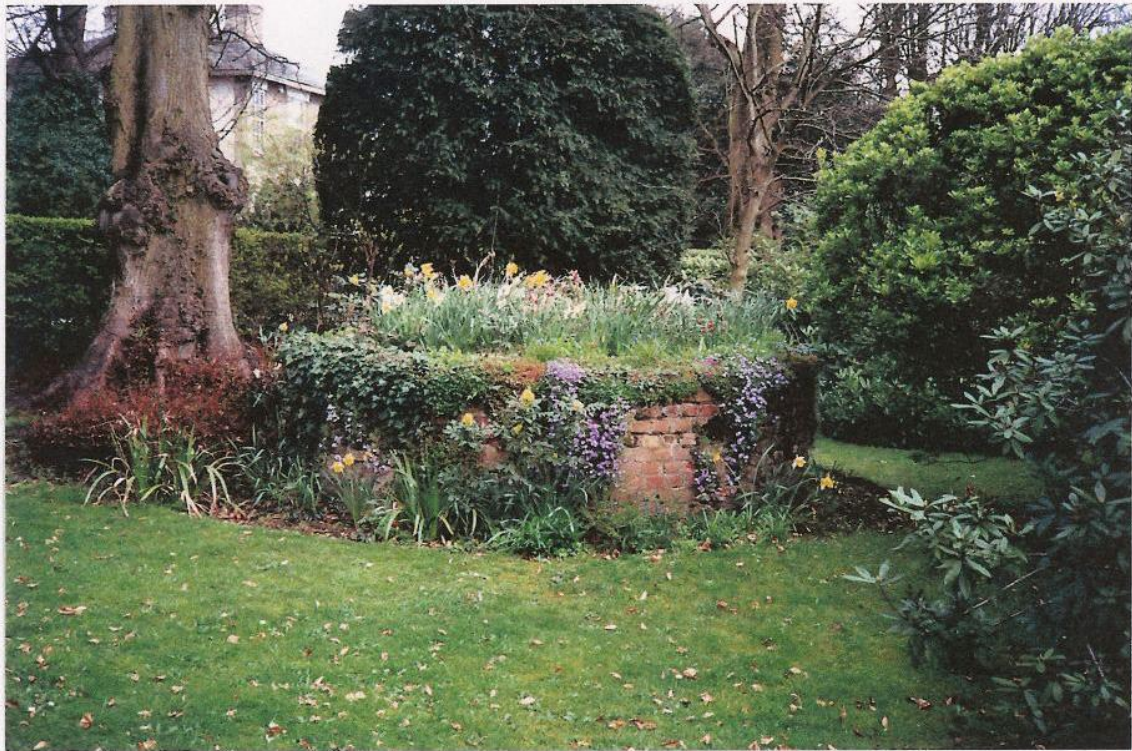
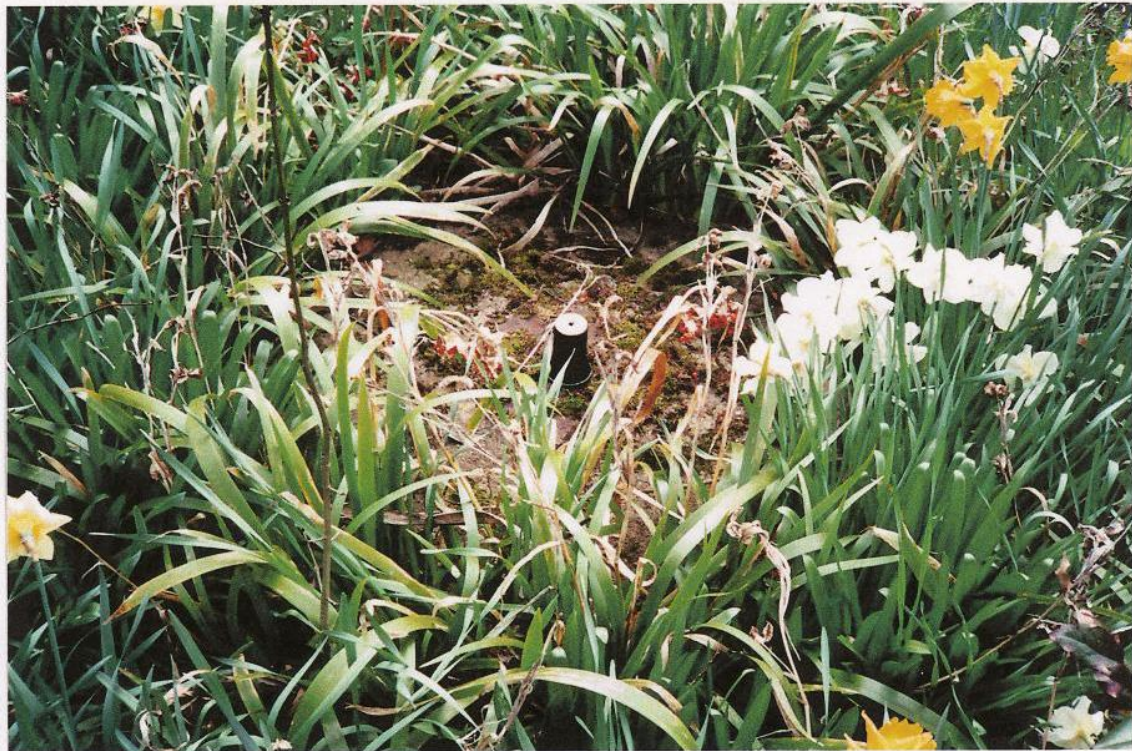
The example at Lexden Road is, however, different to the norm. This pedestal has been built to stand at ground level, 3 feet high, and, instead of a pit, a full-height brick wall has been built around it to give protection. This wall is completely circular with an outer diameter of 11'5". The features of the pedestal - stainless steel pintle, size and construction - appear to follow the standard seen elsewhere. Since the war, the "pit" between the pedestal and the wall has been filled in with soil. This has been planted up and the whole structure now appears as a circular, raised flower bed. However, from above, the top of the pedestal and its pintle can still be seen.

*SMR 20515: An imaginative and particularly attractive way of conserving a spigot mortar emplacement.*

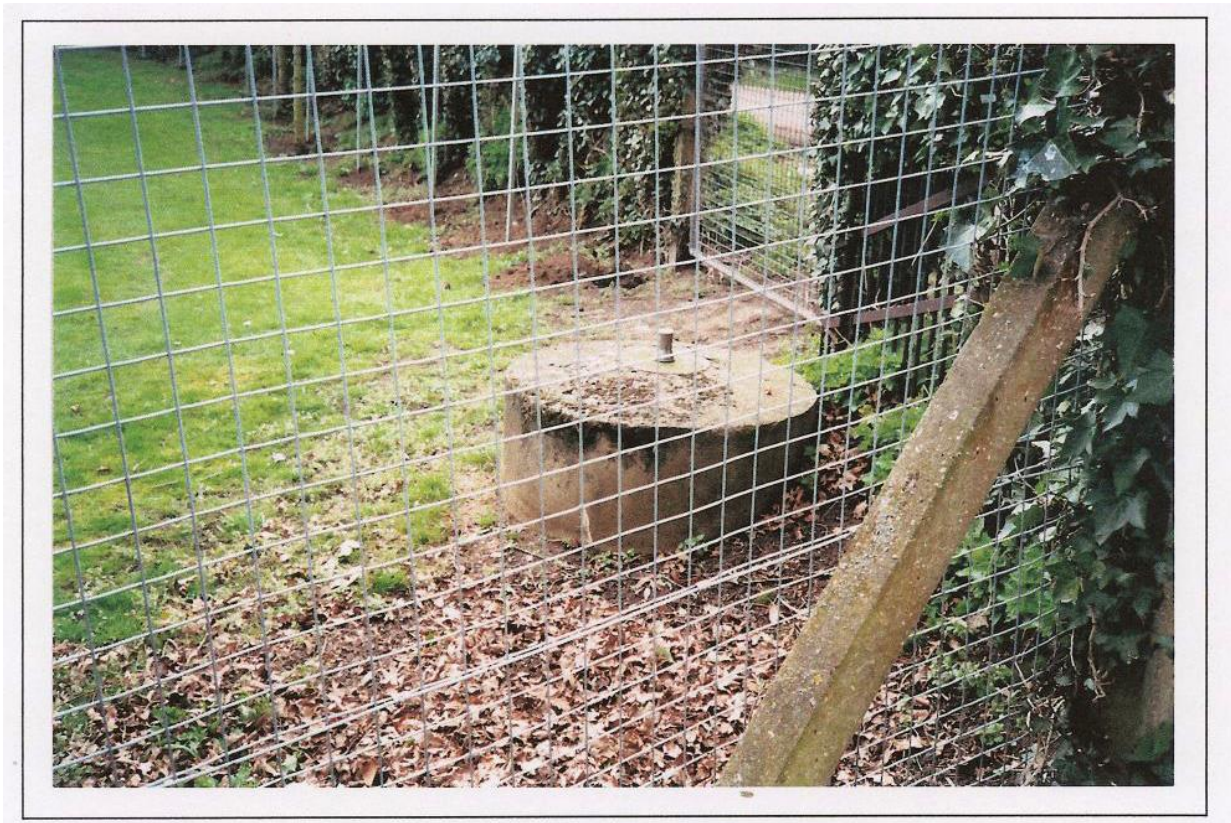
In the extreme NW corner of a playing field, close to Park Road, is the extant pedestal of a spigot mortar emplacement. It stands some 18" out of the grass, measures c. 3' 6" across, and is surmounted by the stainless steel pintle on which the gun was mounted. Typically, these pedestals were constructed within a concrete-lined pit and the remains of this may survive beneath grass level. This emplacement was probably one of two at this location, the other is indicated in contemporary records as having stood on the other side of Park Road to the NW of this position (SMR 20518).

**SITE ASSESSMENT:** At the time of compiling this report, just two spigot mortar emplacements have been found extant in Colchester. This example is therefore a rare survivor of the town's former defences.

*SMR 20519: Surviving spigot mortar pedestals can often stand unrecognised for what they are.*

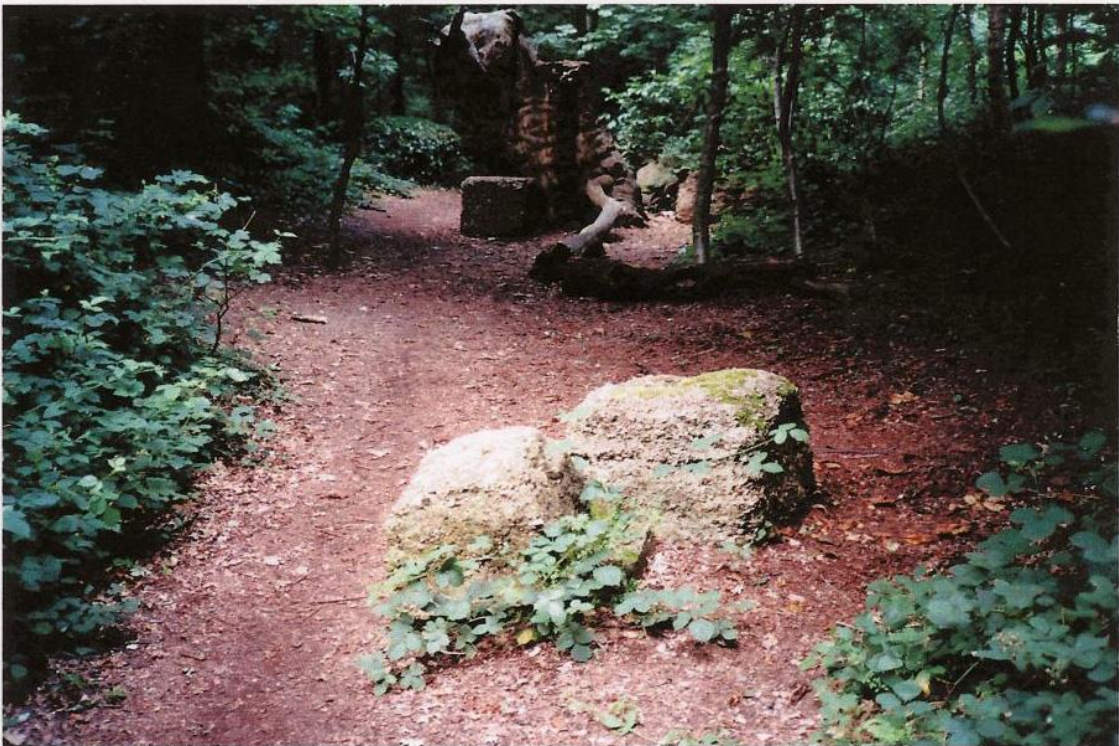
*SMR 20523: Unrecorded in wartime records and not visible beneath the trees on 1940's aerial photographs, the configuration of these anti-tank blocks, as they stood in the ground, is not known*

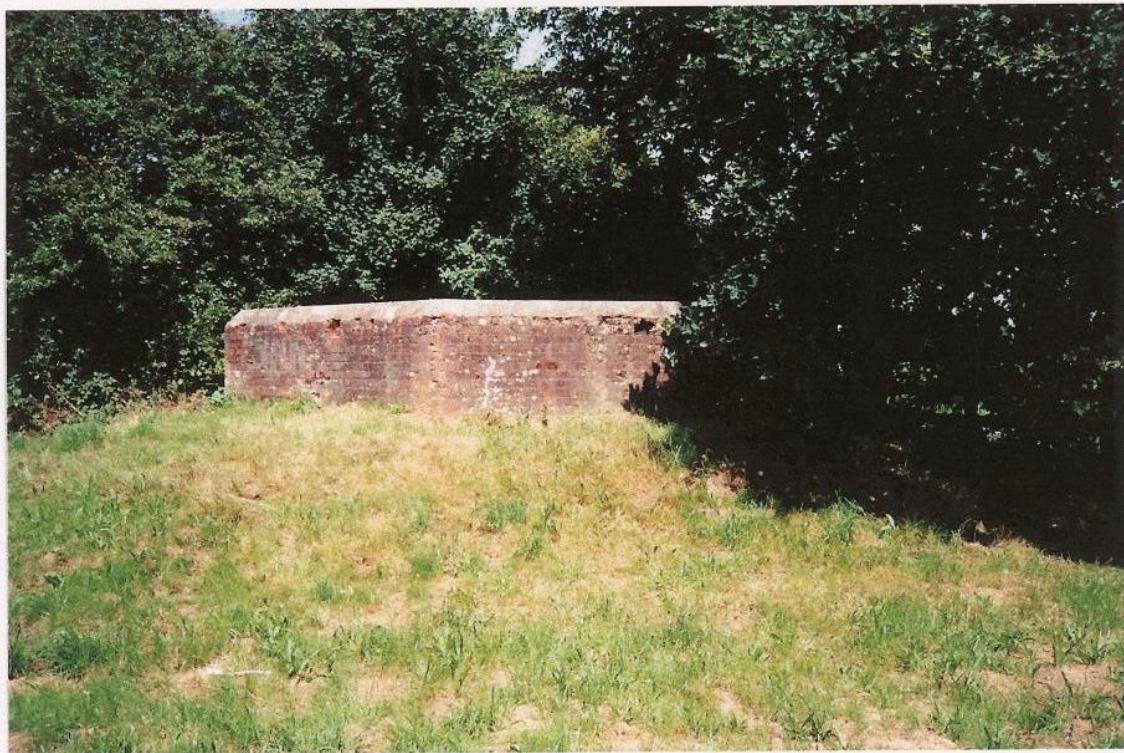
*SMR 20546: One of the three 'There'll always be an England' pillboxes. From the outside it appears to be in good condition but, sealed up, nothing of its interior is known*

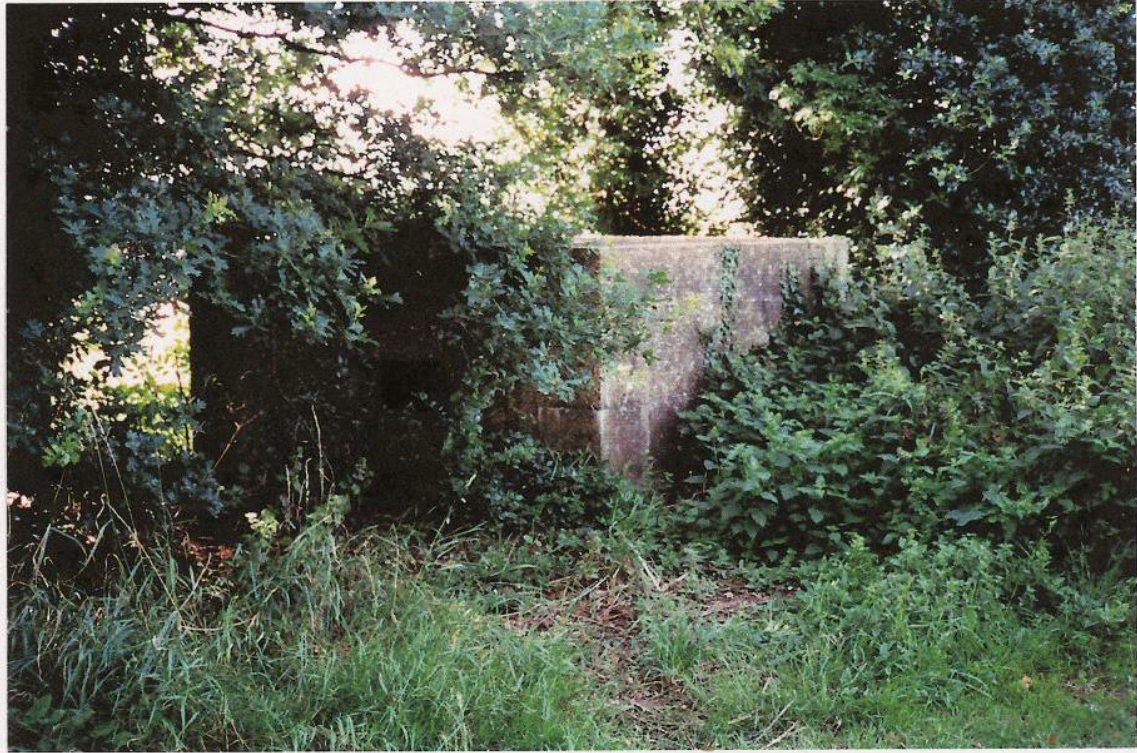
*SMR 20547: All of the three pillboxes which Ross Parker could have used are still extant. This one is only a short stroll away from the entrance to the camp.*

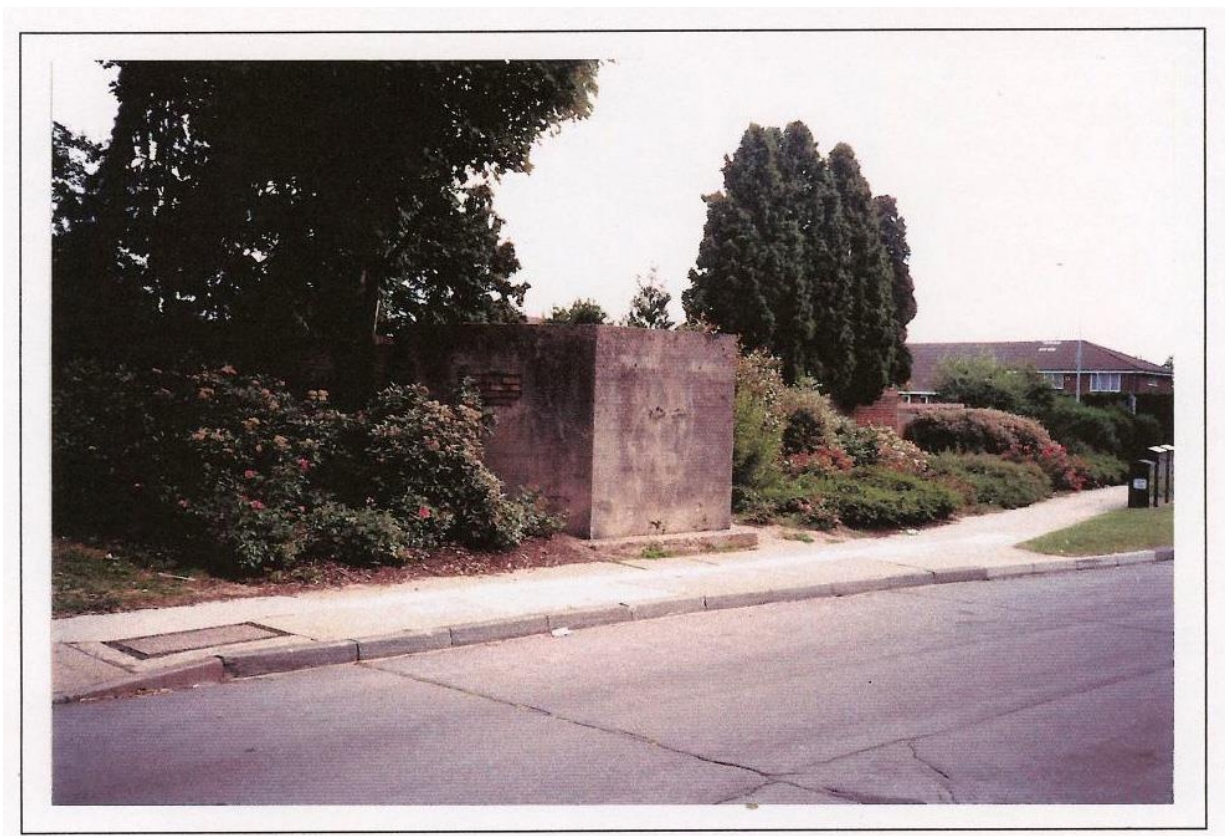
Although the entire edifice, in good condition, is now emplaced in a small rose bed surrounded by housing, aerial photographs taken in April 1946 and September 1947 show it to have then stood just north of a belt of trees in almost open farmland. Only the houses along Mersea Road immediately north of the pillbox were built at that time. This defence point was one of two pillboxes and an anti-tank ditch (see 20553) built in this area of Mersea Road as one of the outer defences of Colchester. <1> <2>

This pillbox, although not accessed internally, is externally in good condition with no sign of vandalism or deterioration. It is a typical type FW3/22 and stands (at the time of writing) as one of only two surviving pillboxes (there were at least ten, but probably significantly more) which formed the outer defences of southern Colchester during World War Two (see 20547).

*SMR 20552: The setting of this pillbox has changed unrecognisably since World War Two. It nevertheless has survived remarkably well.*

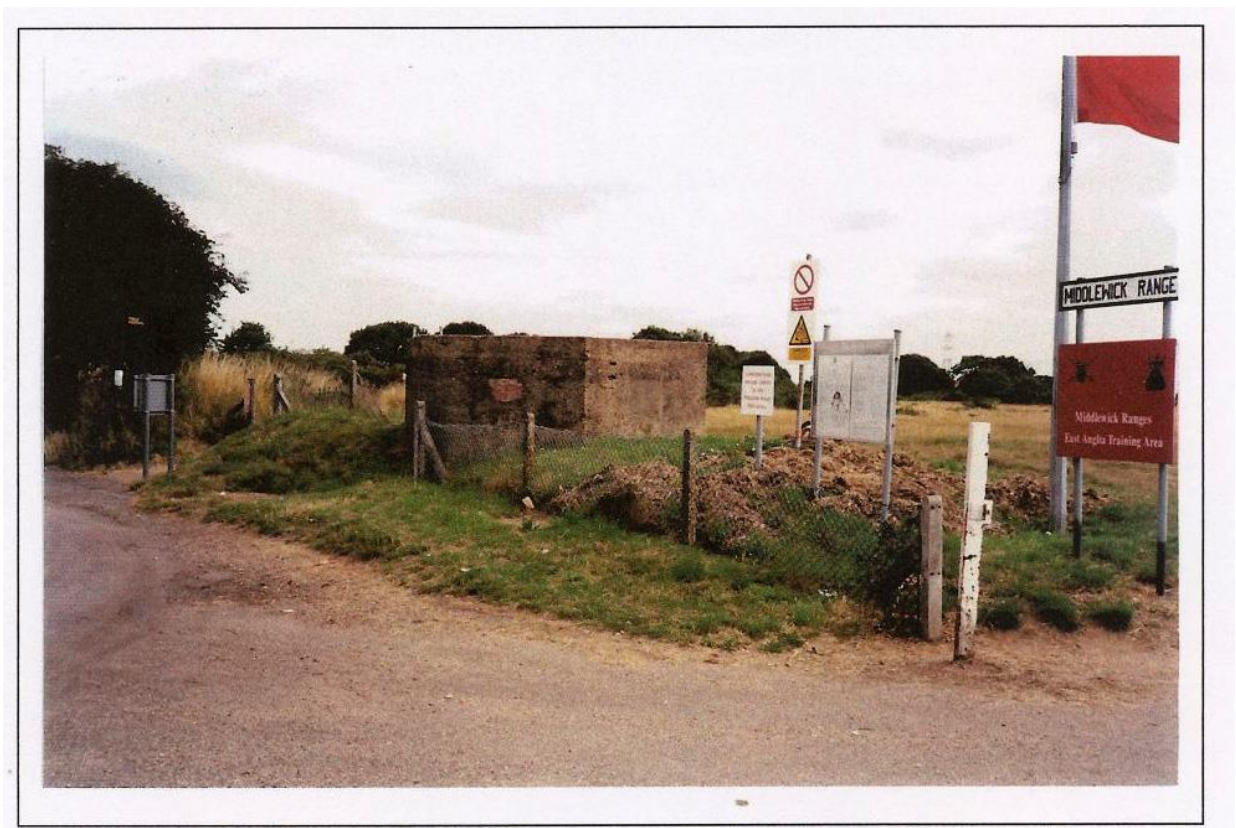
*SMR 20610: A familiar sight along Mersea Road, the pillbox at Middlewick Ranges*

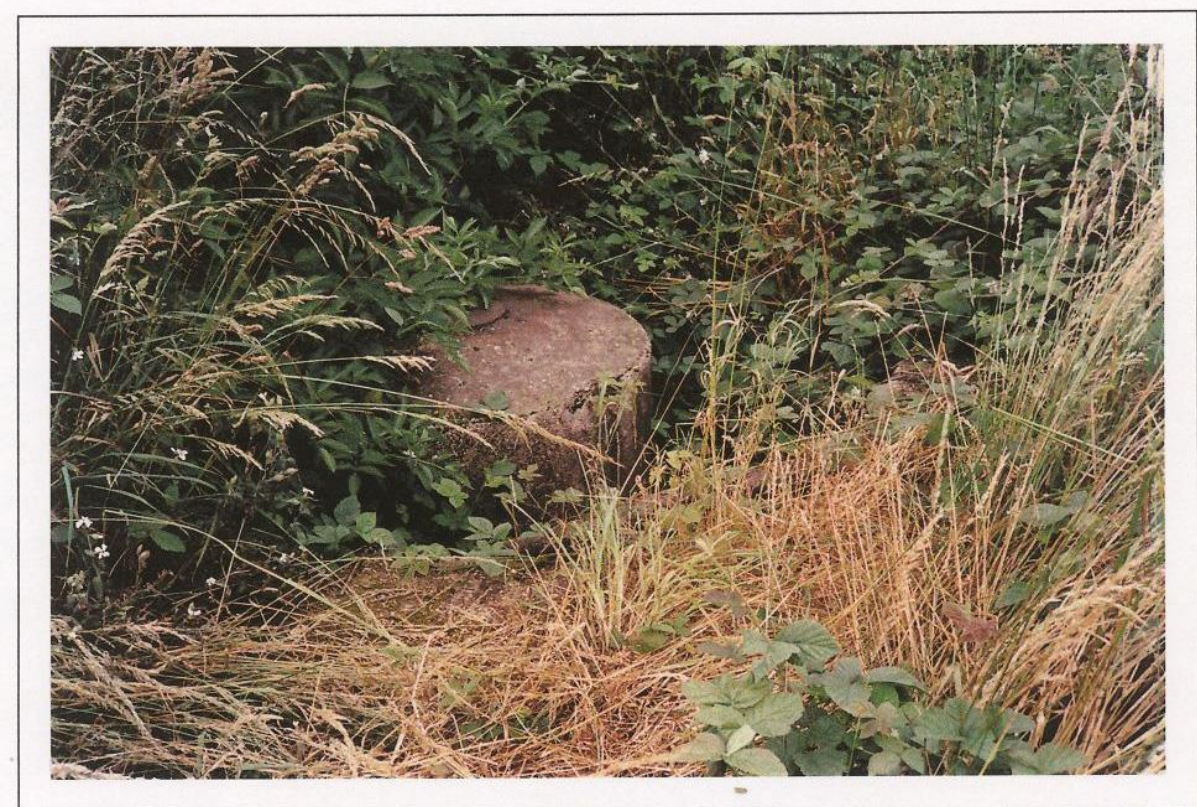
Just a few yards to the E of Mersea Road, on Middlewick Ranges, is a 29 mm spigot mortar emplacement. The pit is extant in tall grass; there are four ammunition alcoves. Off the N face there is probably an L-shaped integral trench although it is difficult to be certain of this in the bramble and thicket. In the centre of the pit is the mounting pedestal, typically constructed of a sewage pipe standing on end. The stainless steel pintle has, oddly, a steel collar. This is unusual and indicates that perhaps either part of the spigot mortar was left on the pintle or a different type of gun was mounted, using the steel collar.

*SMR 20611: One of two surviving spigot mortar emplacements close to the pillbox (SMR 20610) at Middlewick Ranges.*

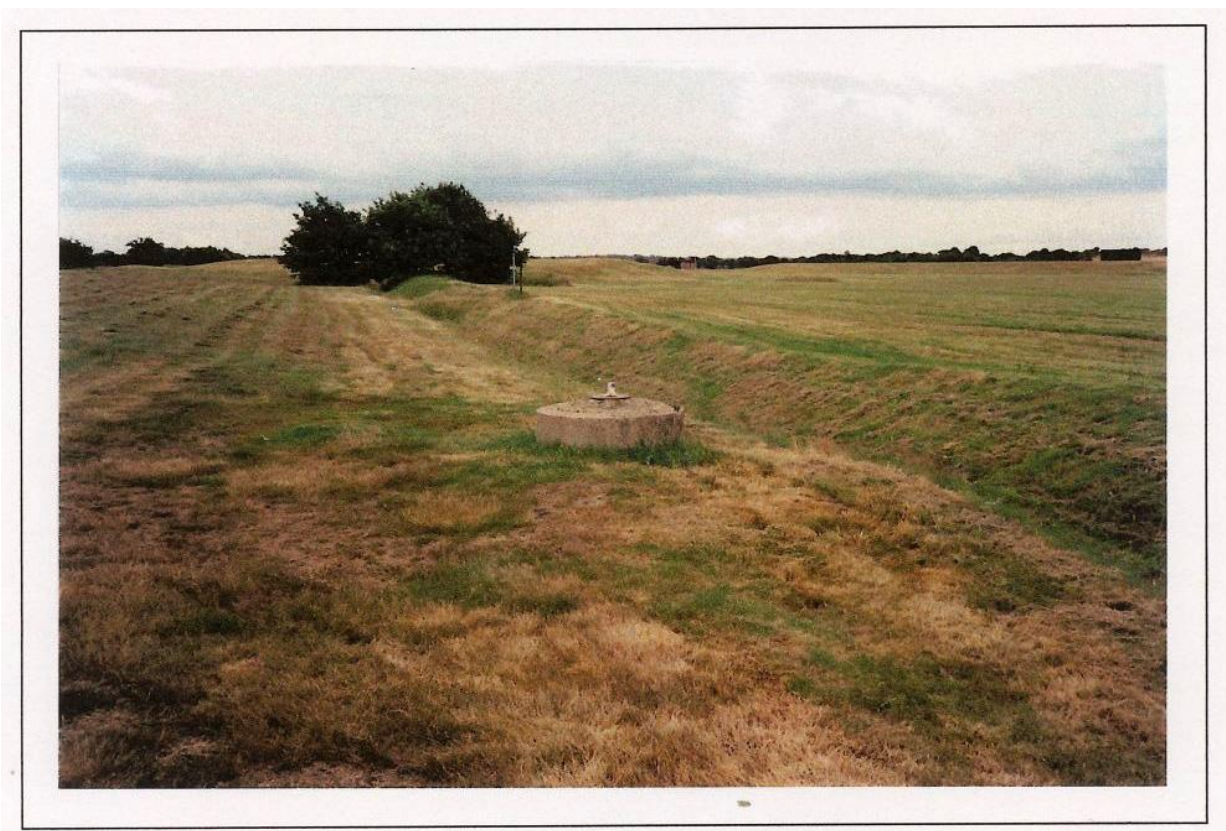
*SMR 20612: The pit and alcoves around this pedestal were filled in many years ago, but probably still survive beneath the grass and soil*

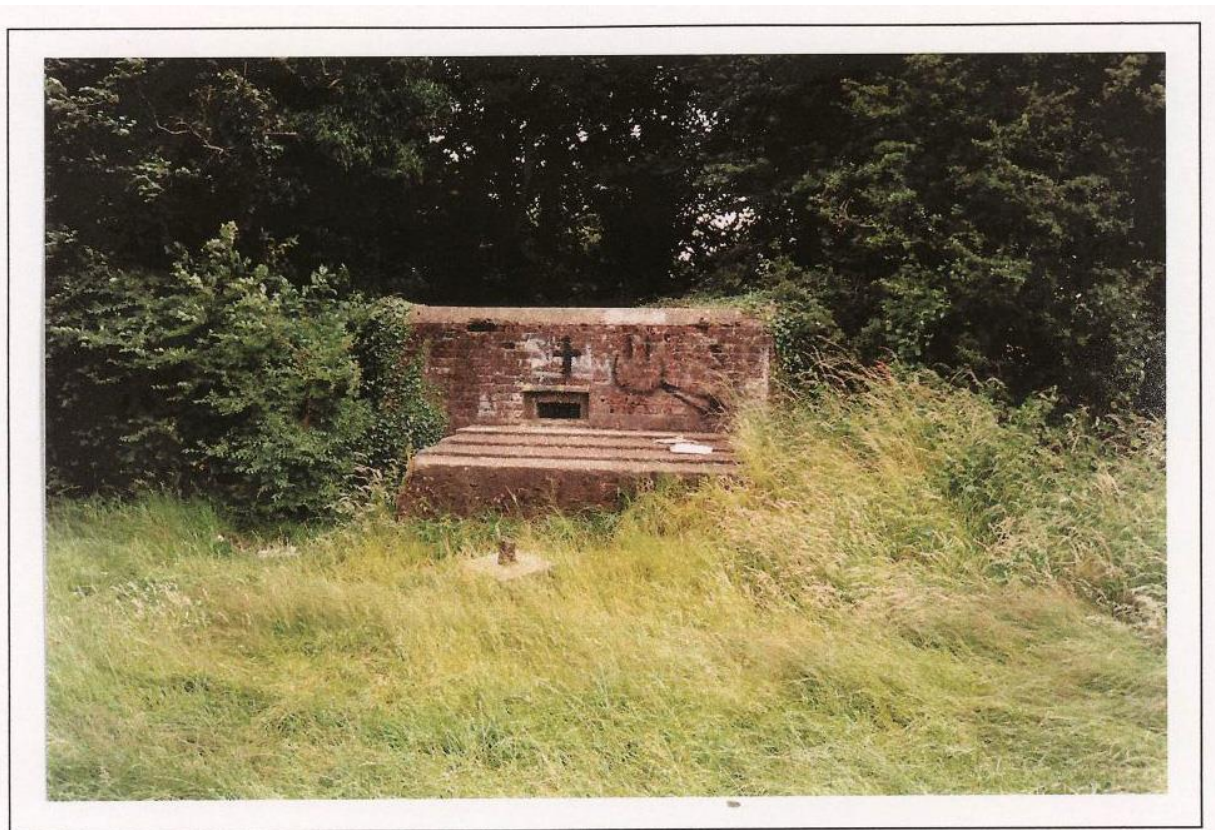
*SMR 20614: Pillboxes were designated as 'bullet-proof', generally with 15" walls, or 'shell-proof' with much thicker walls, as with this example.*

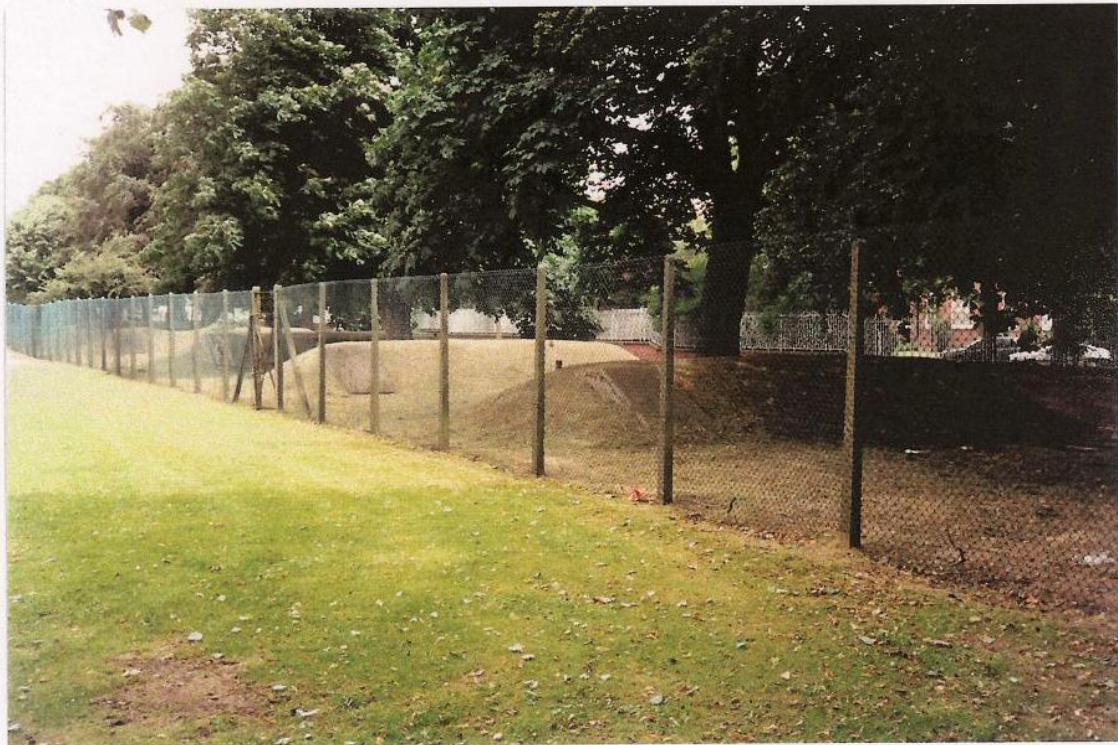
*SMR 20625: In a compound at Colchester Garrison, these six military air raid shelters have been sealed for many years.*

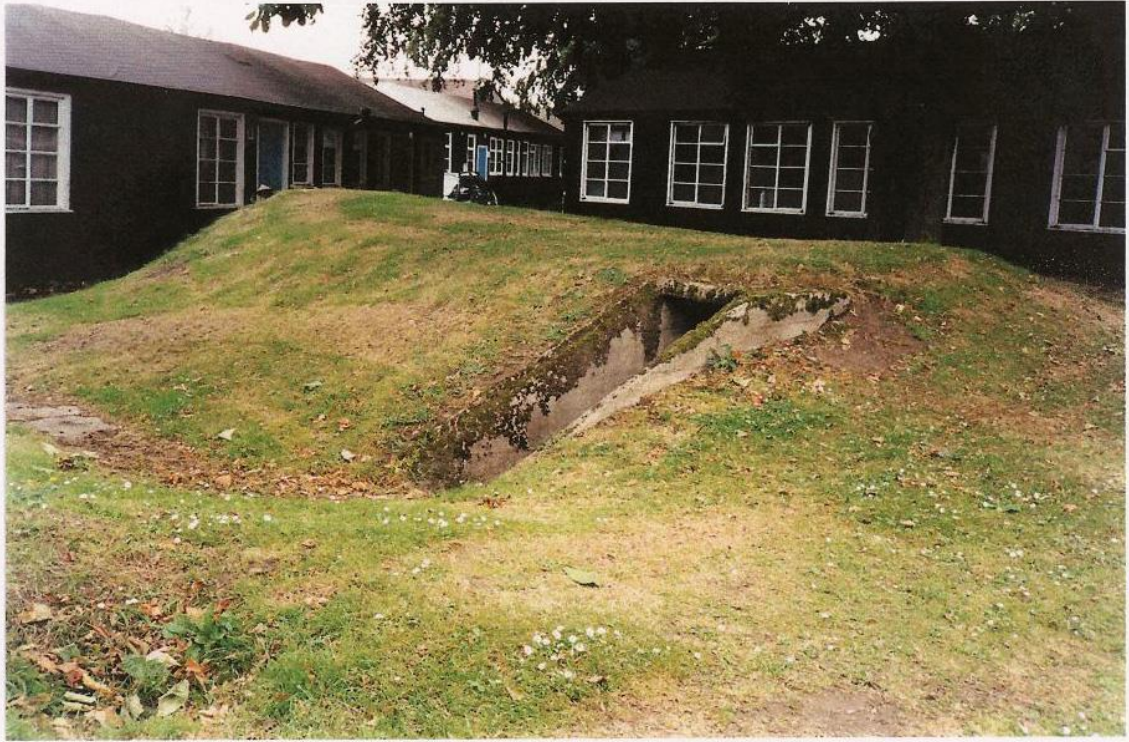
On the S side of Napier Road, immediately alongside the road, two air raid shelters of a type found on military sites, still survive. They appear to be of the same type as the six shelters recorded at TL 9993 2429 (SMR 20625) semi-sunken, an entrance at opposite ends of the sloped faces, and banked-over earth. However, the easternmost of the pair has been heavily modified with up-standing brick-built entrances and a tall brick and steel flue outlet. A notice on the door identifies its current usage as a "Plant Room". The western shelter is significant in that one of the normally slabbed-over entrances is clear, enabling access down the concrete steps to a wooden internal door. This, however, is barred and bolted. A sign says "53 COY. (v)." Outside the door, opposite the entrance steps, is a toilet cubicle, although the door is missing. At the opposite end of the shelter, the second entrance remains slabbed over.

*SMR 20626: These military air raid shelters have clearly been modified to some extent.*

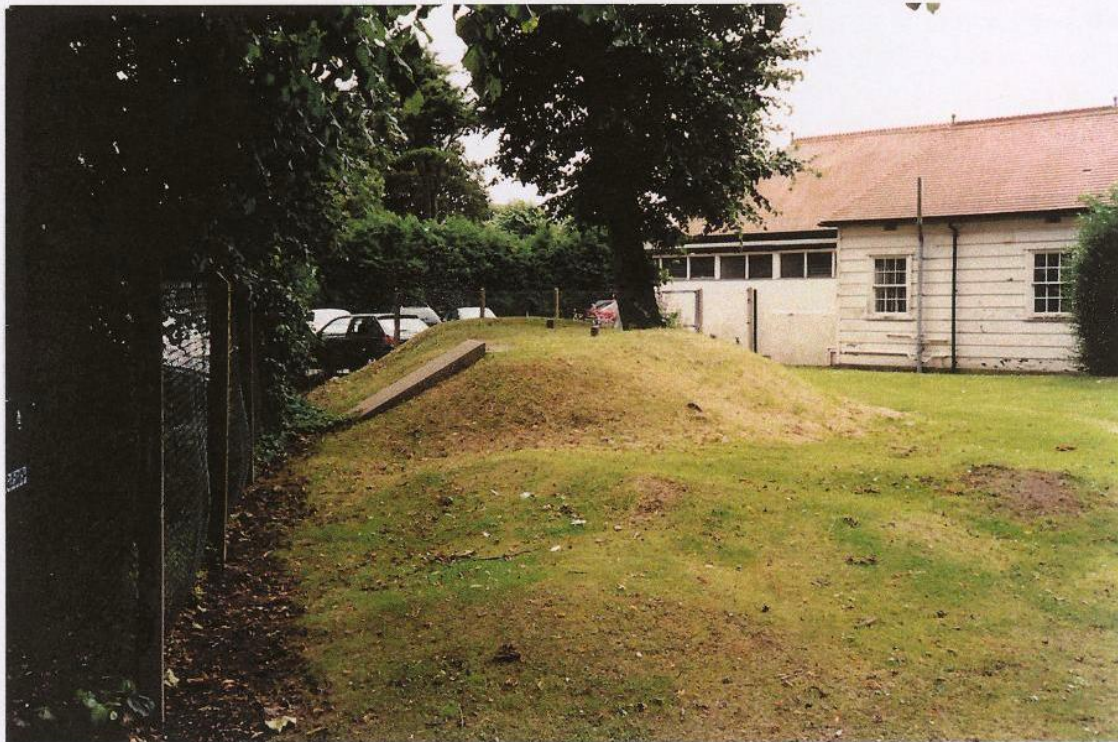
*SMR 20627: During World War Two there were a great many air raid shelters at Colchester Garrison. Now, just a handful survive*

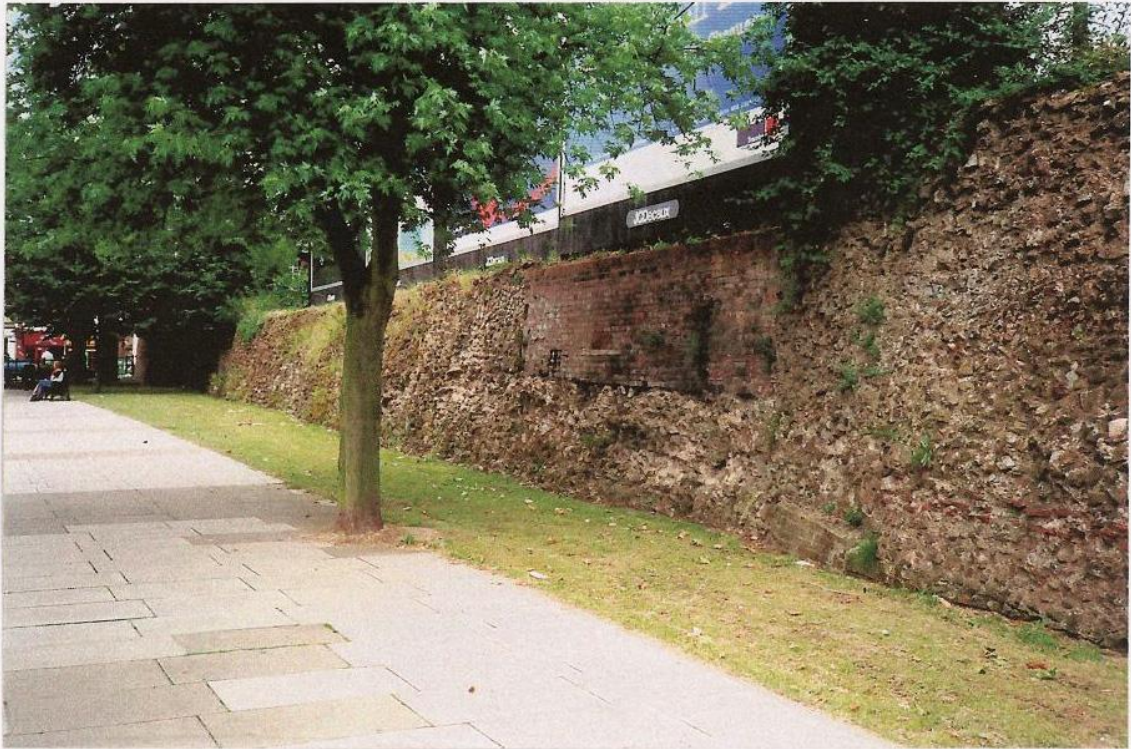
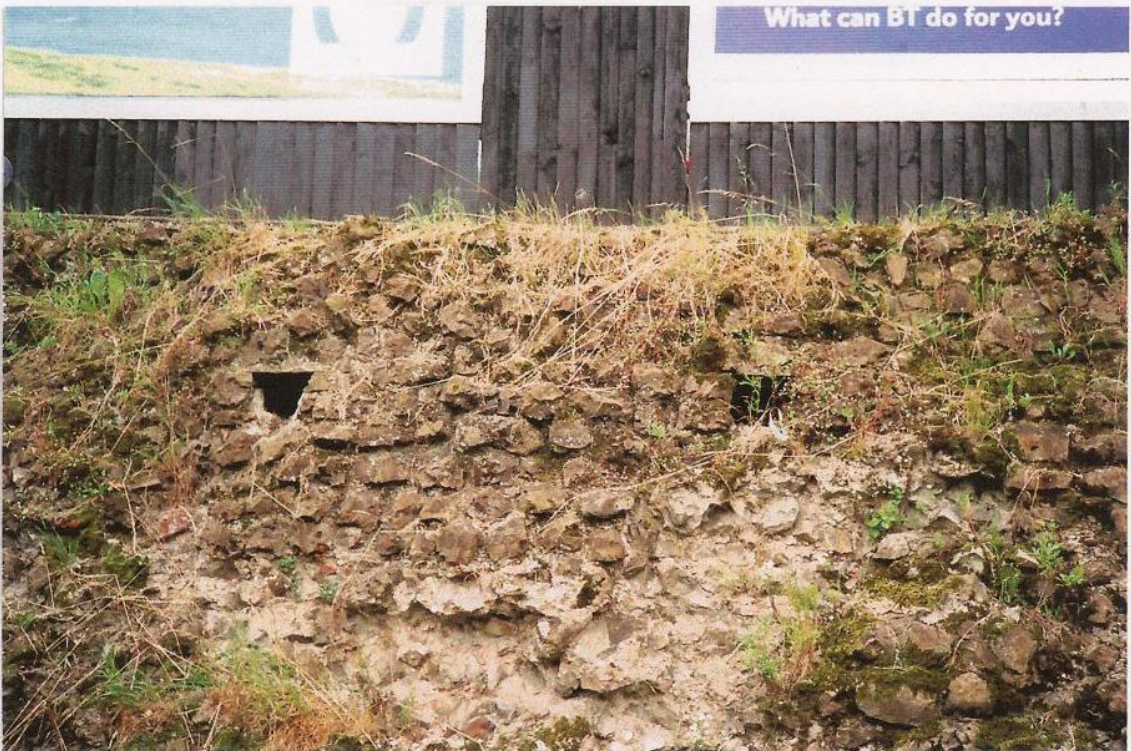
*SMR 20628: No further details of a bunker beneath Cistern Yard have come to light. These are the holes in the wall.*

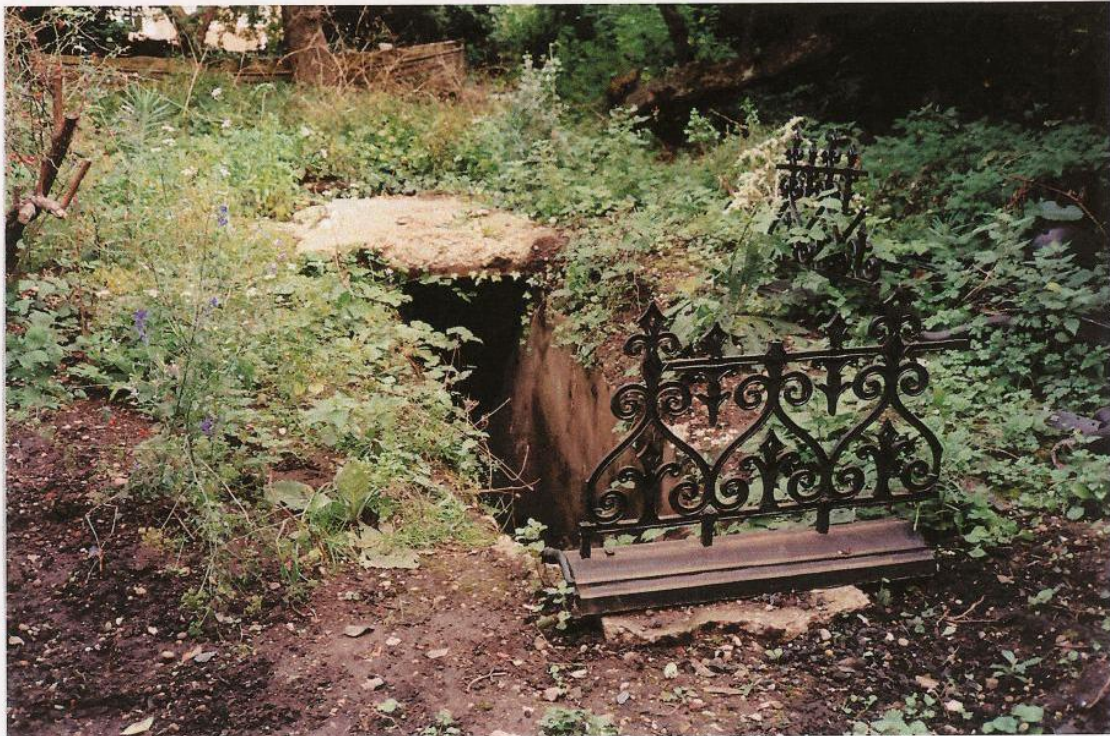
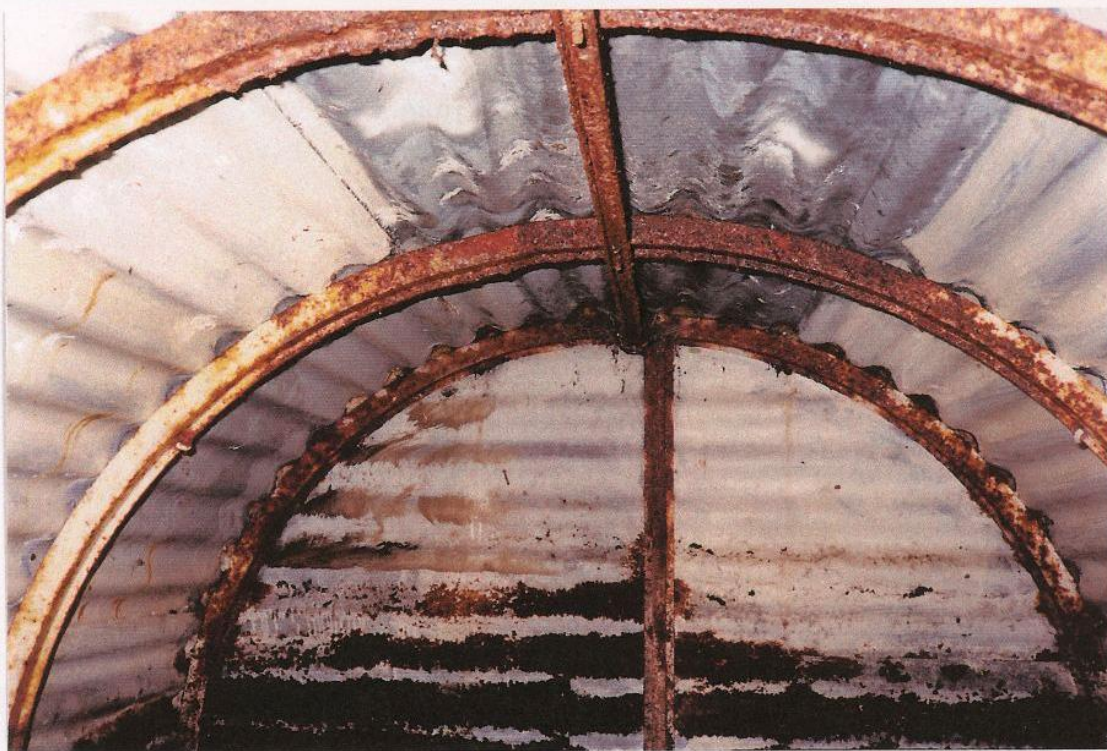
*SMR 20630. Private air raid shelters are not normally recorded by the World War Two Defences in Essex project but this example, discovered only recently, is particularly unusual.*

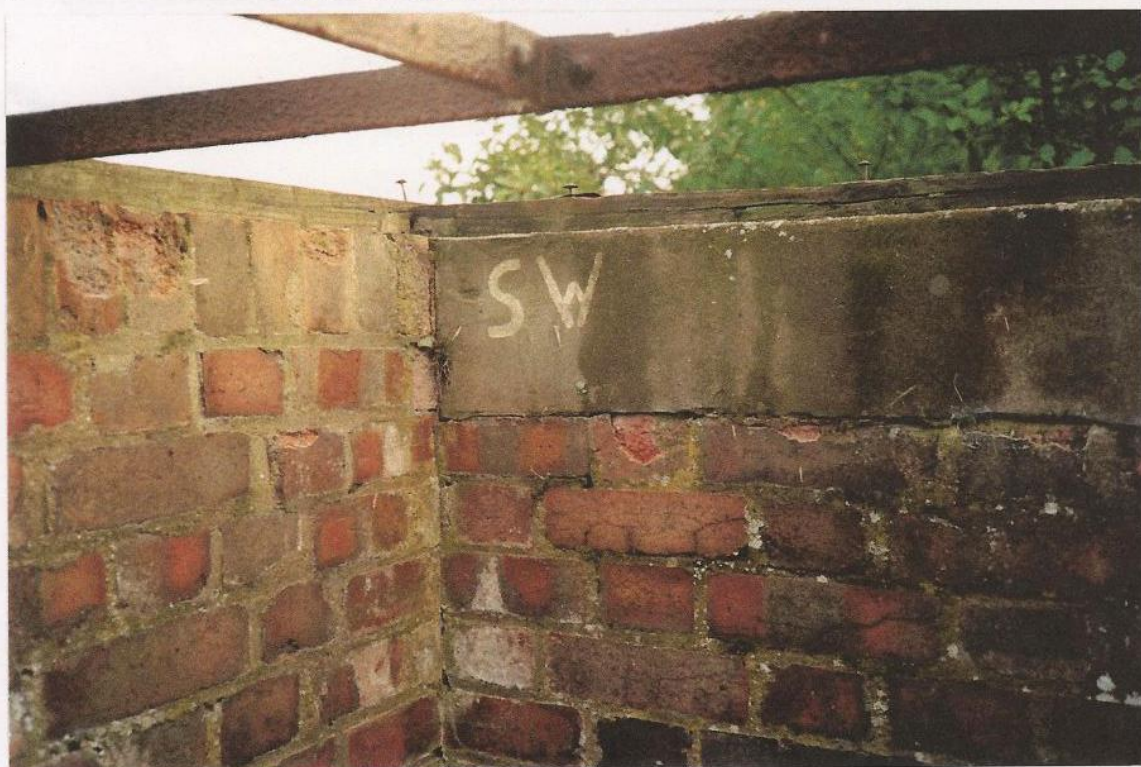
*SMR 21090: The survival of the R.O.C. post, by no means as substantial as, say, a pillbox, is remarkable.*

R.O.C. posts of this type are now thought to be very rare, certainly in Essex, and this example is in particularly good condition. As such, every effort should be made to ensure its continued survival, ultimately to Scheduled Monument status.

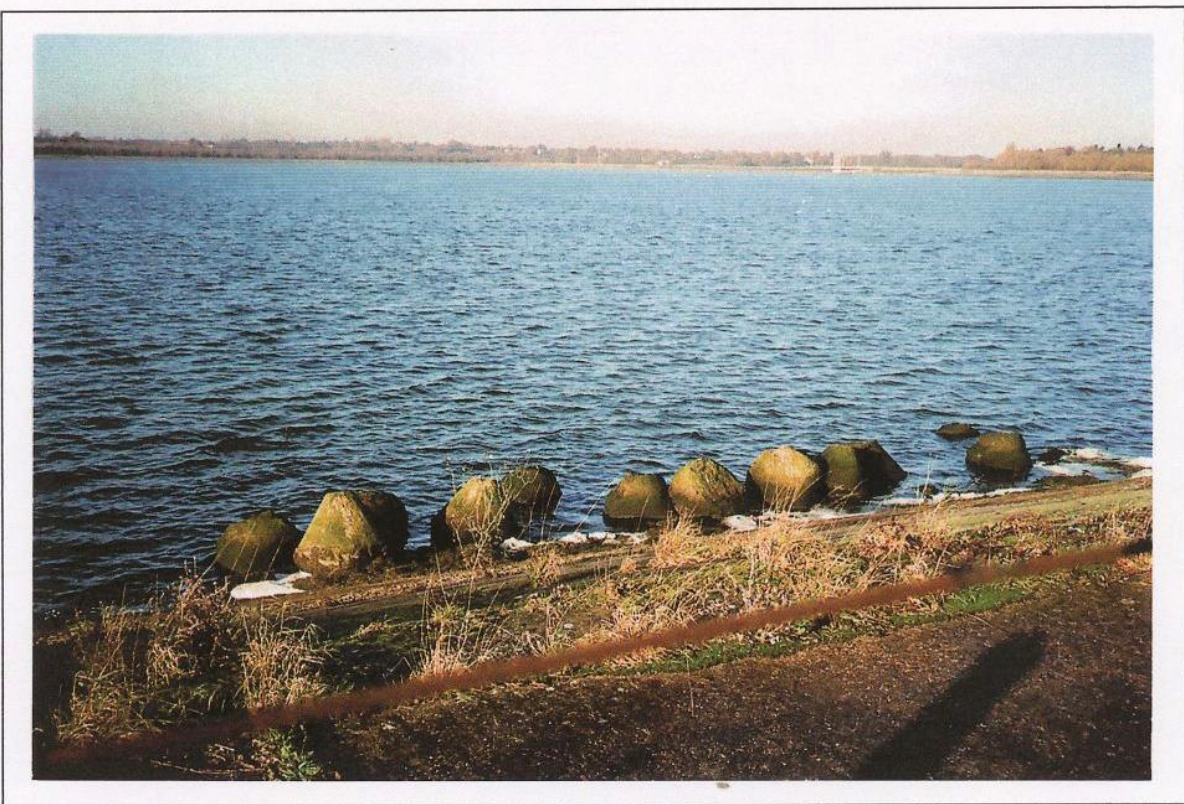
*SMR 21102: Although it is clear that these anti-tank pimples are some of those which breached the gap between the anti-tank ditch and the reservoir, it is not known how they came to be dumped in the water.*

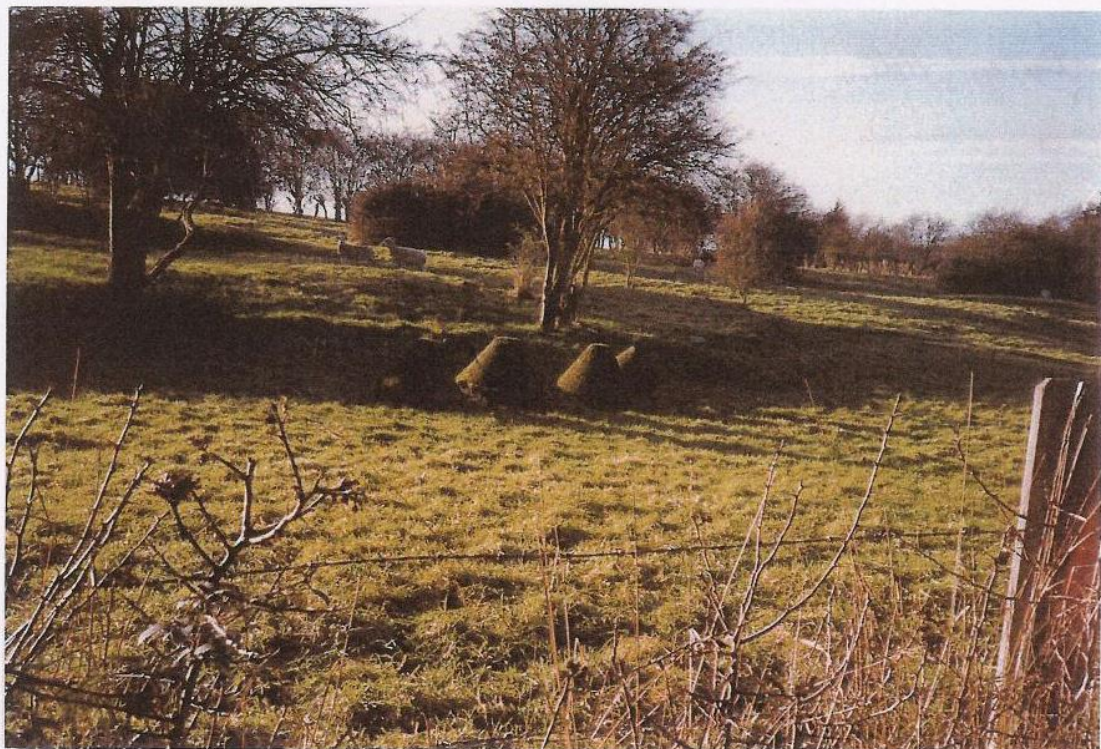
*SMR 21104: Just one pimple remains in situ in the hedge, but on the other side of the road some of those which were taken up still lie in a field.*

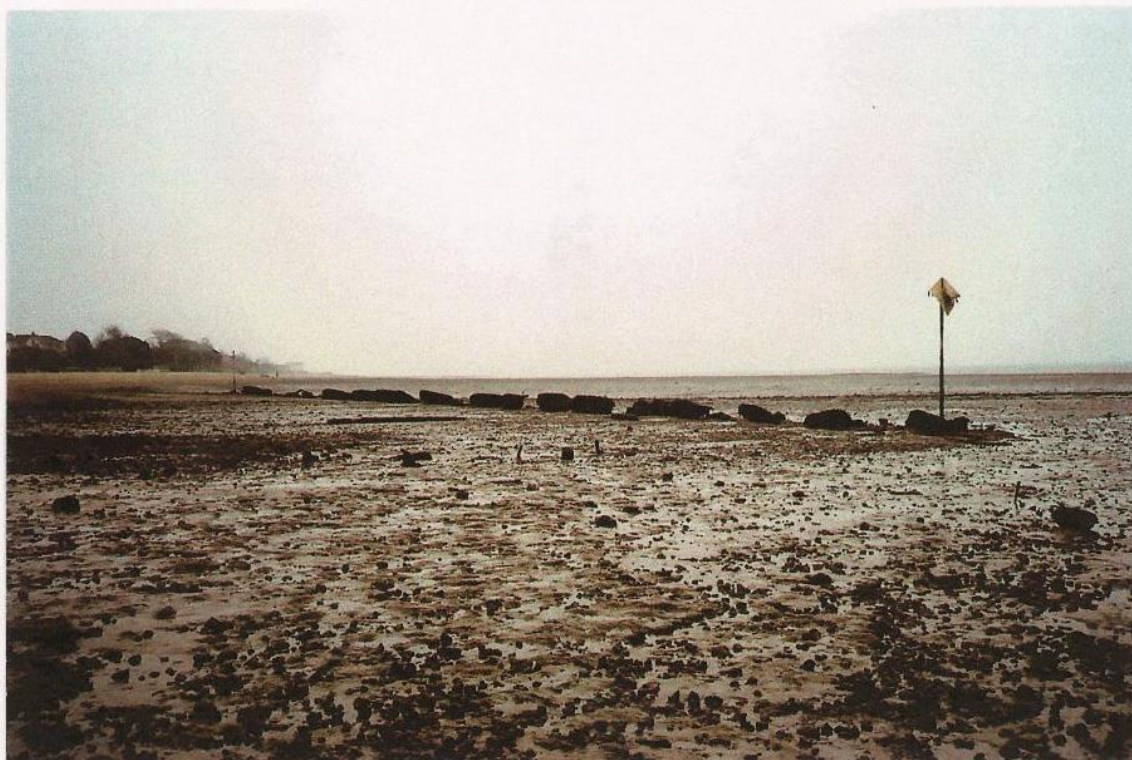
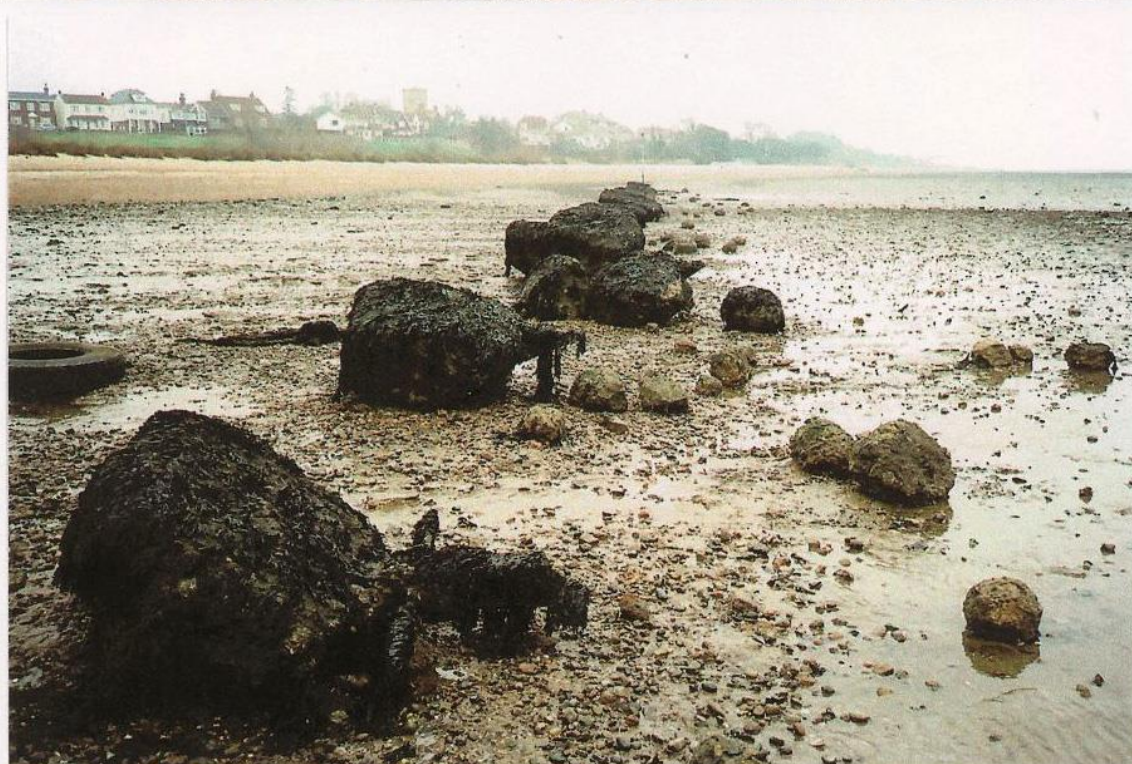
*SMR 21111: Uprooted by man or nature sometime during the past 67 years, these anti-invasion obstacles now lie encrusted in mud and seaweed. It is not known whether this was the total length of the line of such obstacles here or whether, perhaps soon after the war, others were removed.*

This type of anti-invasion obstacle in the sea is now very rare and these are an important part of our World War Two heritage. No others are known to still exist in Essex. However, there is little doubt that they could present a danger to wind surfers, jet skiers and swimmers. A tall steel post with a warning triangle has been erected at each end of the line but there is no indication of what this means or the fact that a potentially dangerous obstacle lies hidden between the posts at high tide. It is strongly recommended that a more explanatory warning sign be erected on the beach, possibly combined with an information board on the World War Two heritage of Mersea.
