# **SURVEY OF WORLD WAR TWO DEFENCES IN THE BOROUGH OF COLCHESTER**

**PROJECT REPORT: NOVEMBER 2007**

### **Section C: SMR 20494 -- 21159**

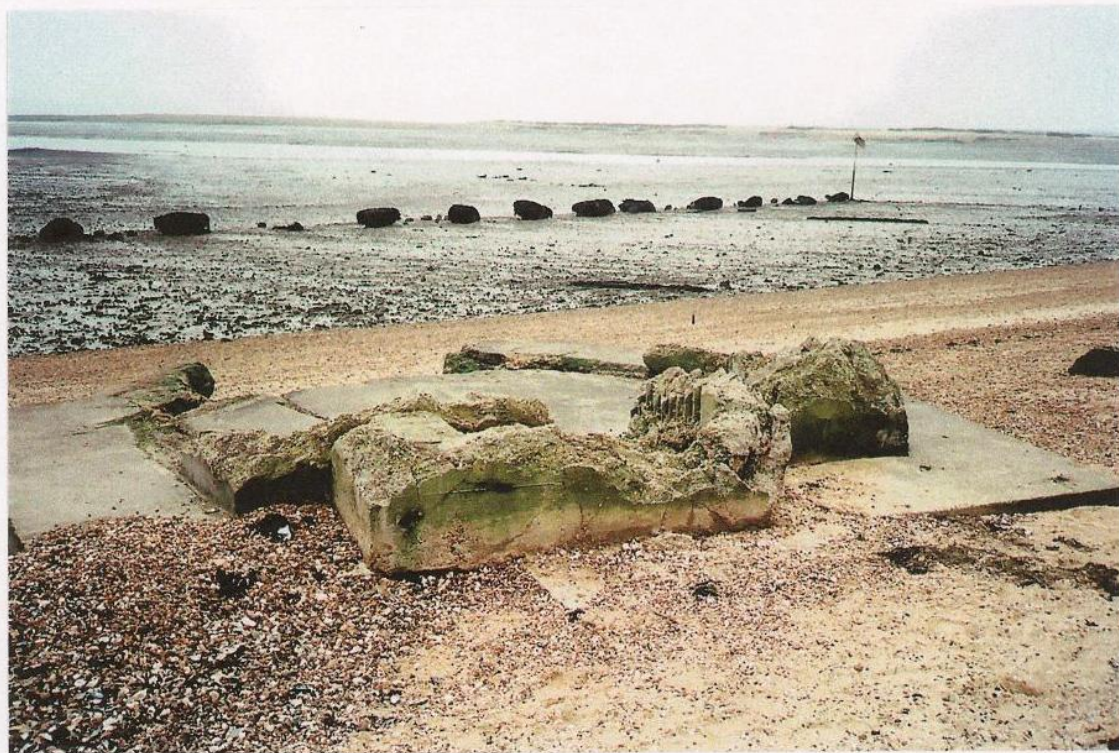
*SMR 21112: Although not much more than the base of this pillbox now remains, much can still be made out of its original size, type and structure.*

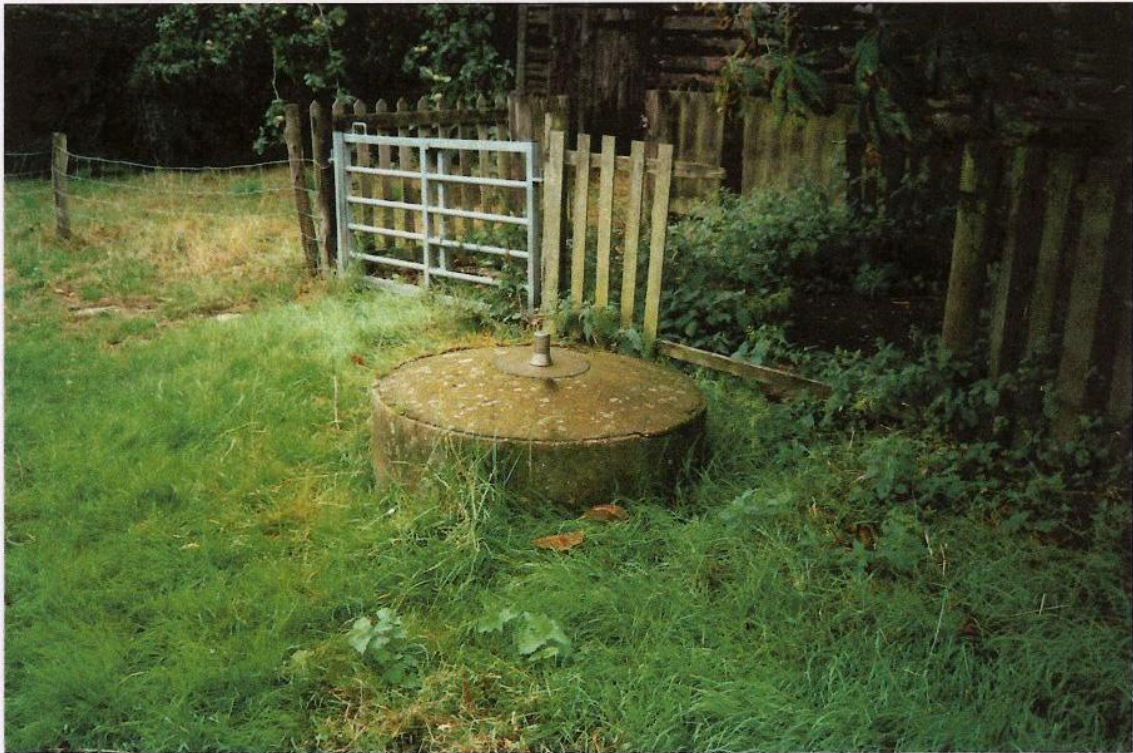
This pedestal, with its stainless steel pintle on top, stands just a foot out of the grass to the W of a small hay shed or pig sty. From here, the gun could have fired on both Wormingford Bridge less than 100 yards to the NW or along Bowdens Lane which runs N to S just a few yards away.

*SMR 21125: Like its partner (SMR 21126) it is probable that beneath the grass and soil, the pit, with its ammunition alcoves, still survives.*

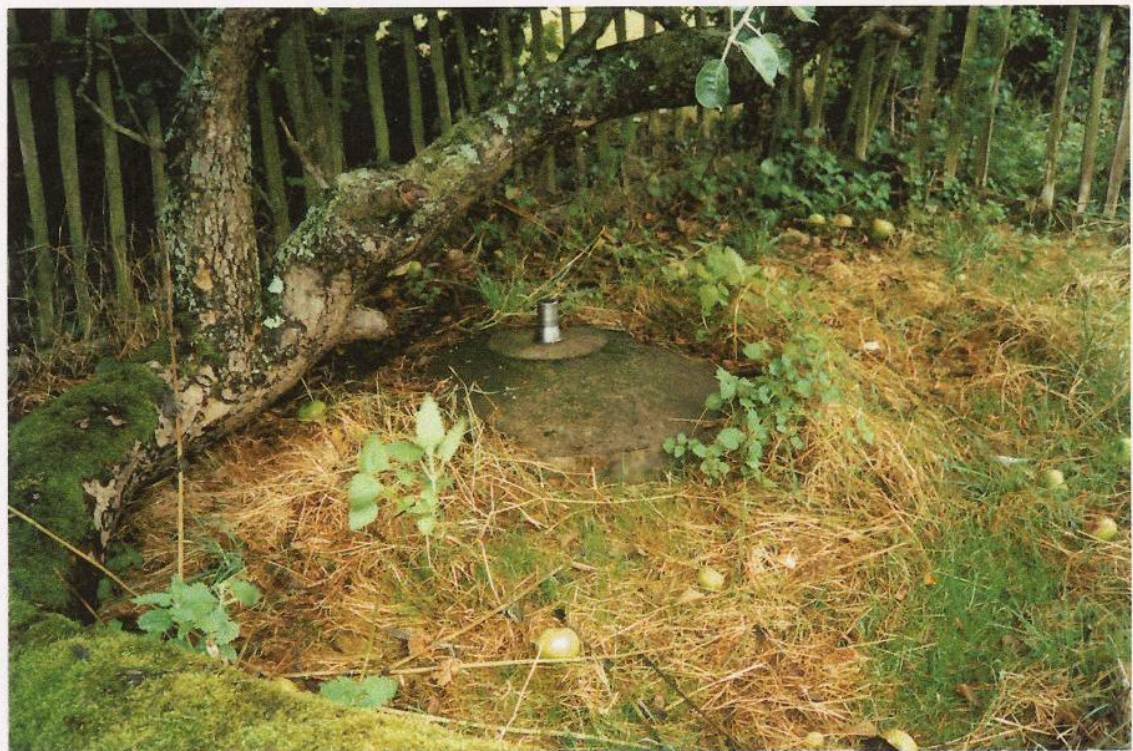
*SMR 21126: Most spigot mortar pintles were formed from high grade stainless steel which still remains bright to this day*

Just the top of the pedestal, with its stainless steel pintle, can be seen of this emplacement. It lies in the SE corner of a small meadow bordering the River Stour which runs alongside the property. From this position the gun could easily cover the approach to Wormingford Bridge which is less than 100 yards away to the SW.

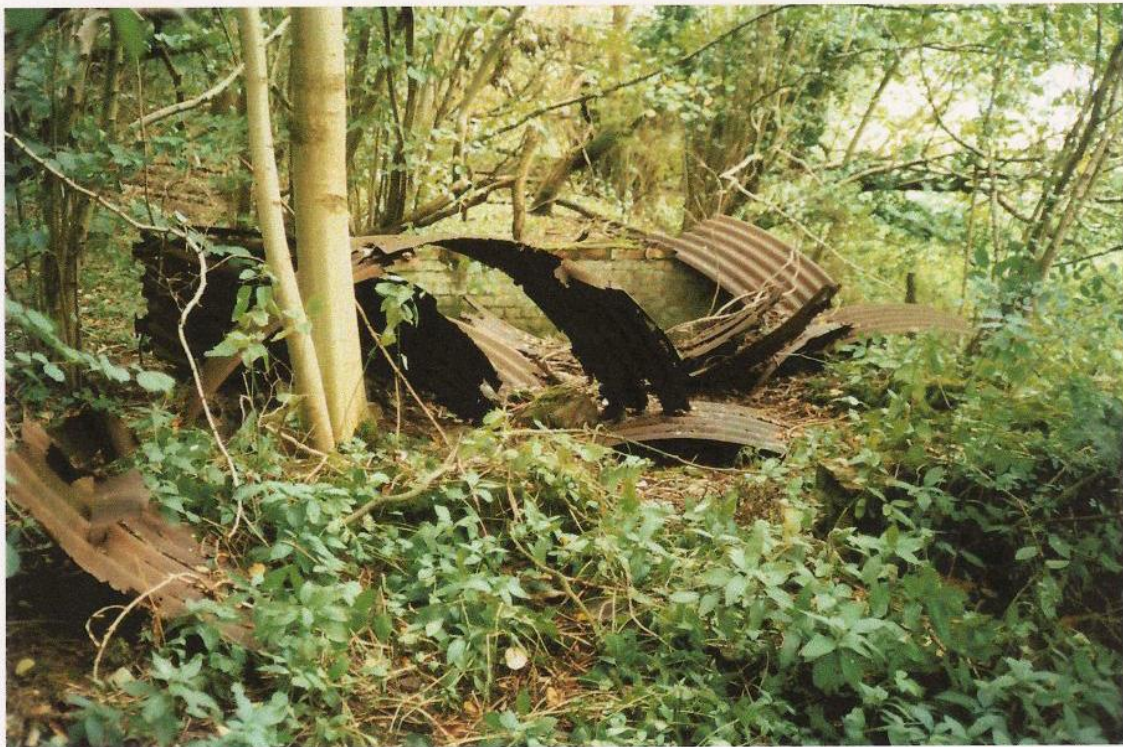
*SMR 21130: Documented in wartime records, the remains of the Fiddlers Wood ammunition shelter still lie beneath the trees.*

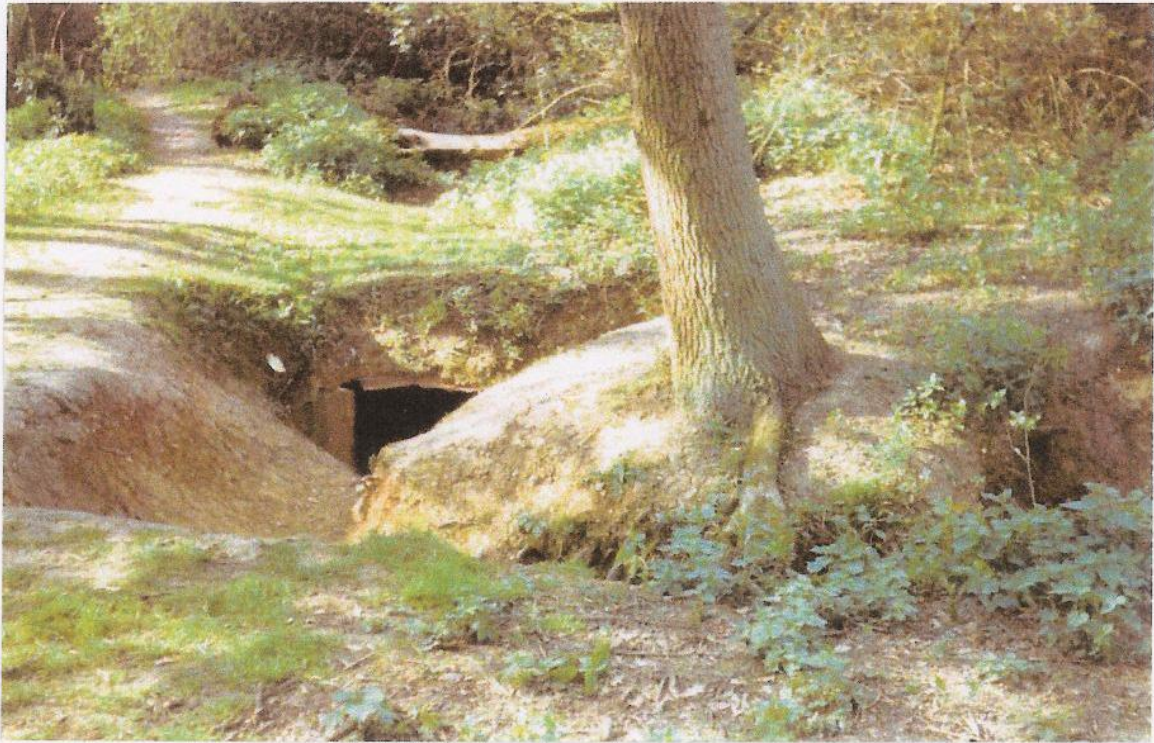
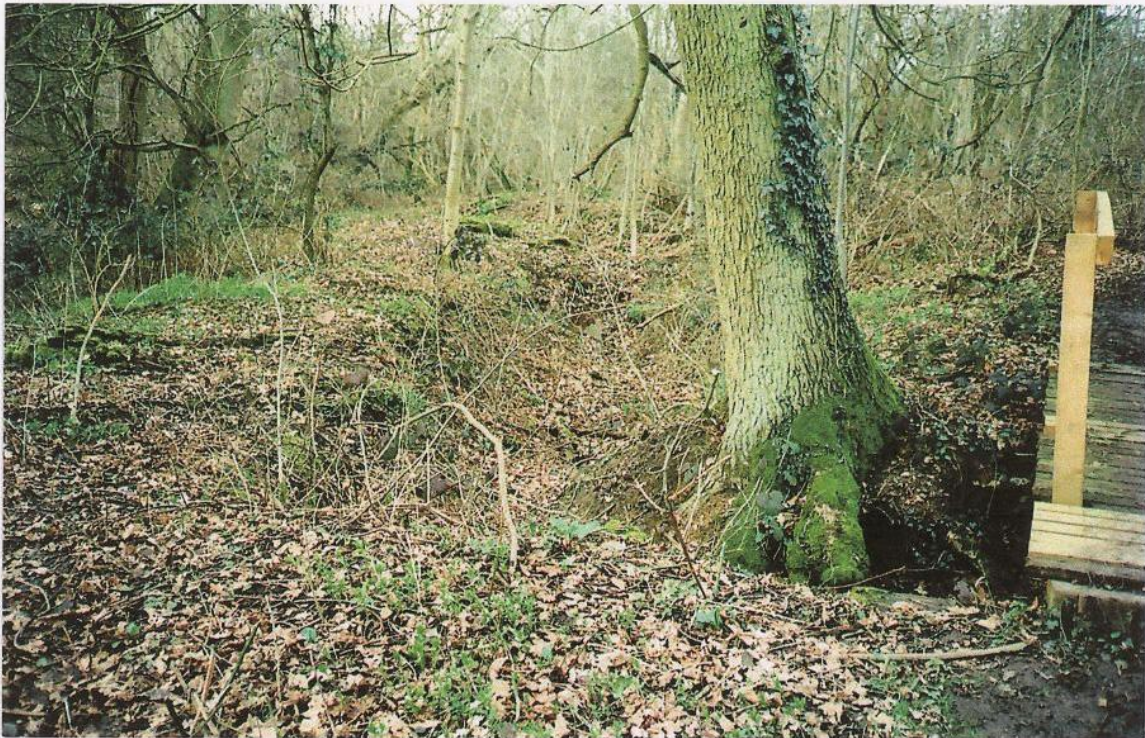
*SMR 21143: The British Resistance hideout at Gravelpit Wood. By 1974, the entry tunnel had collapsed leaving the main chamber intact and clearly visible. Thirty-three years later, in 2007, this too had fallen in leaving a much more difficult to recognise depression. However, the tree provides an excellent reference point from which to trace the remains. (1974 photograph, Derek Moore)*

deteriorating rapidly and nothing should be done to increase this deterioration. Interest in WWII remains has grown considerably in recent years. It is recommended that alongside the wooden bridge, erected to enable local people to further enjoy walks through the woodland, an interpretative board should be erected outlining the history of the British Resistance "Auxiliary Units" during World War Two and the significance of the remains at Copford Pits Wood.

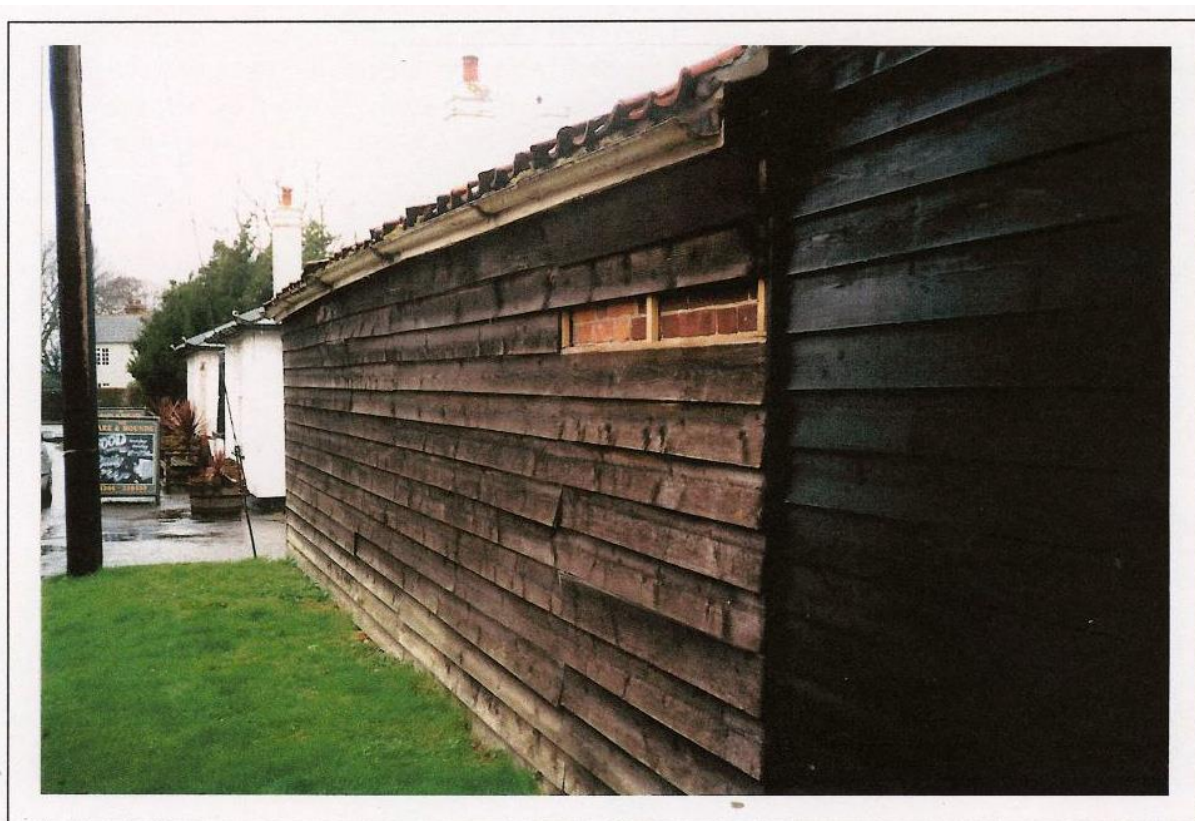
*SMR 21149: Differing brickwork can be seen beneath the wooden cladding but it is not known if this indicates blocked-up loopholes.*

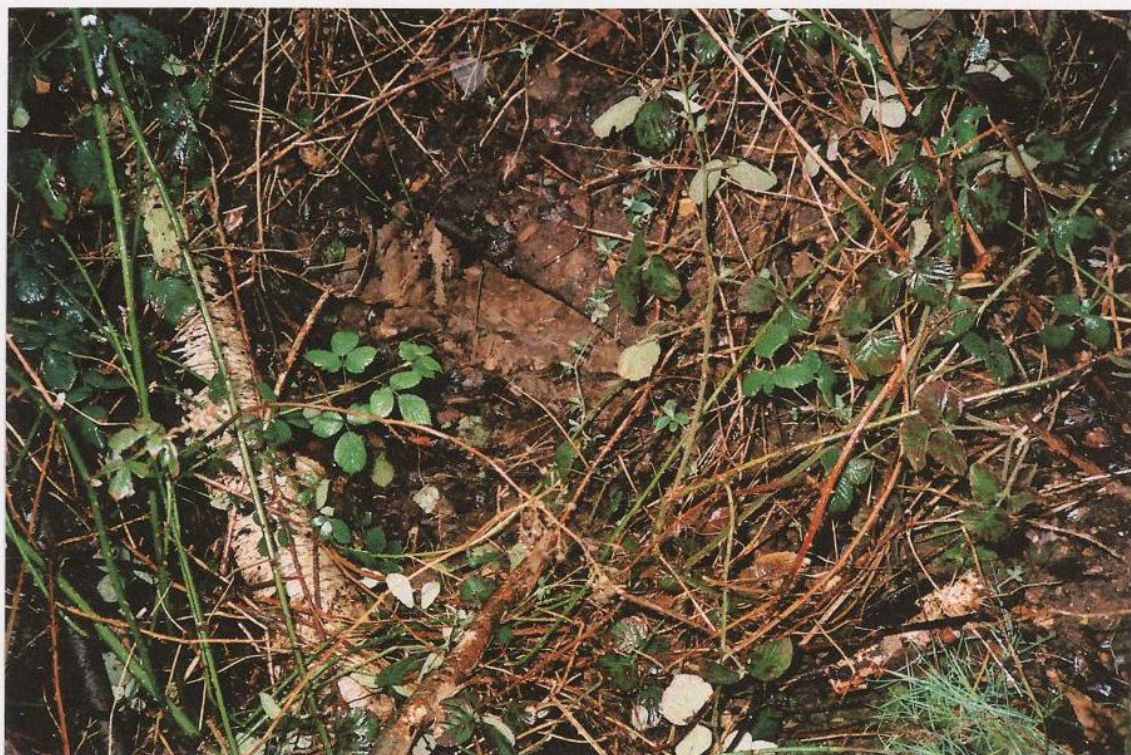
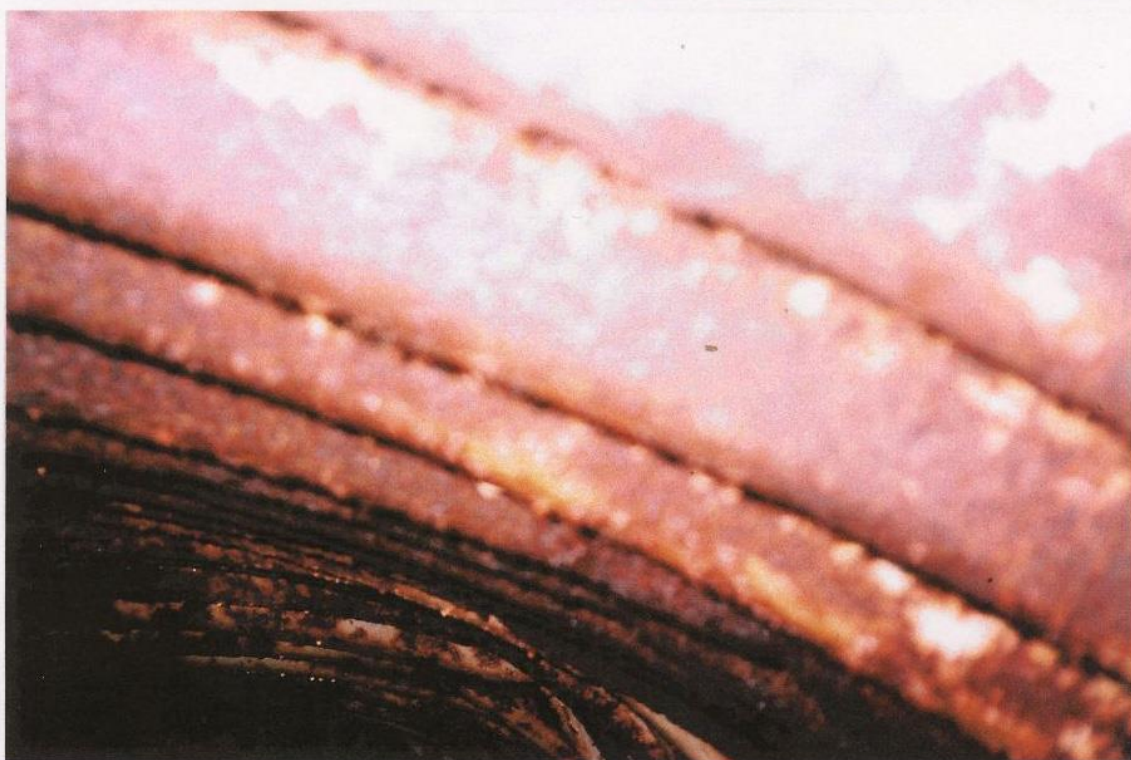
Around the site, bits of corrugated steel sheeting lie half-buried in the overgrown, broken-up ground. Along the W side of the dyke a small stream contributes to the difficulties in gaining the overall picture of the site.

*SMR 21150. In the brambles and thicket, the remains of the British Resistance hideout at Chest Wood are difficult to find, and photograph. The bottom picture was taken by thrusting a hand-held camera into the roof opening.*
